Damage Survey from the 2024 Noto Peninsula Earthquake

ver.01 (2024/02/01)

Understanding geotechnical failure and ground motions

This report partially covers damage due to ground failure with a focus on liquefaction and some damage to buildings. (This is not an extensive report of all damages in the area)

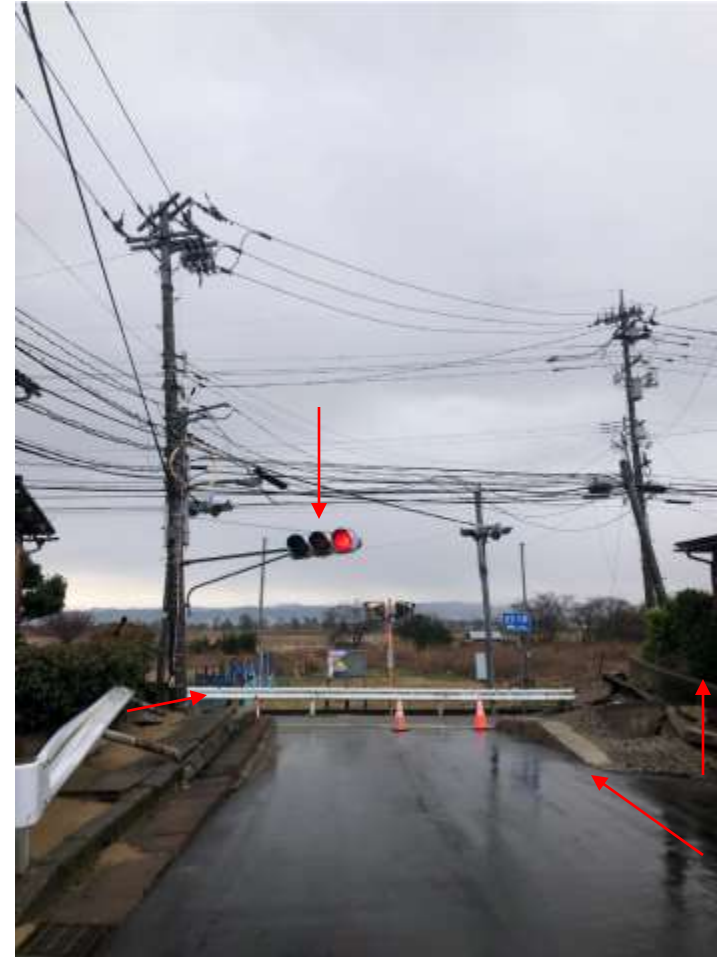
Uchinada

1. Sinking of Traffic Light and upheave of side walk

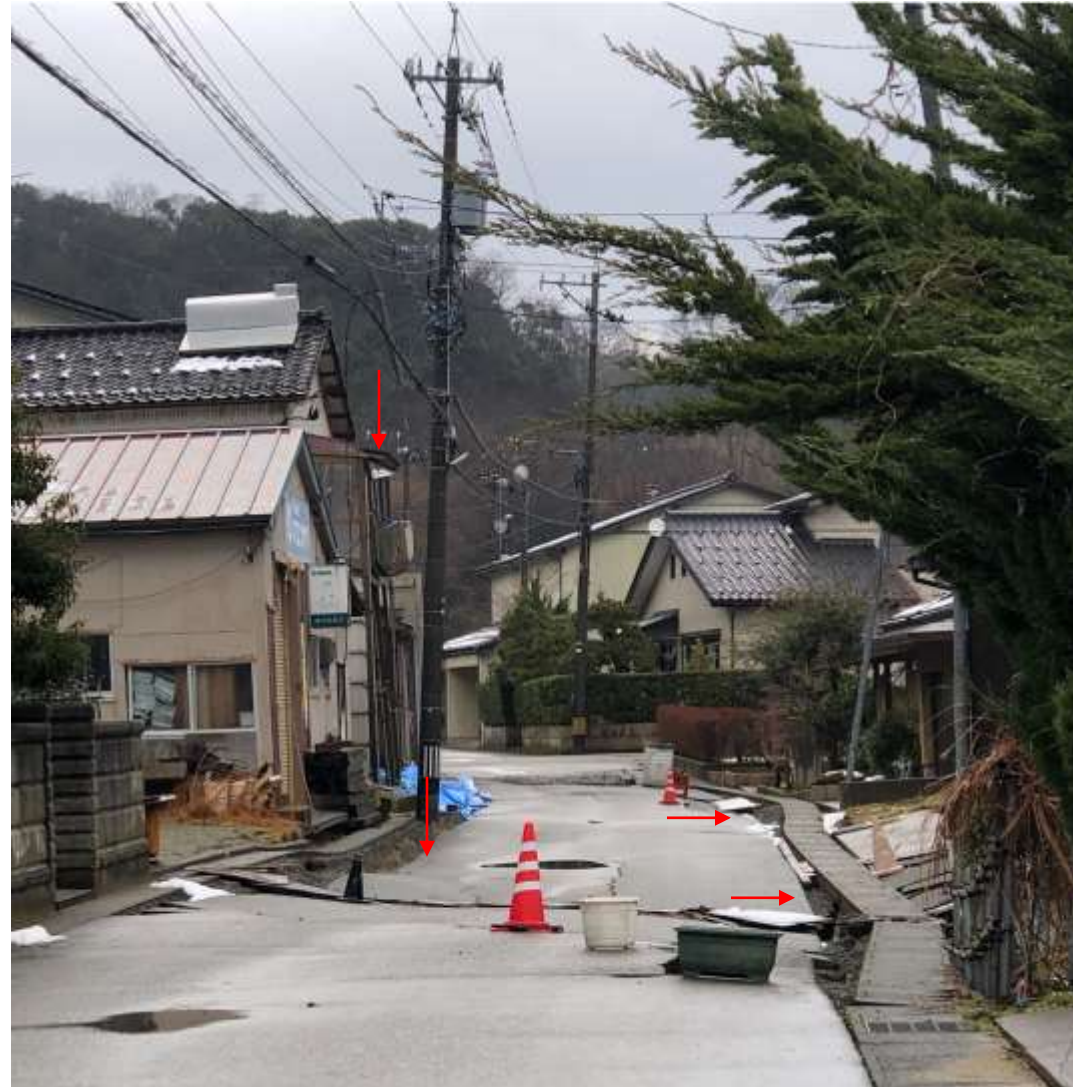
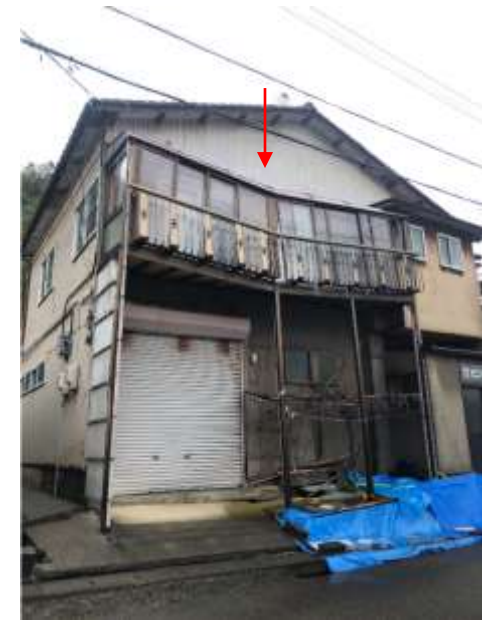
Uchinada

2. Lateral displacement (NW to SE) and vertical relative settlement

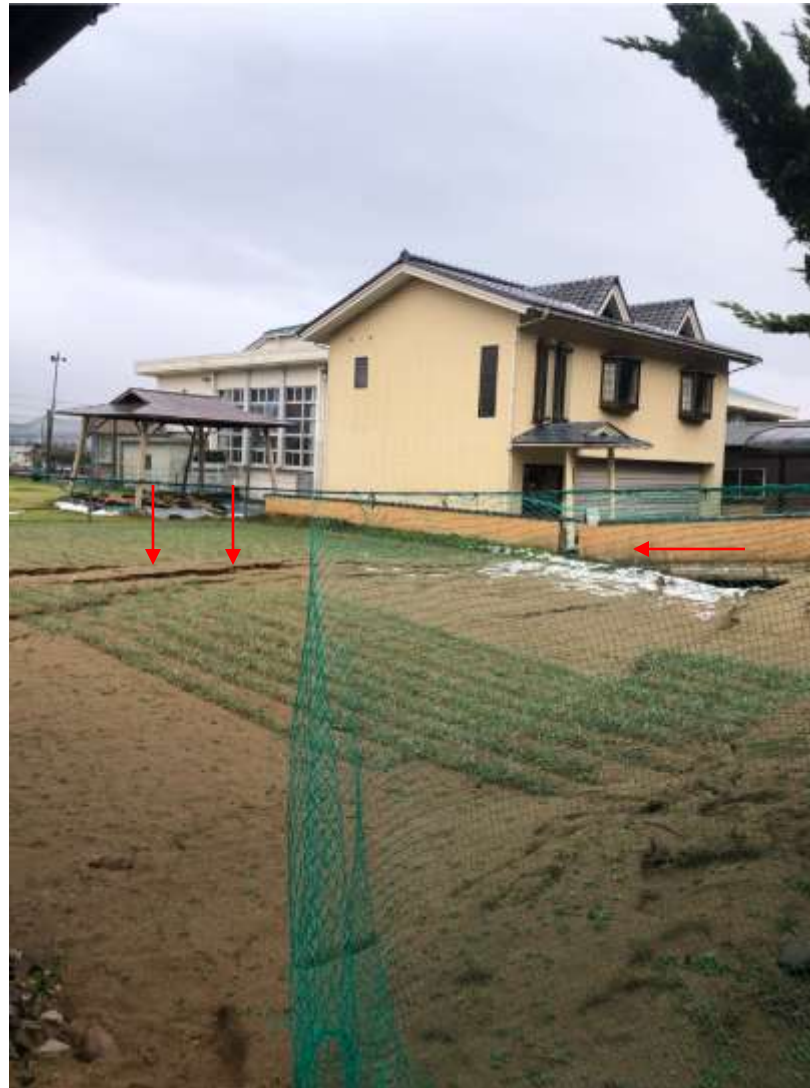
Uchinada

3. Tensile cracks, settlement and lateral spreading

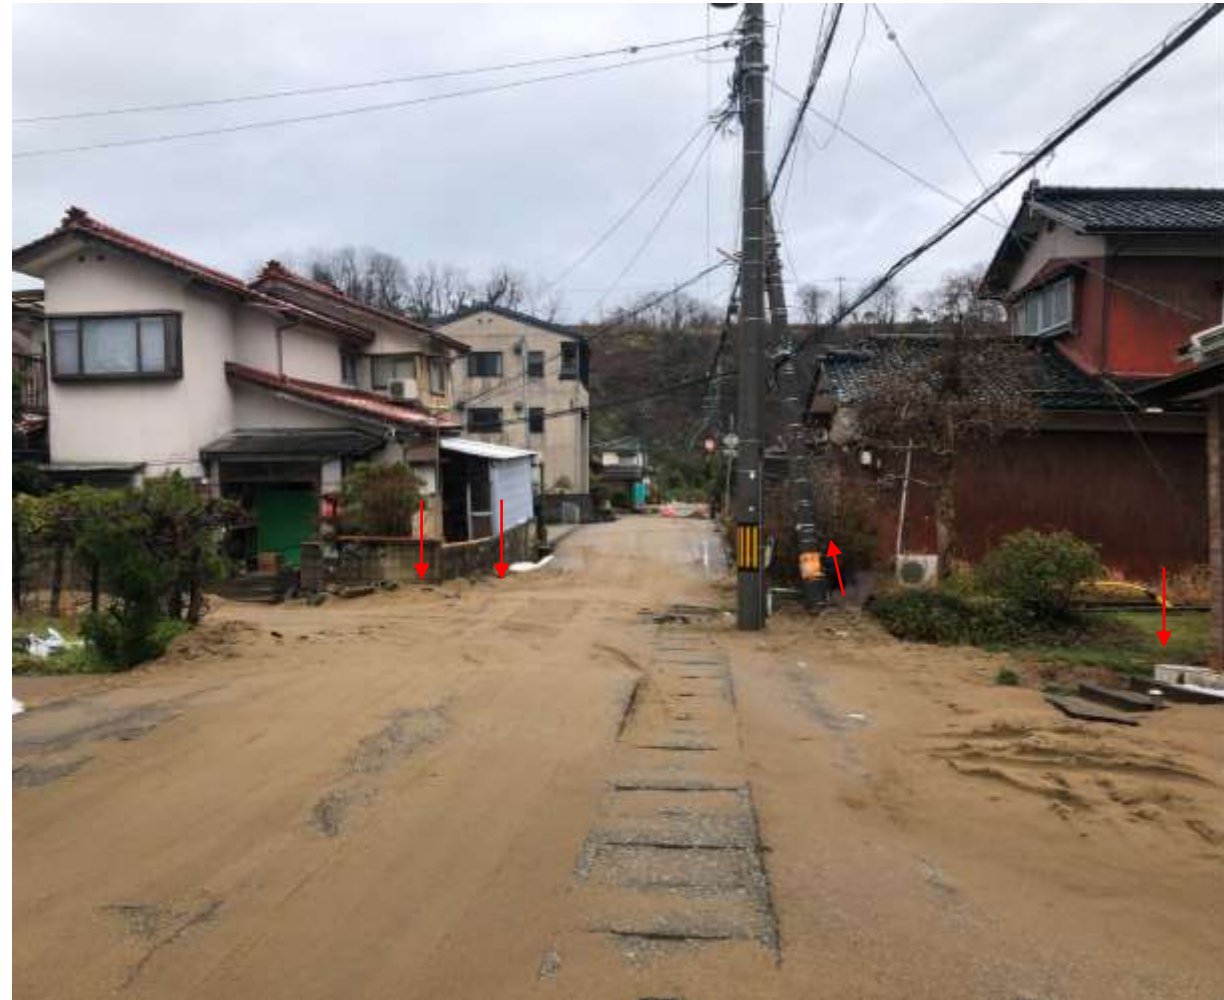
Uchinada

4. Sand ejecta, utility pole rotation and structures' settlement

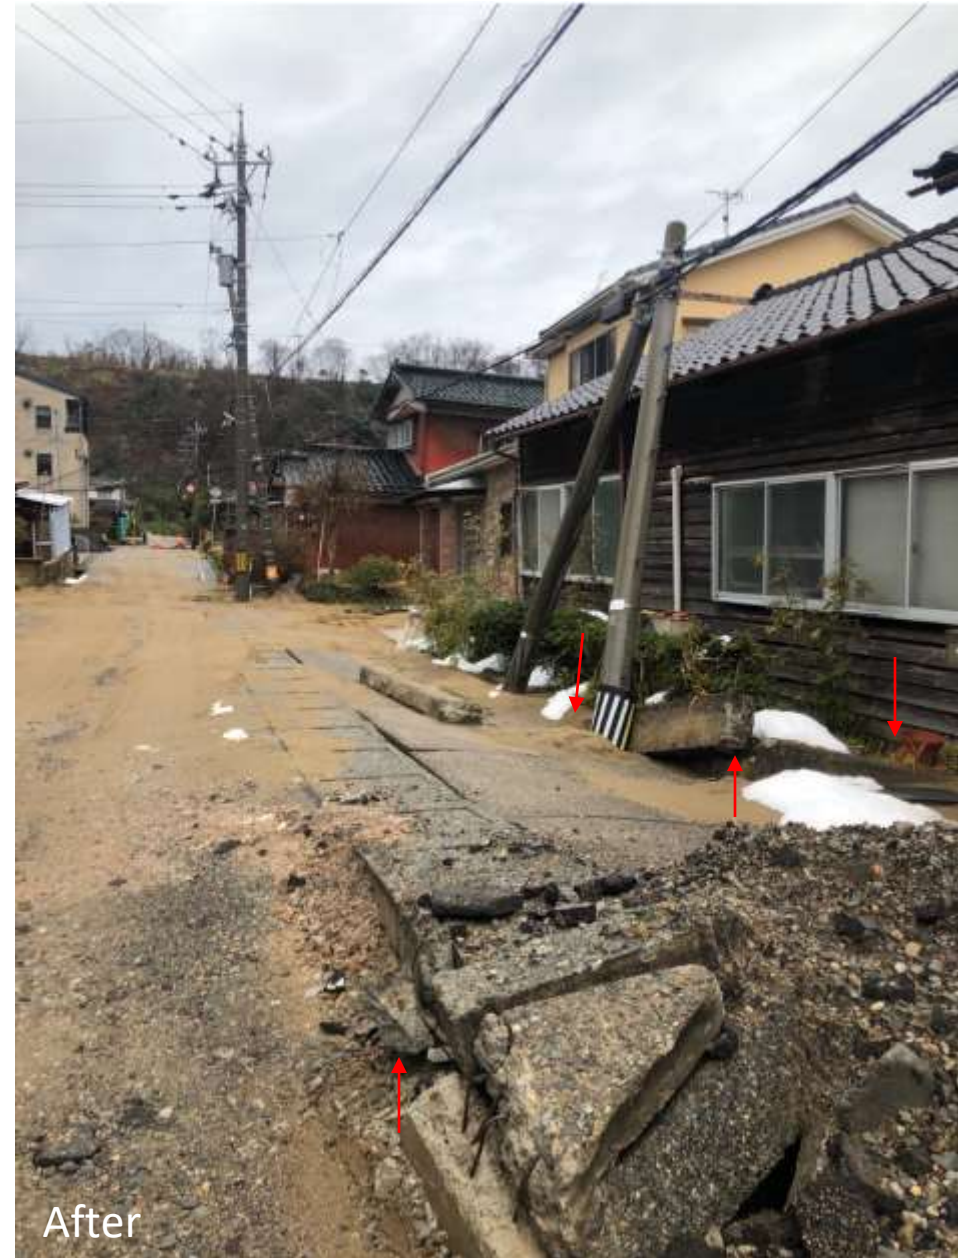
Uchinada

5. Sand ejecta, utility pole sinking and ground upheave

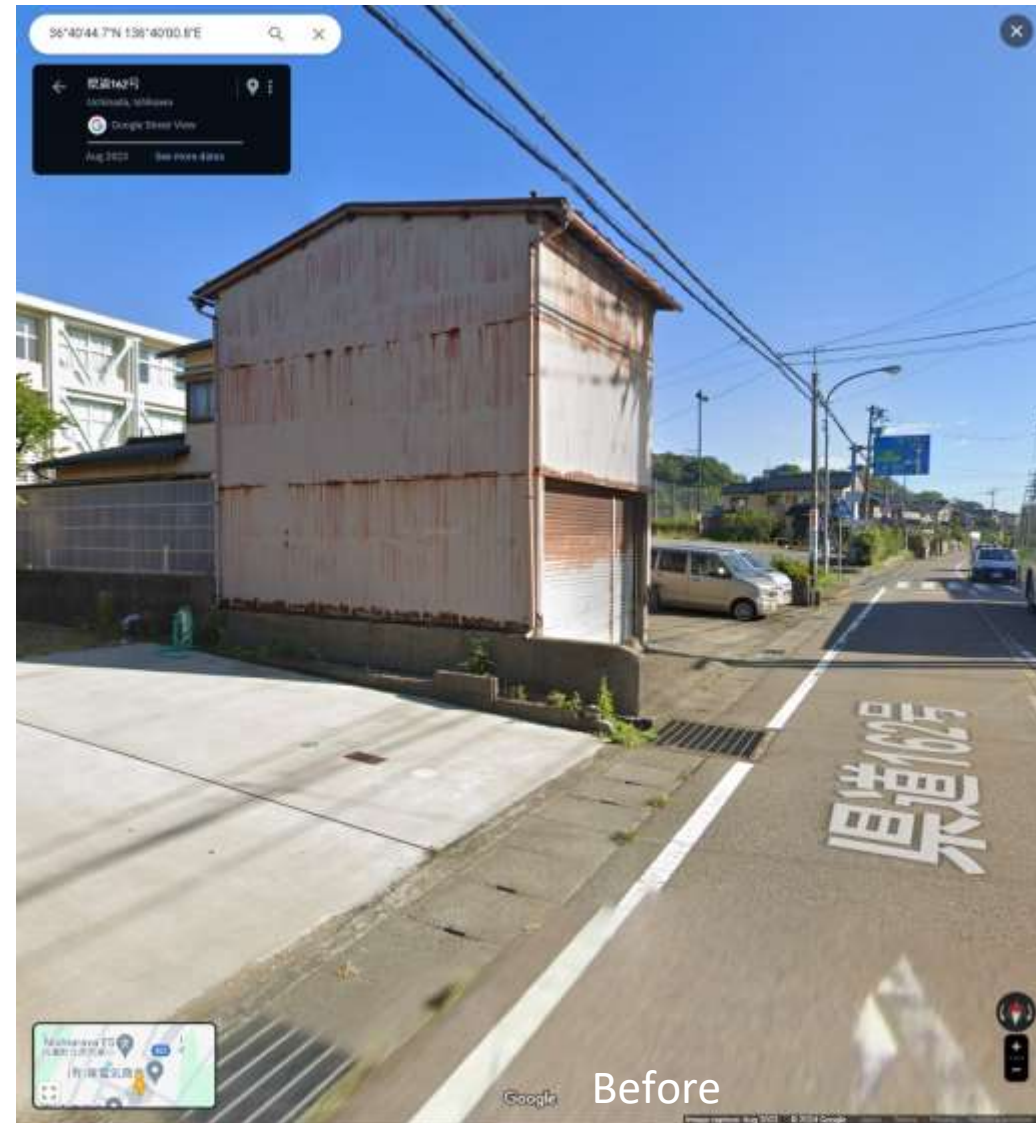
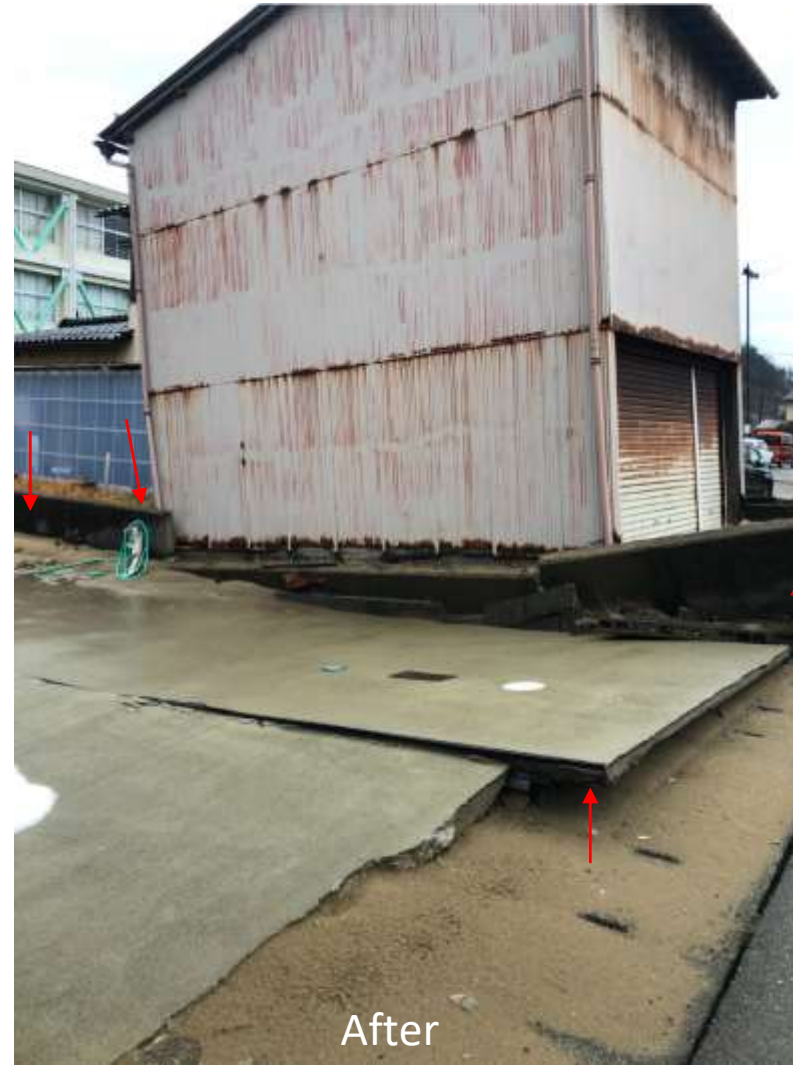
Uchinada

6. Sand ejecta, relative settlement and ground upheave

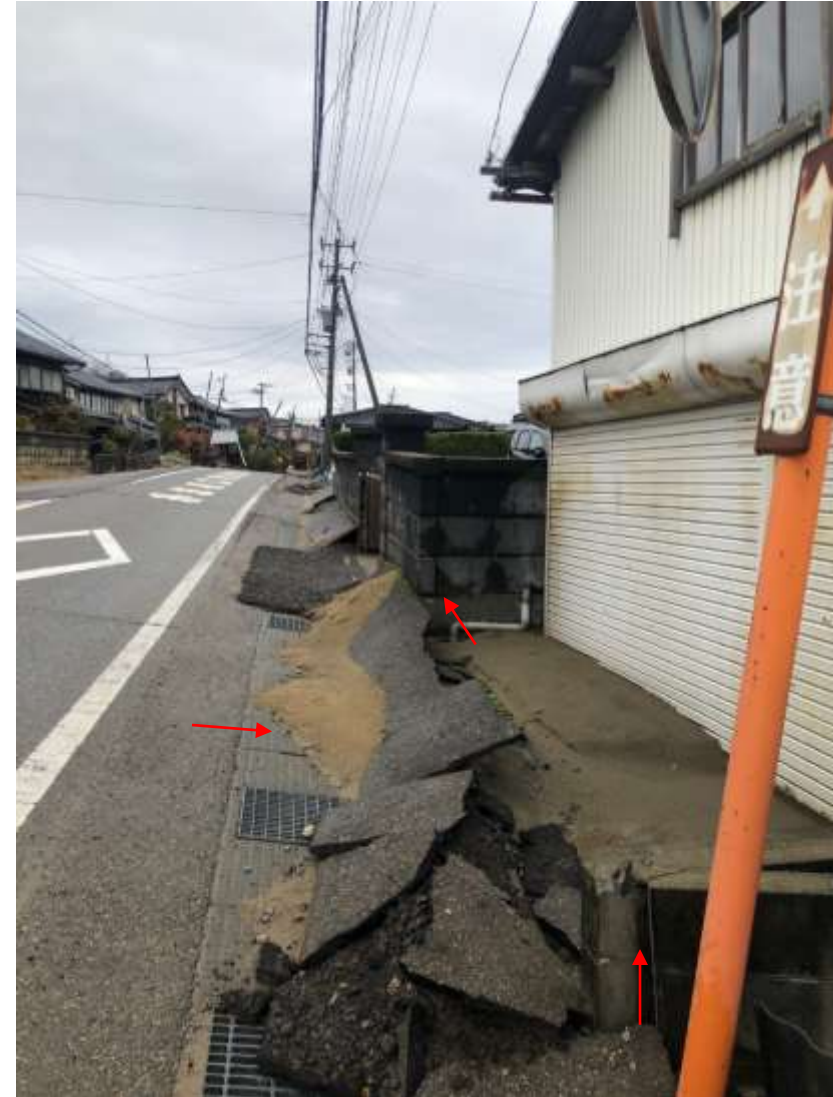
Uchinada

7. Sand ejecta, horizontal displacement and ground upheave

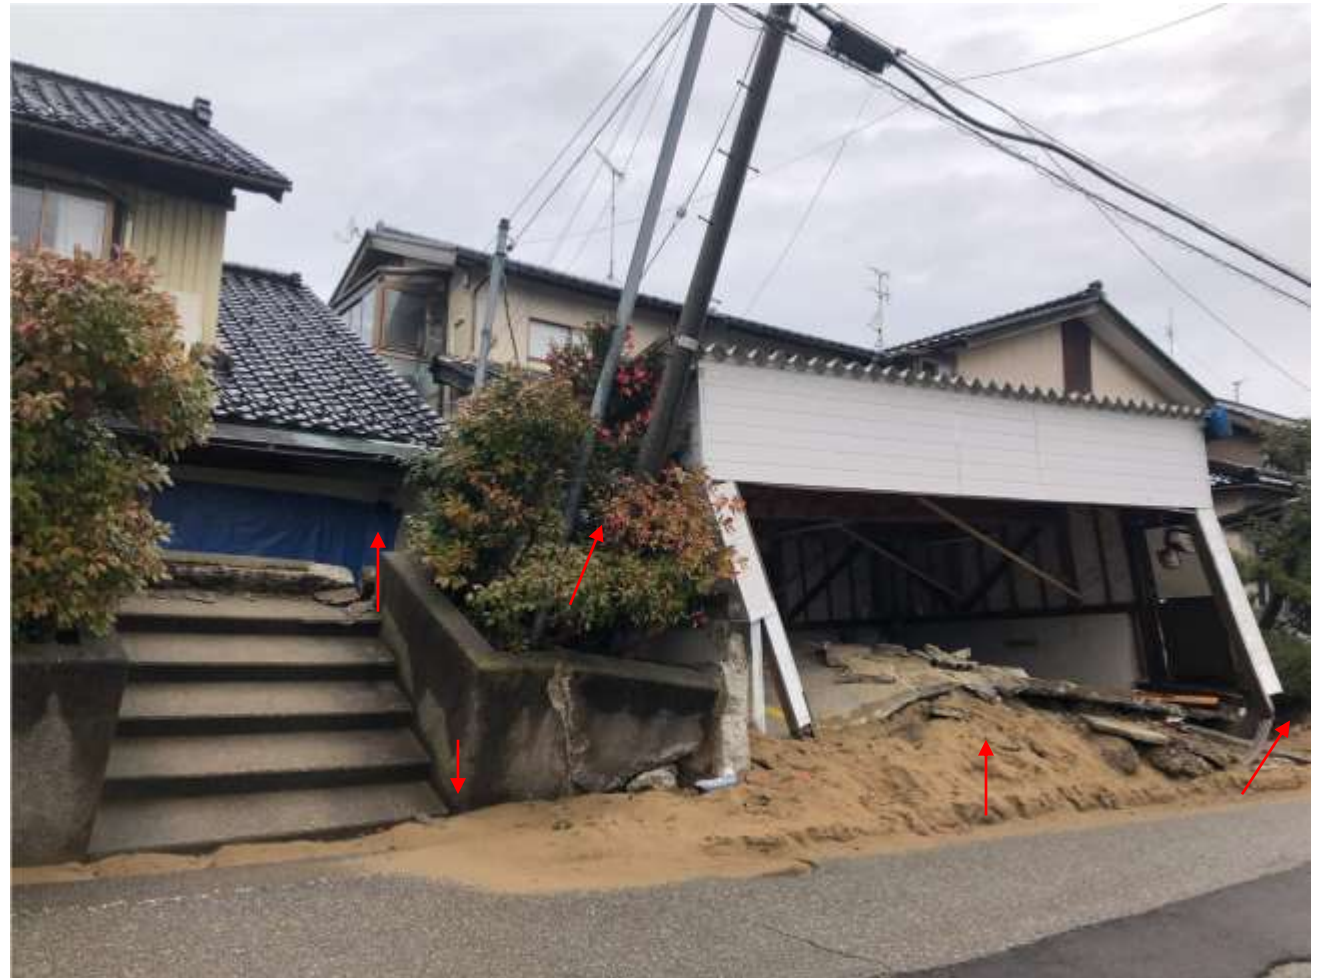
Uchinada

8. Sand ejecta, rotation, and ground upheave

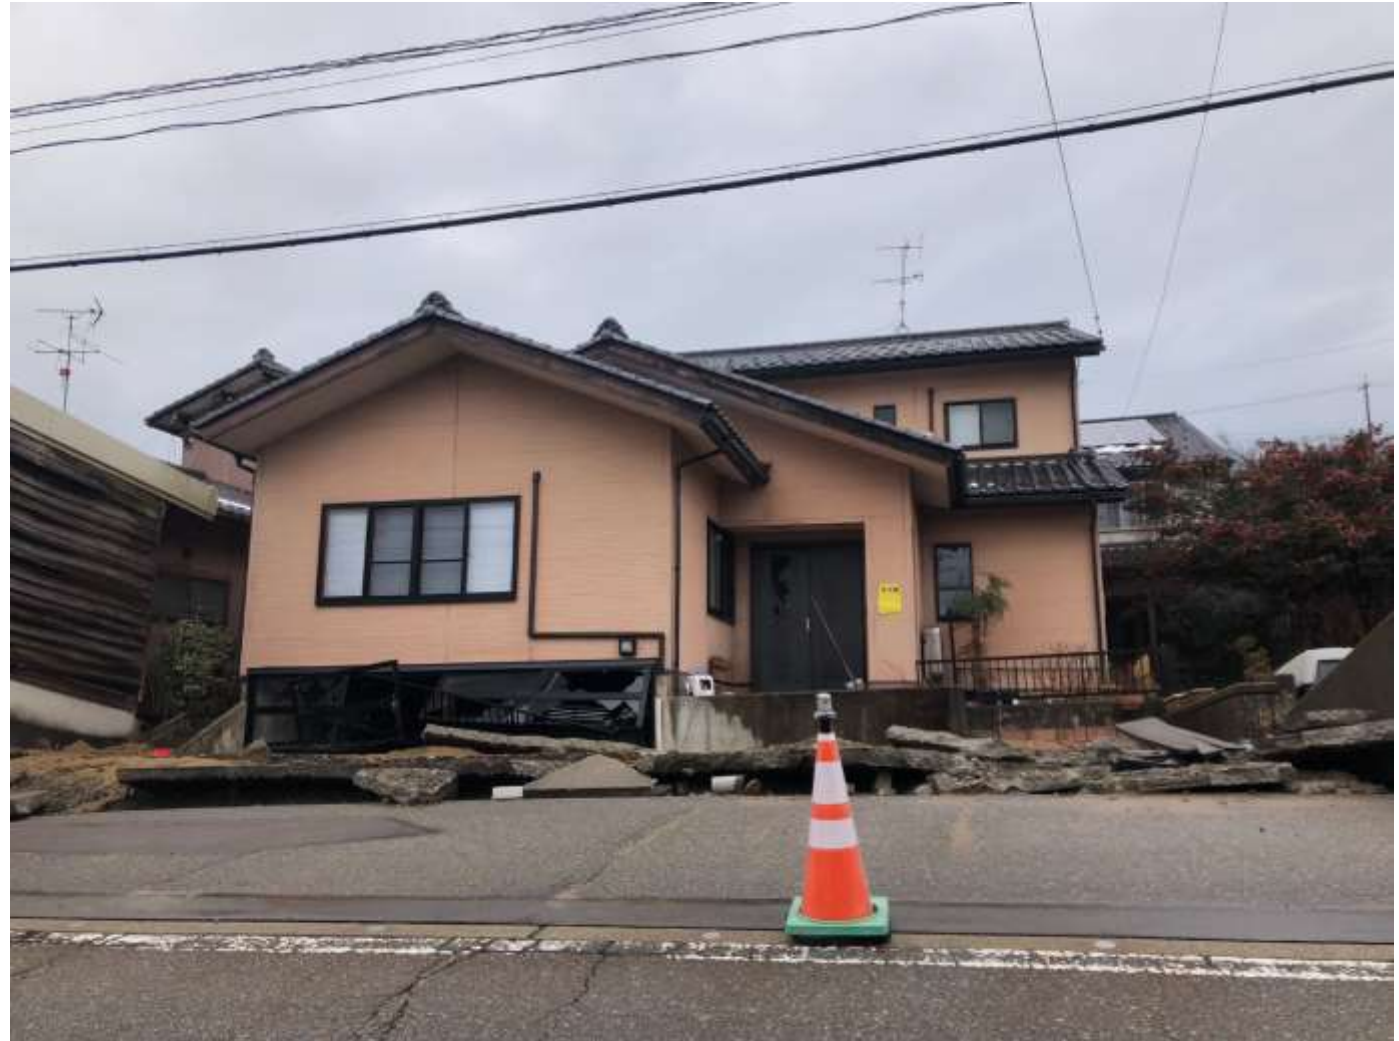
Uchinada

9. Vertical settlement

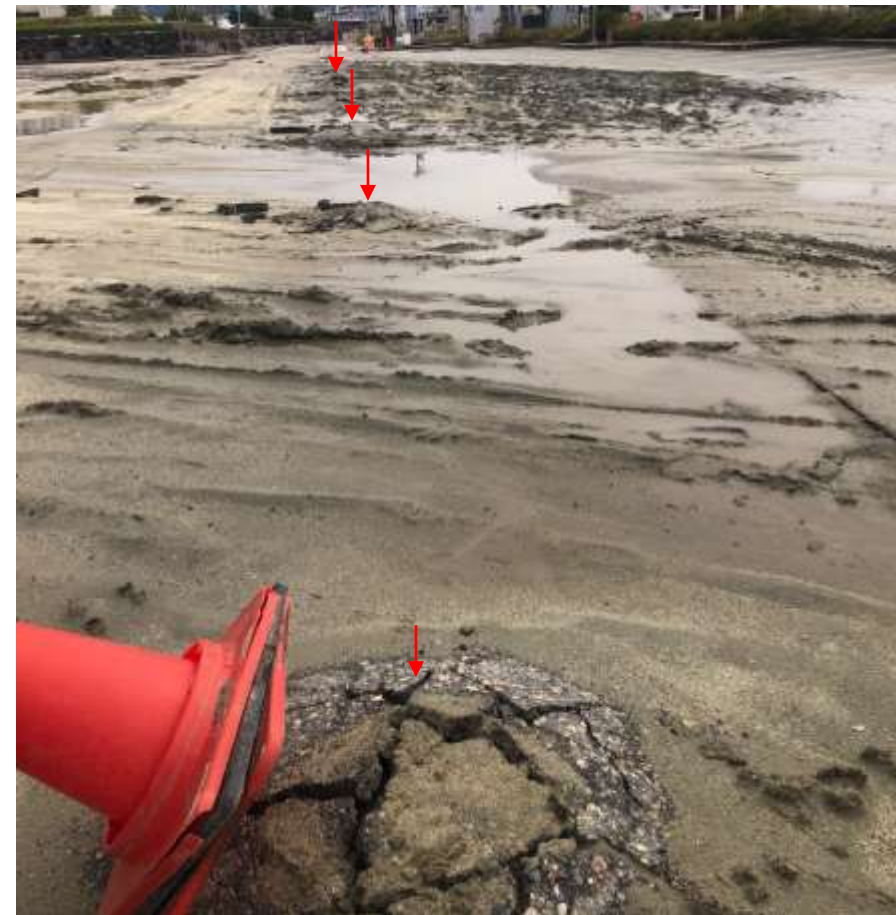
Manholes and pipeline uplift

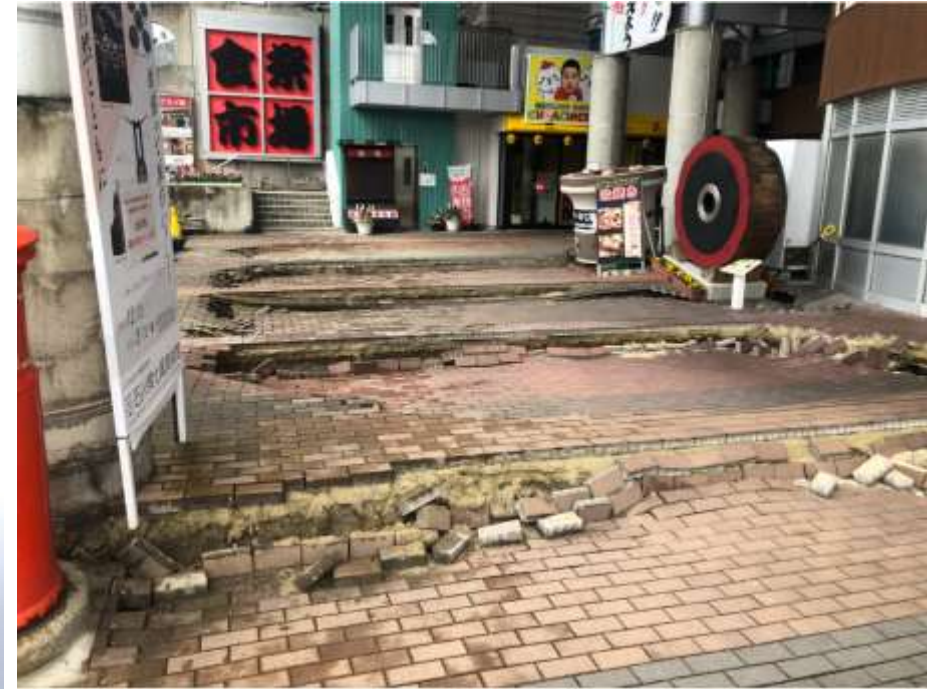
Ground subsidence

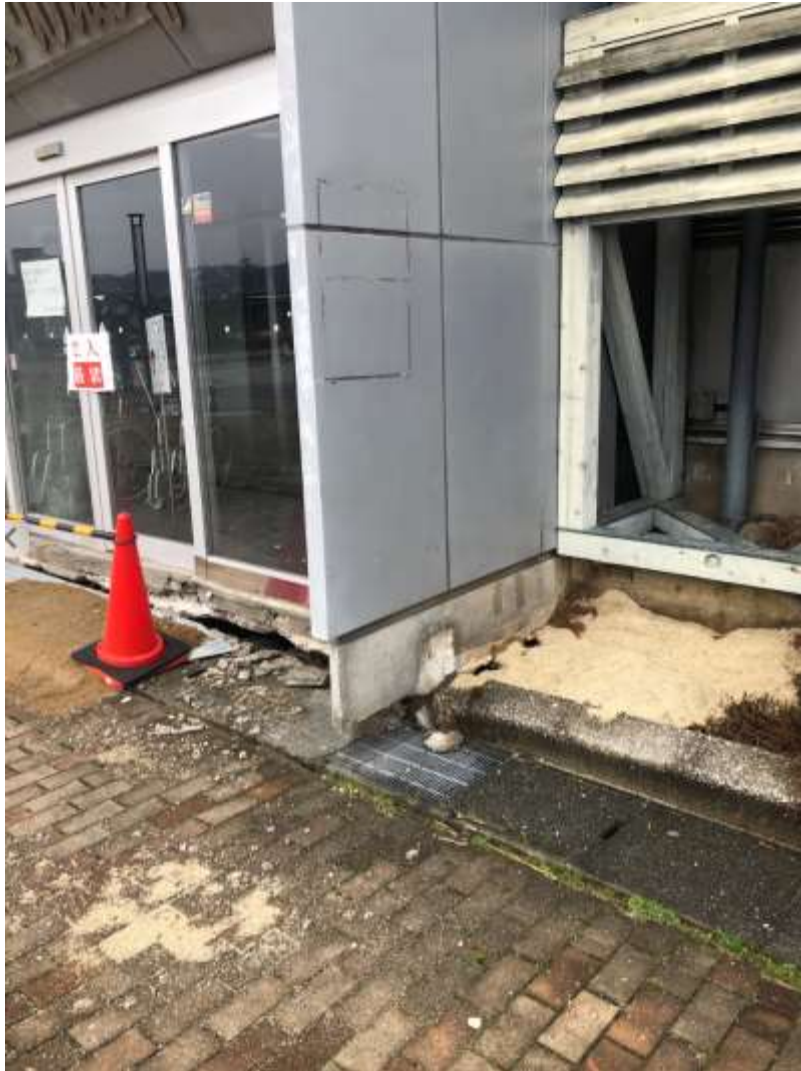
Ground subsidence and sand ejecta

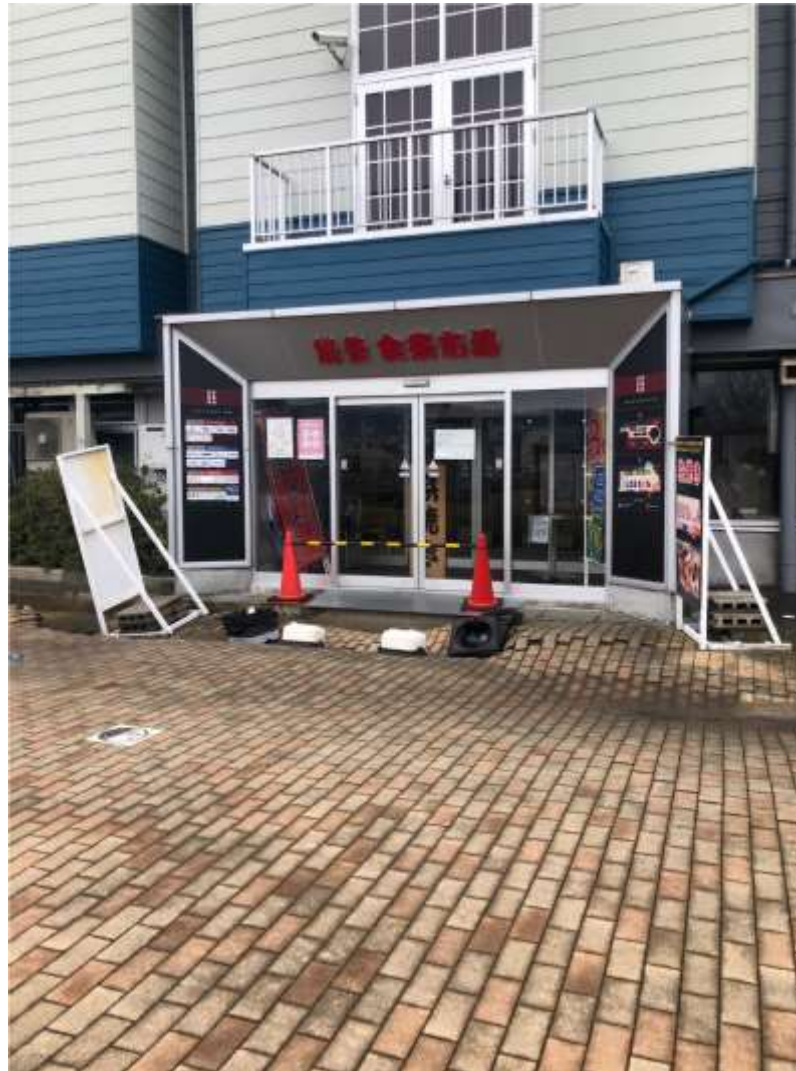
Ground subsidence

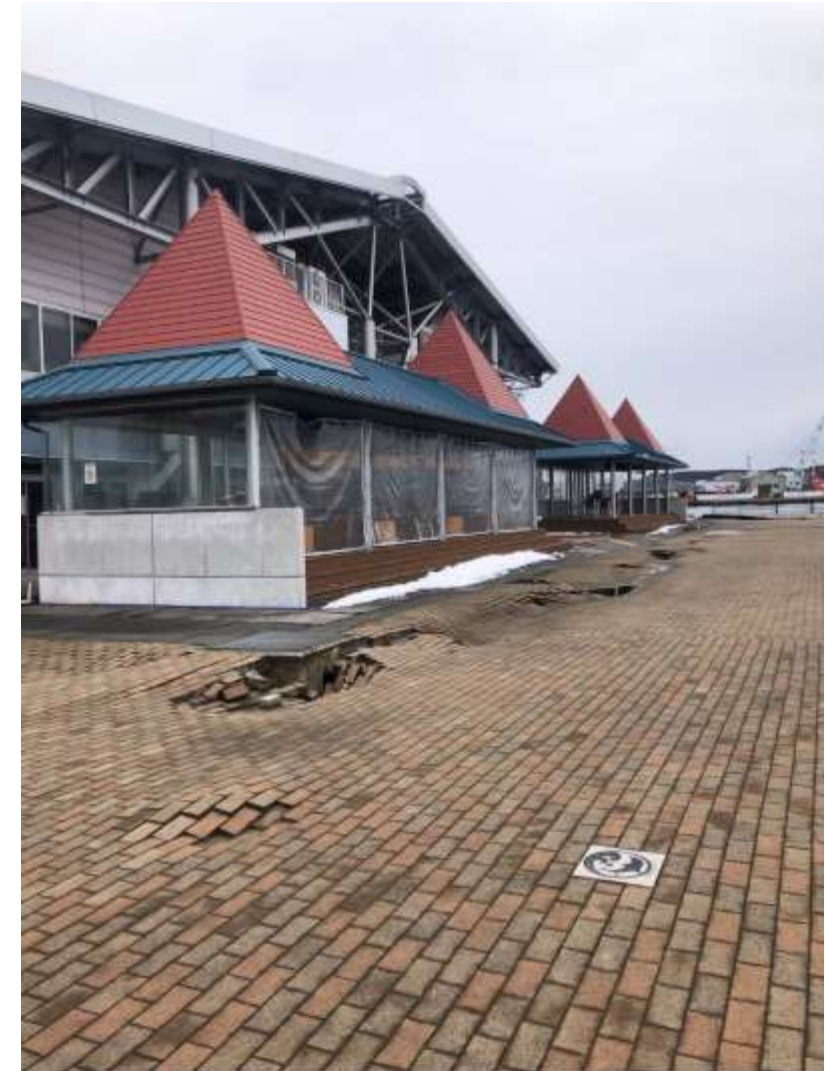
Ground subsidence

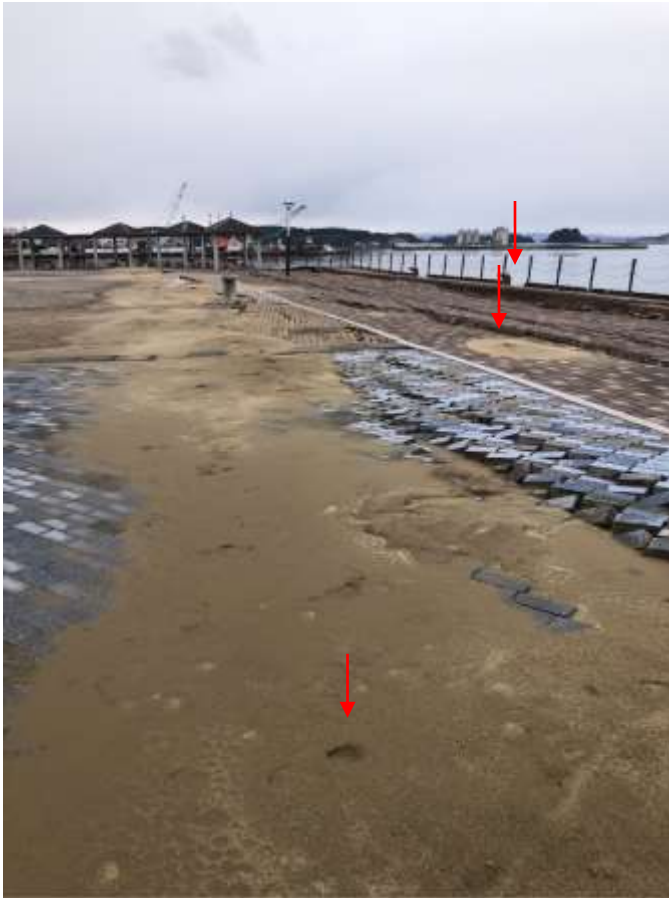
Nanao

Tilted quay, sand ejecta and ground subsidence

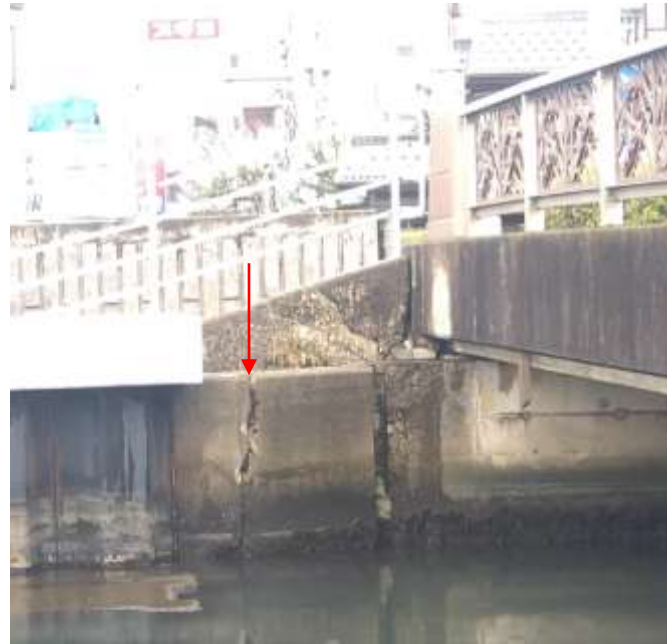
Cracks in bridge stairs

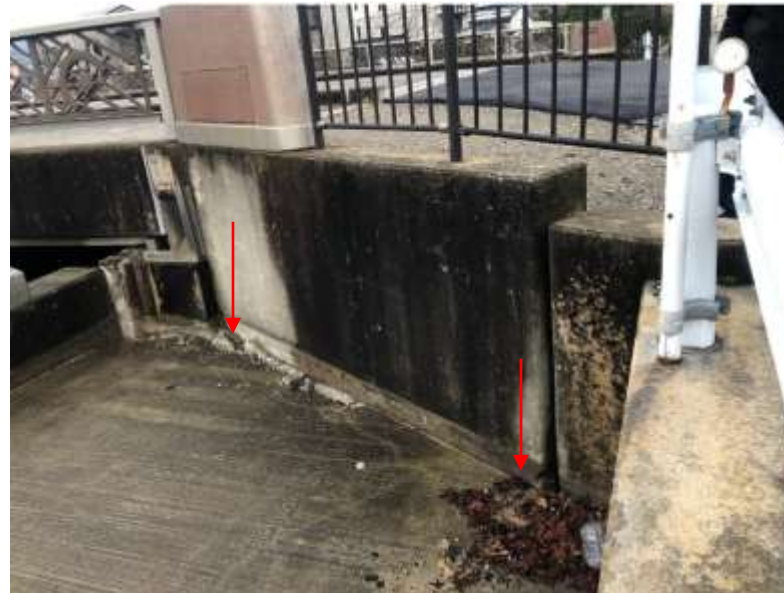
Ground subsidence

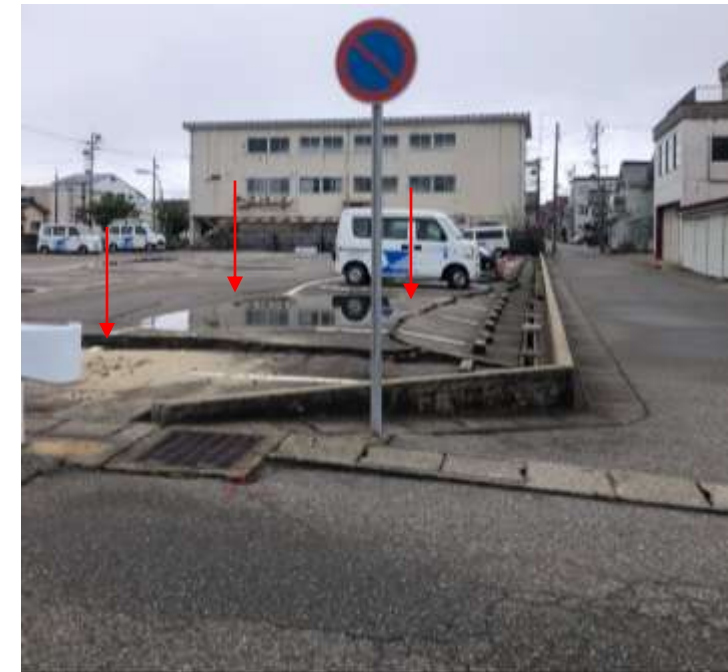
Cracks and ground subsidence at parking lot near bridge

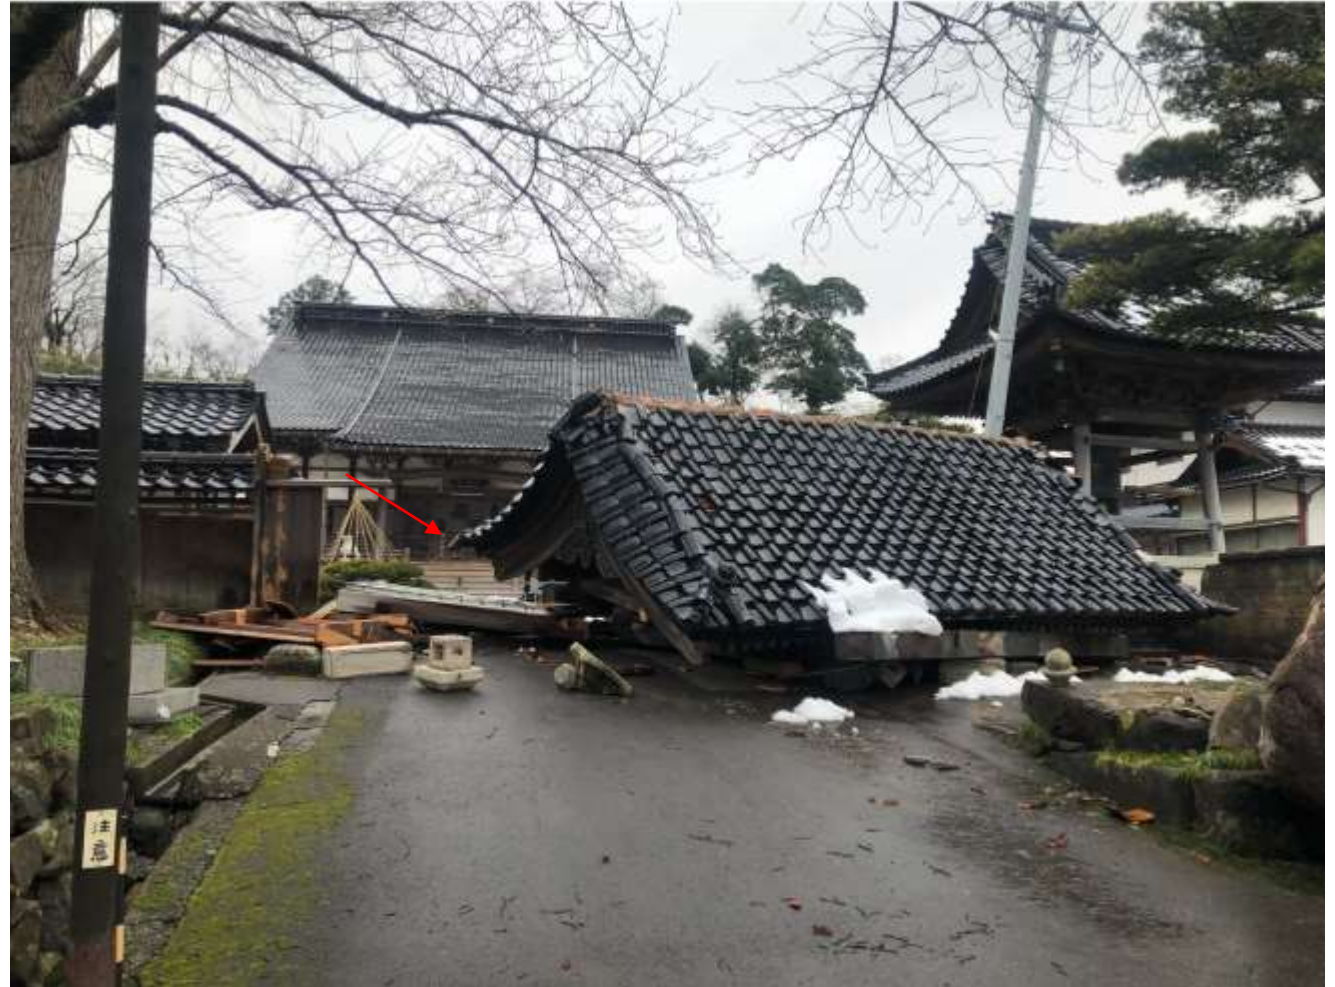
Nanao

5. Collapsed entrance gate

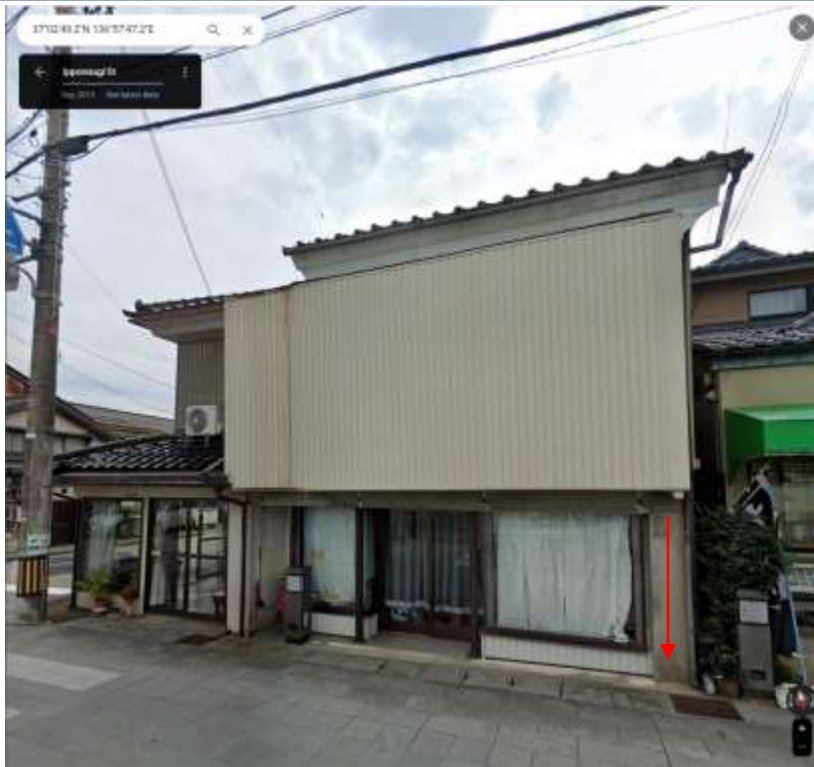
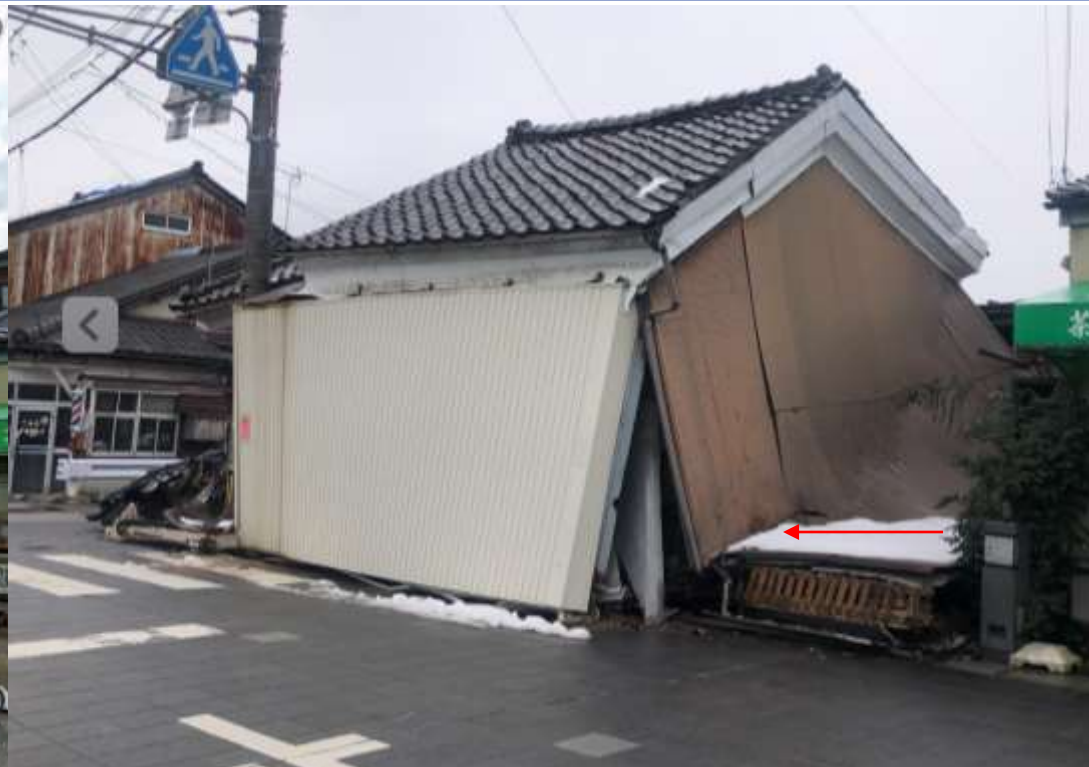
Nanao

6. Collapsed of first floor of wood house

Vertical and horizontal asymmetry

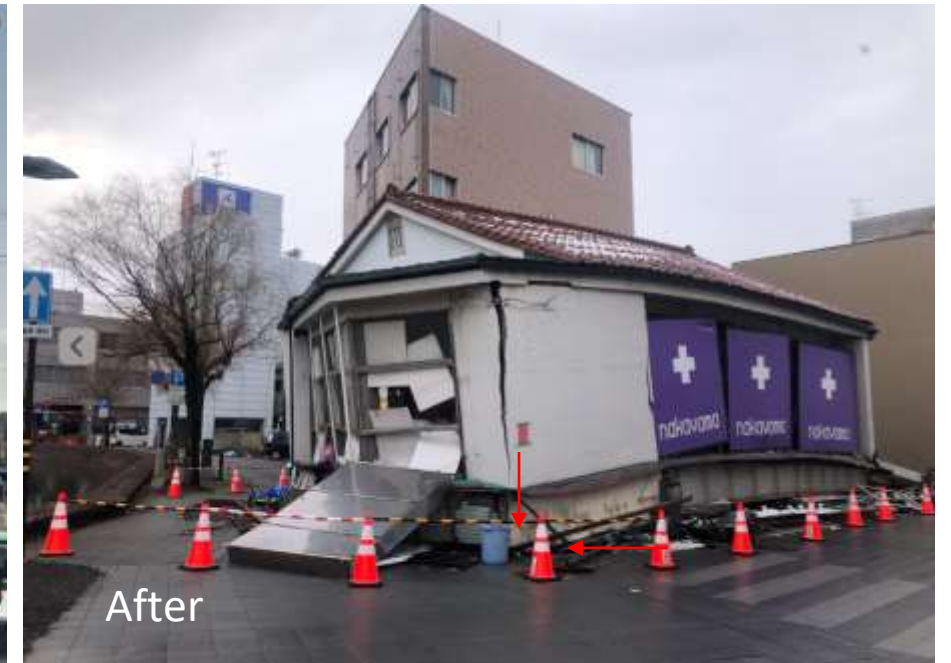
Nanao

6. Collapsed of first floor of wood house

First “Weak floor”

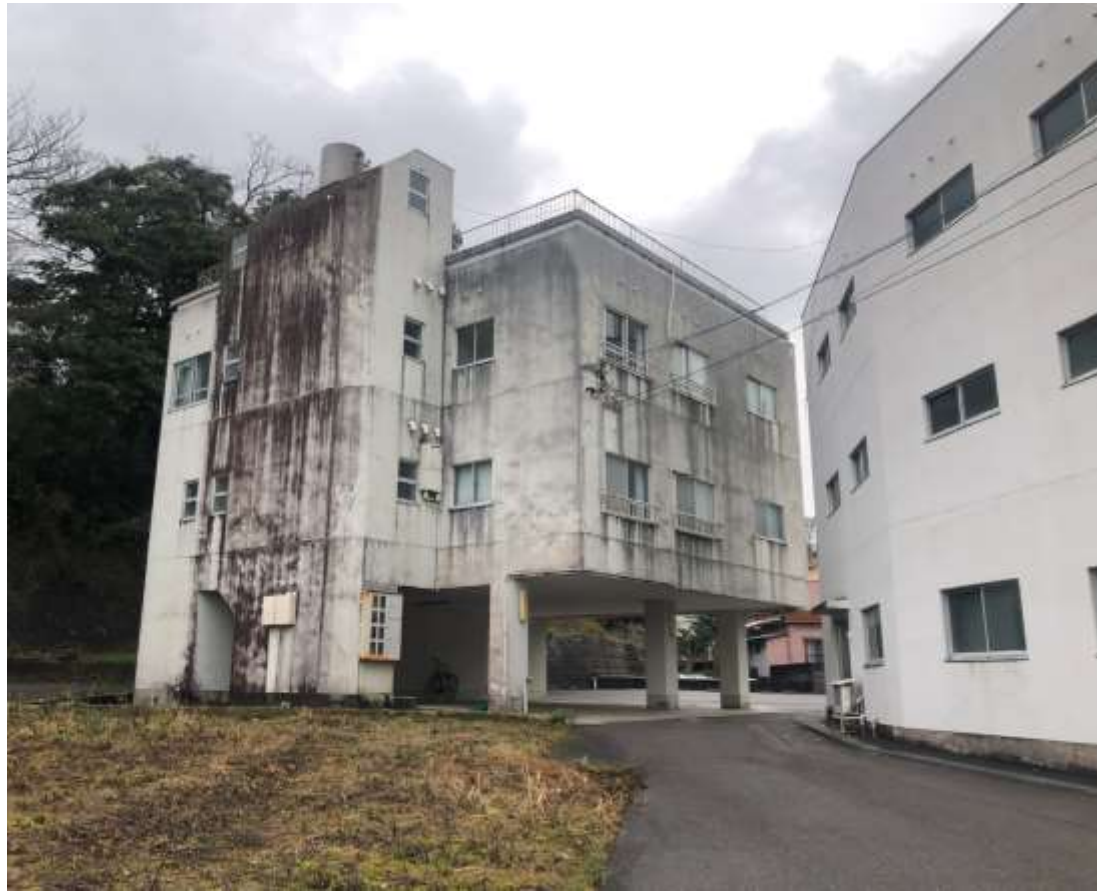
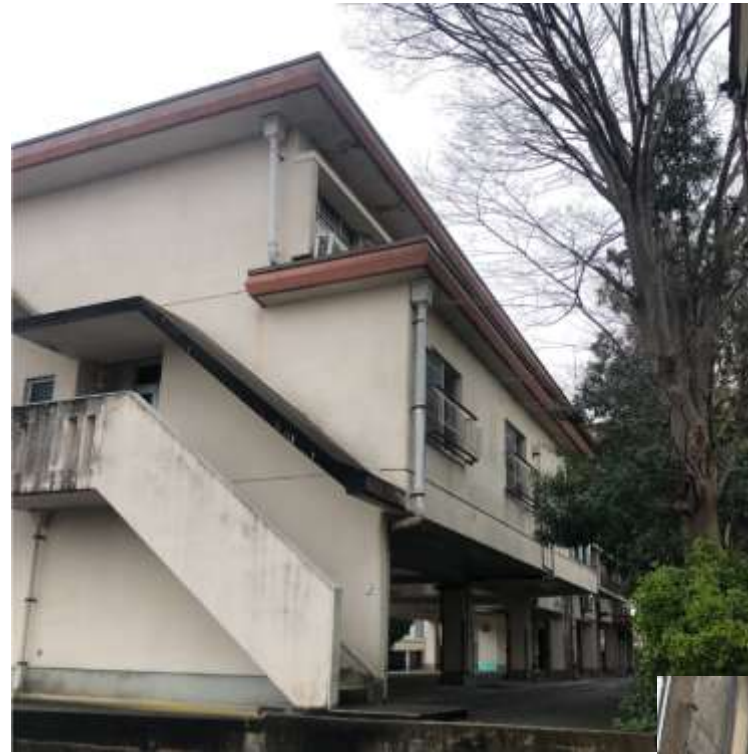
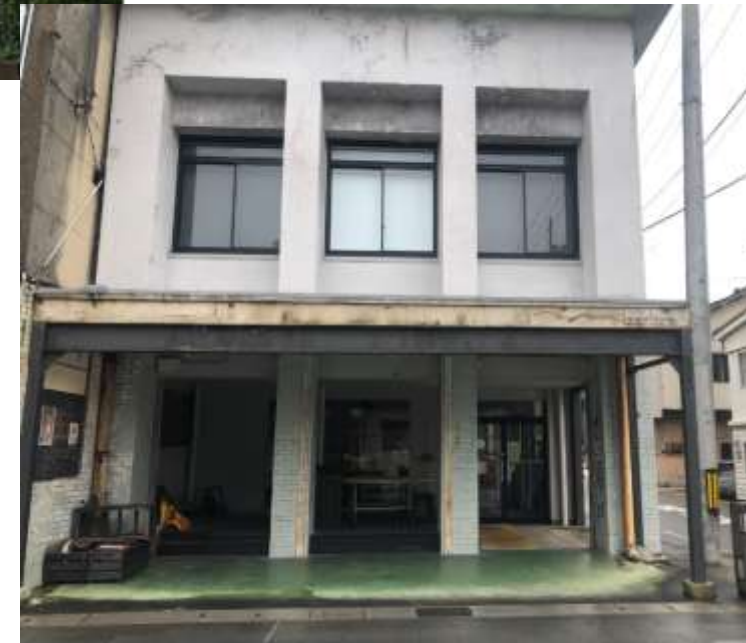
Nanao

RC buildings with no visible damage
