Damage Survey from the 2024 Noto Peninsula Earthquake

ver.01 (2024/02/01)

Understanding geotechnical failure and ground motions

This report partially covers damage due to ground failure with a focus on liquefaction and some damage to buildings. (This is not an extensive report of all damages in the area)

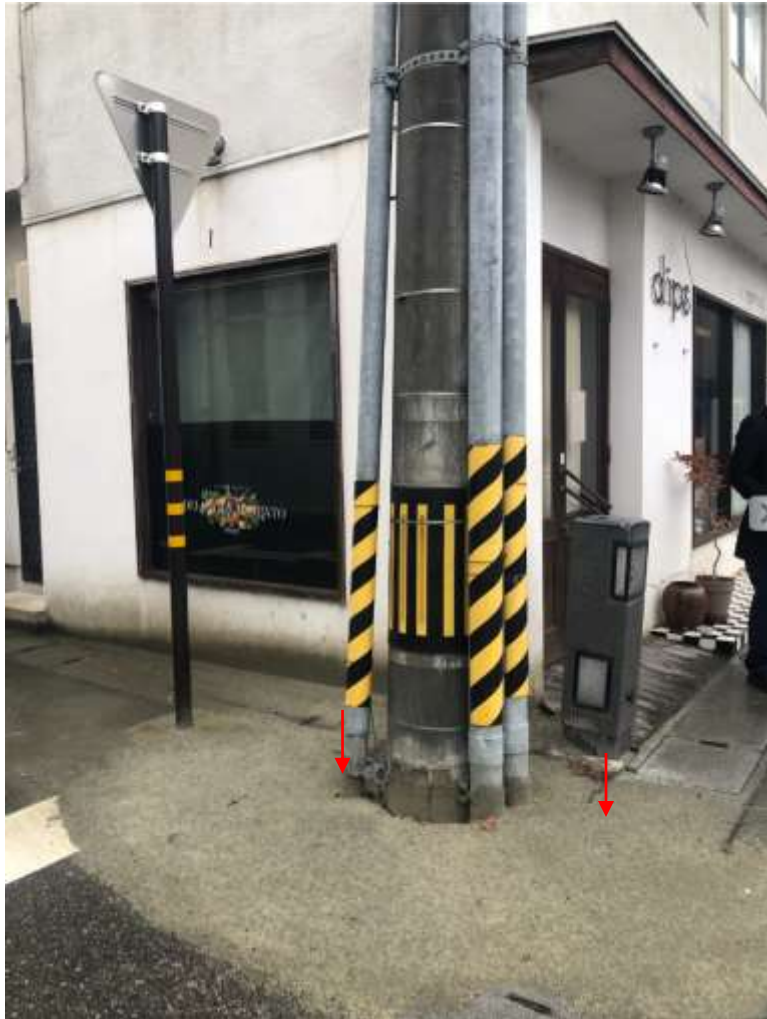
8. Liquefaction evidence near damaged and collapsed houses

Pole settlement and sand ejecta

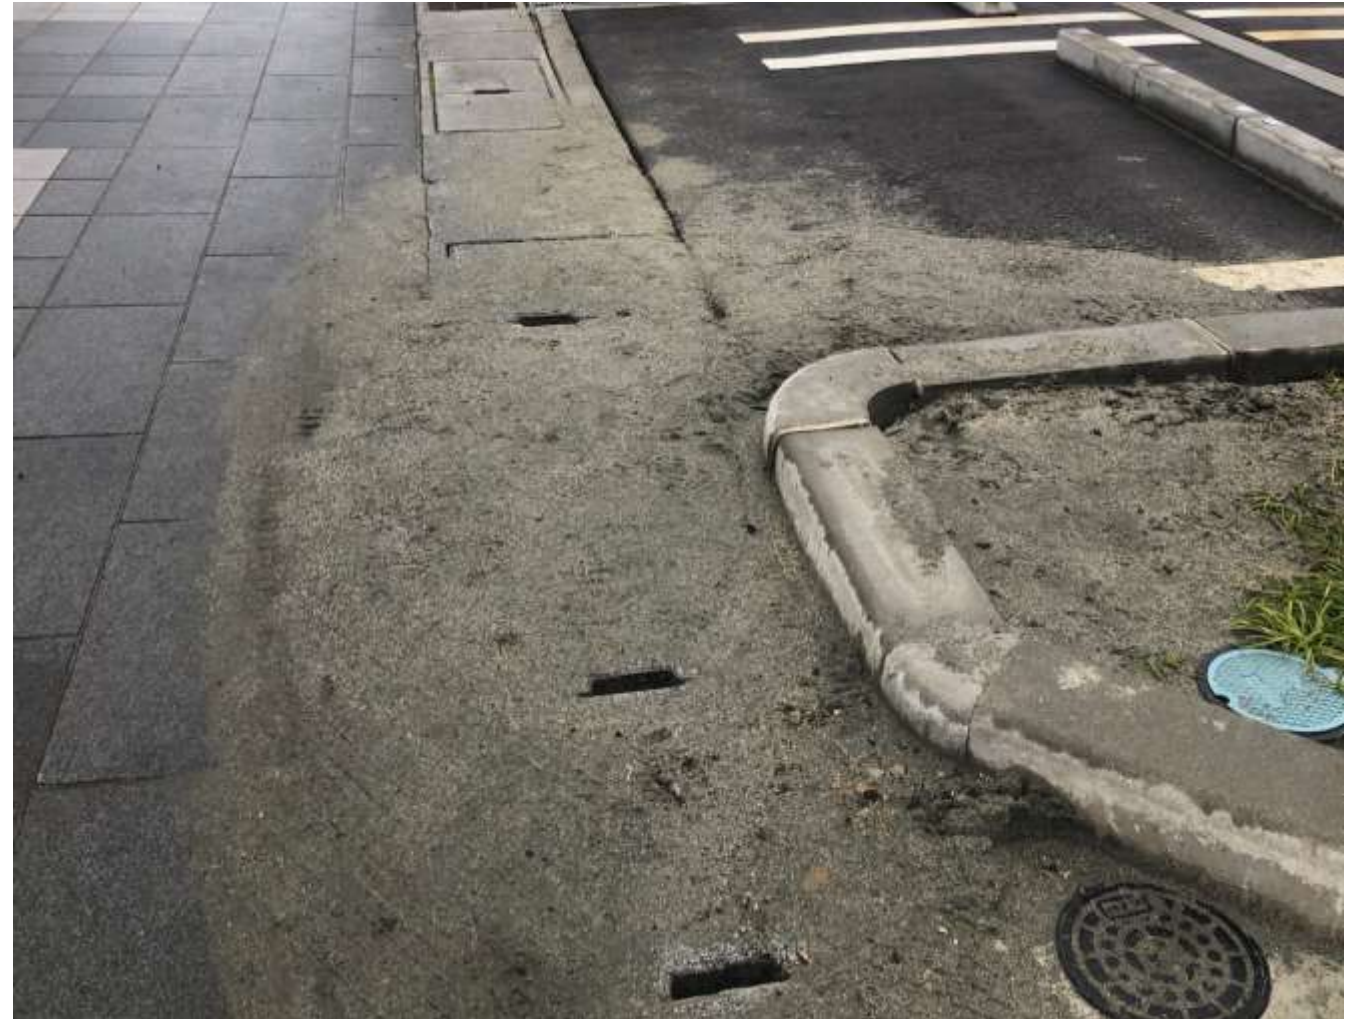
Sand ejecta

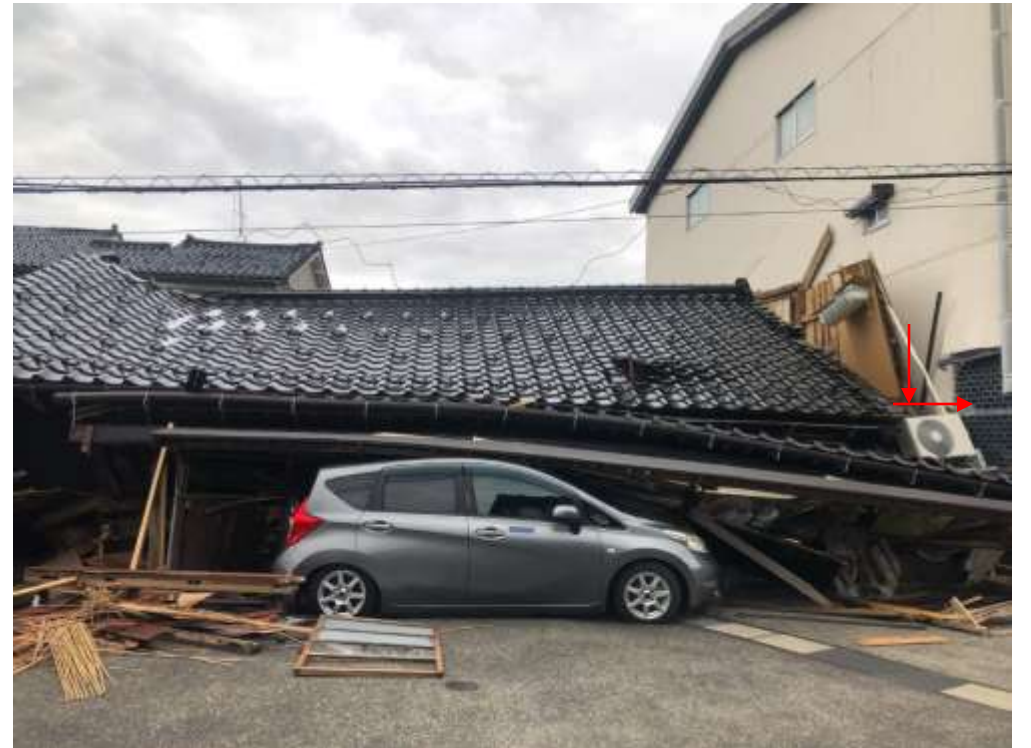
Wajima

5. First floor collapsed

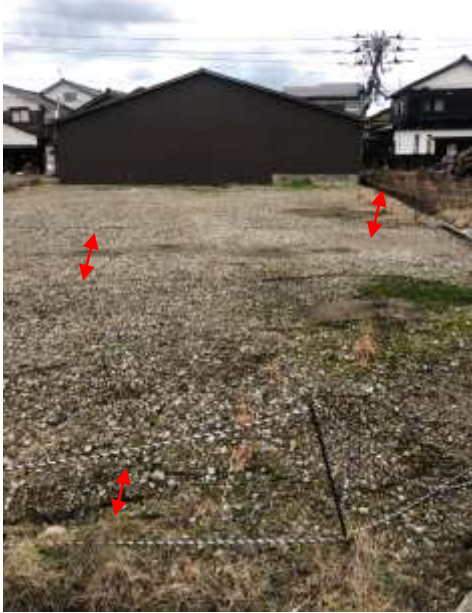
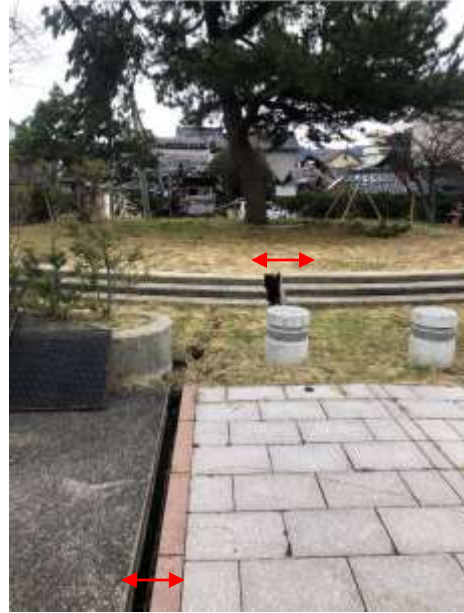
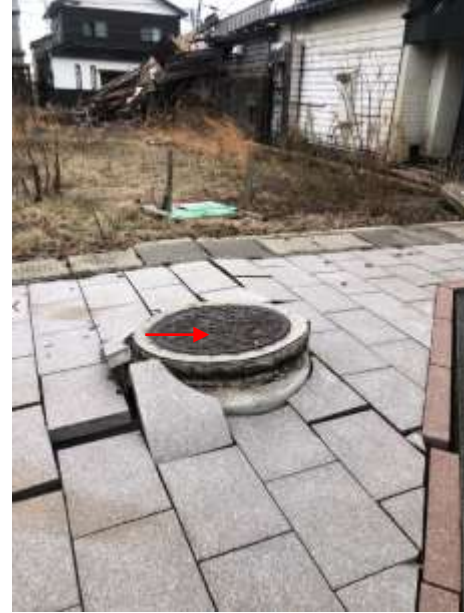
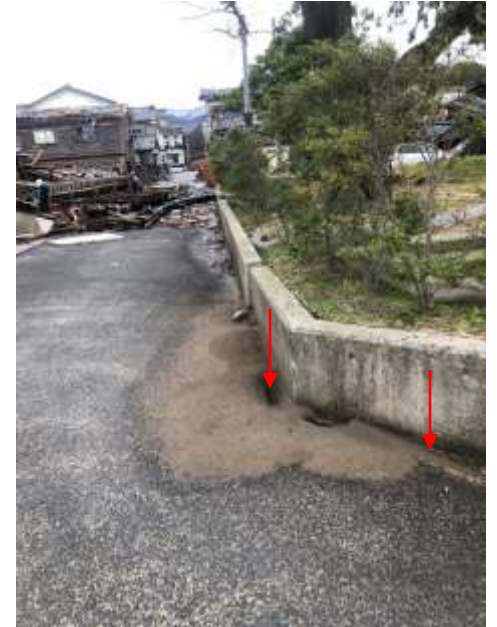
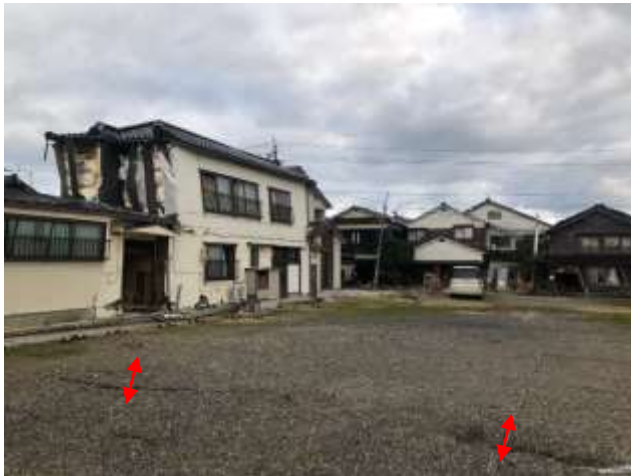
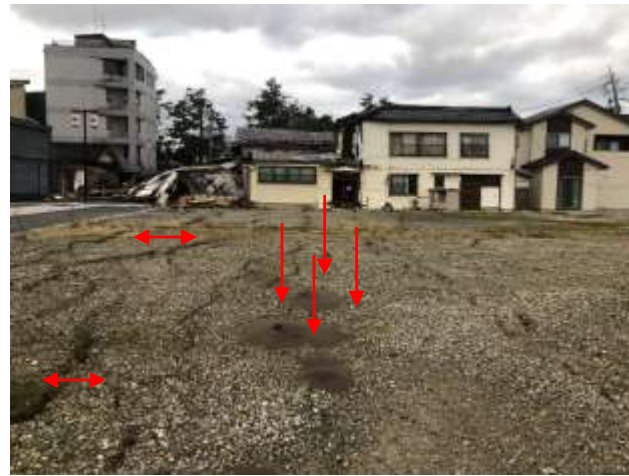
Wajima

6. Liquefaction evidence: sand ejecta, ground cracks and manholes uplift

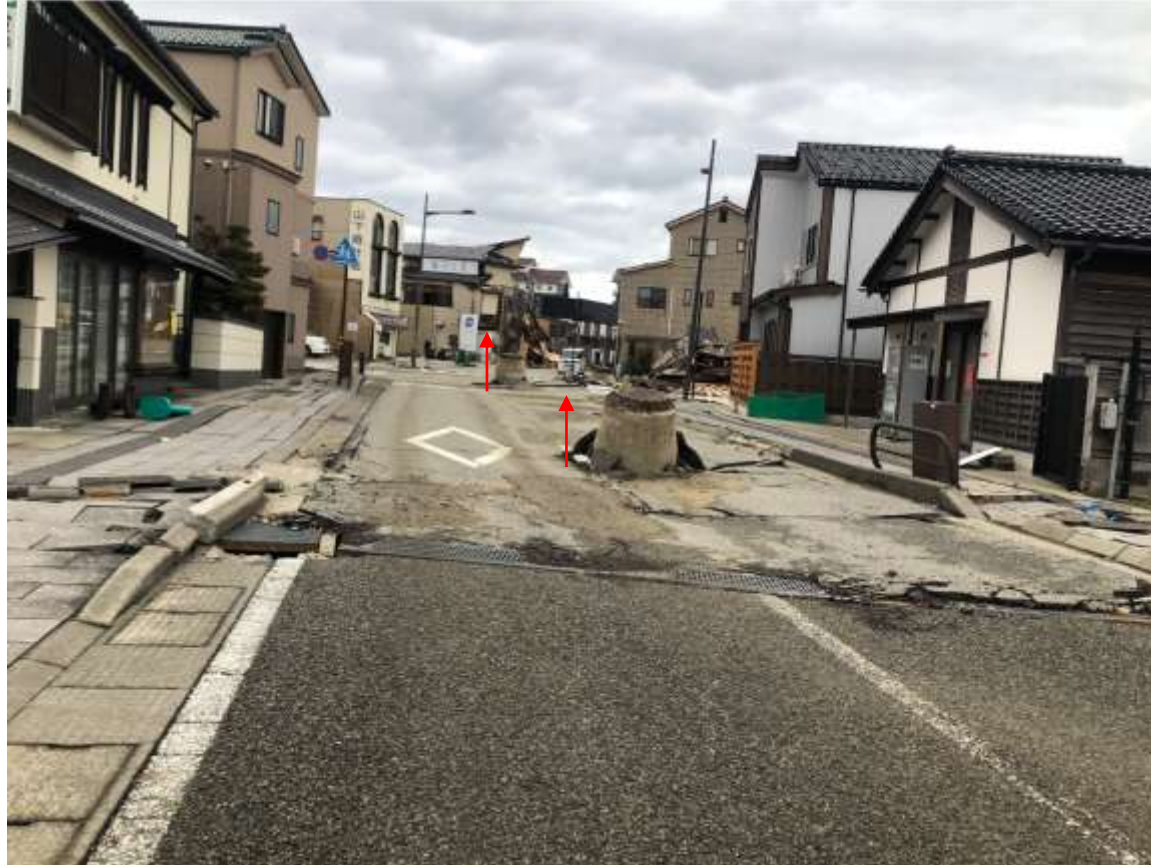
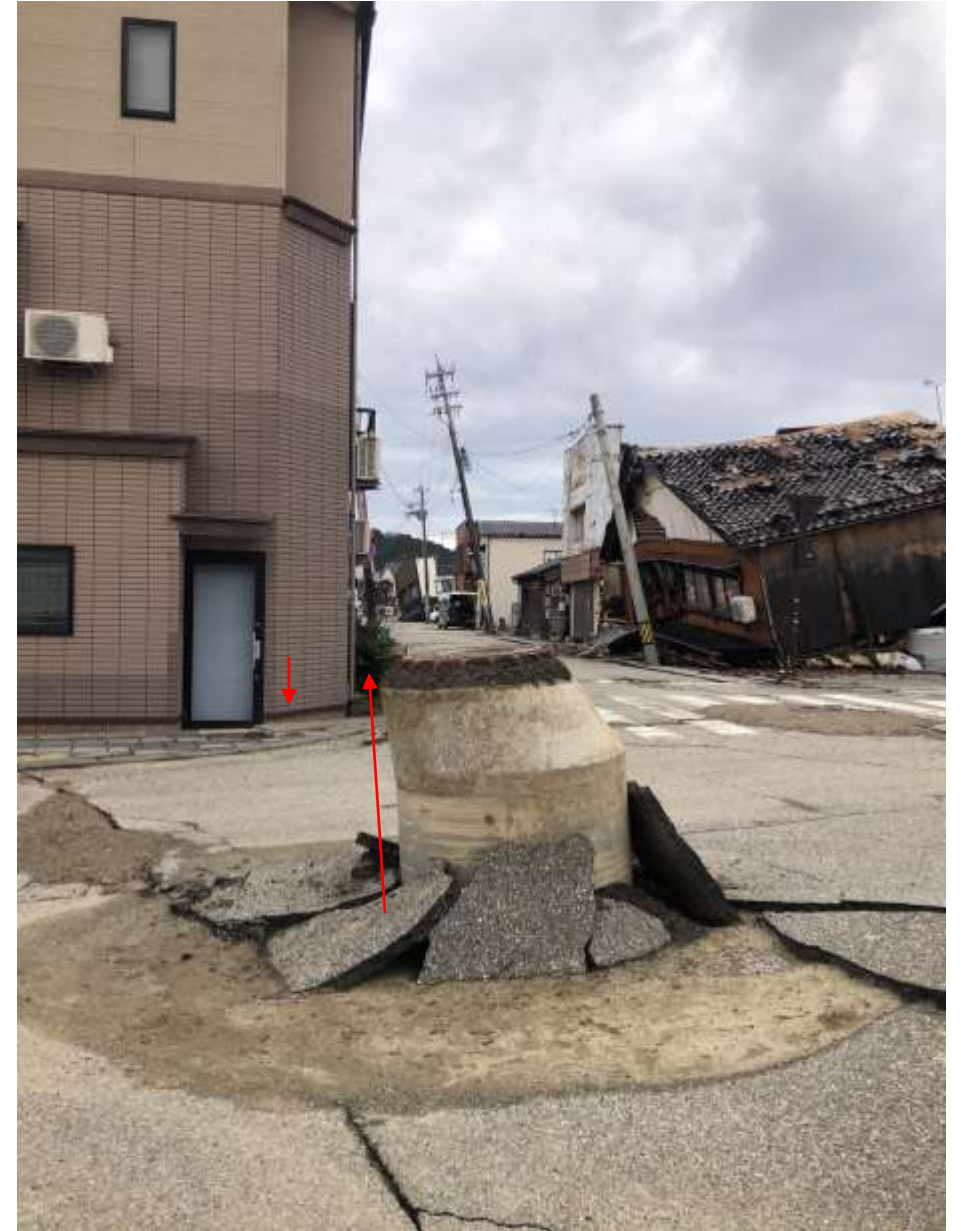
Wajima

6. Liquefaction evidence: manholes uplift and settlement

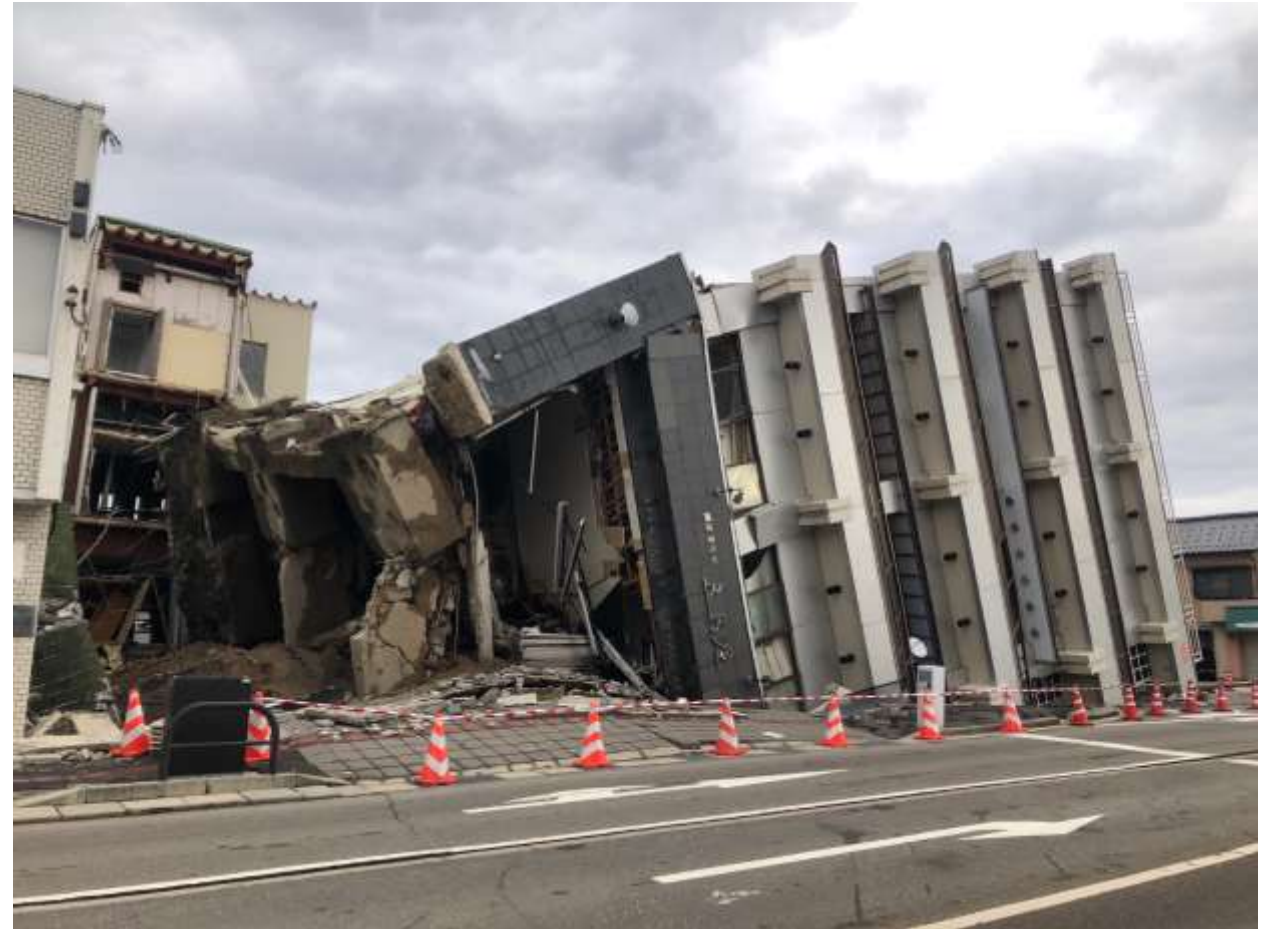
Wajima

7. Collapsed seven-story building (toppled)

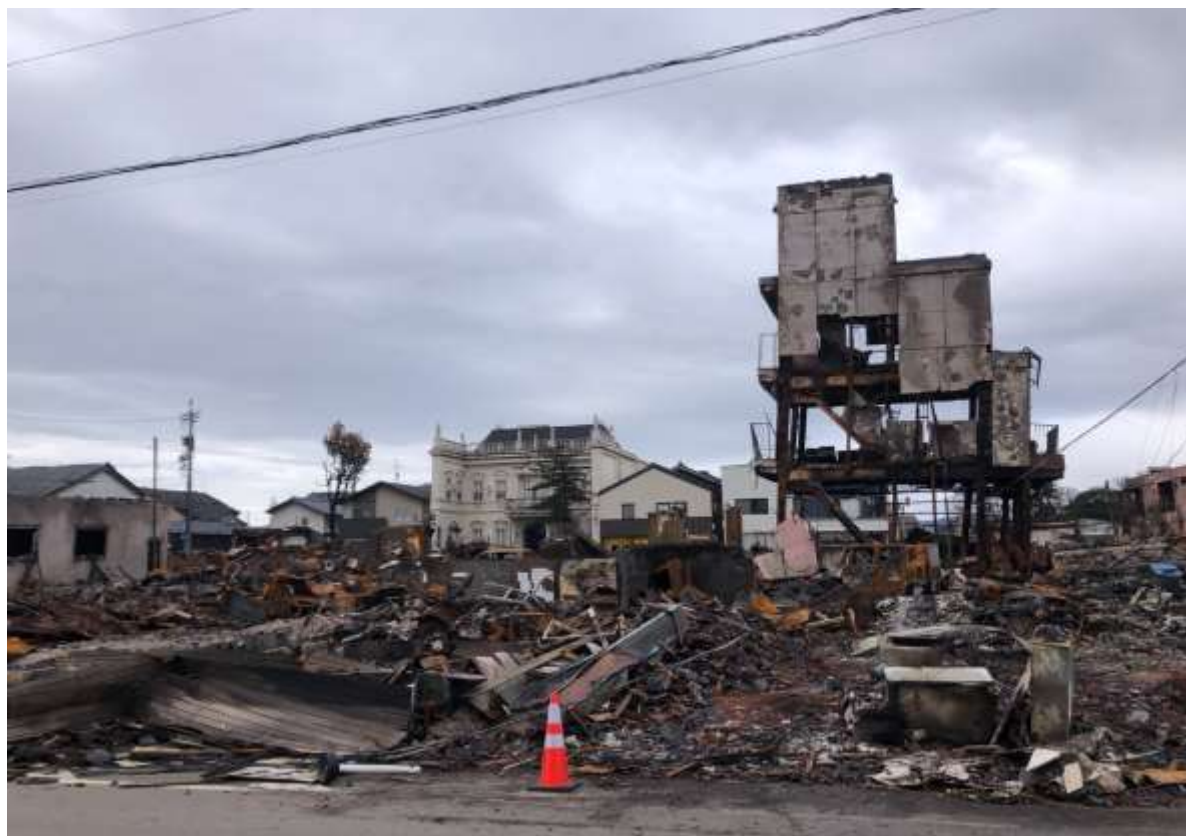
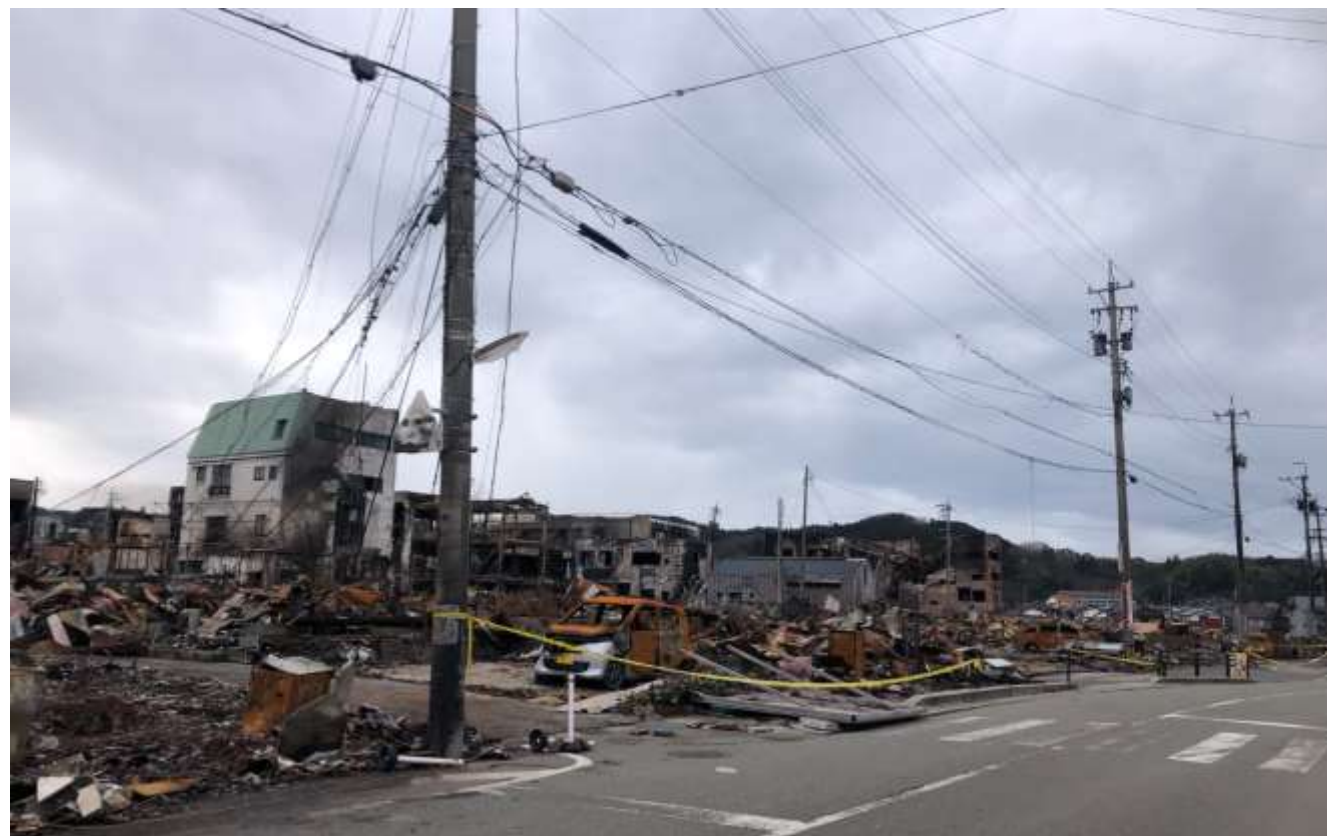
Wajima

8. Fire after earthquake

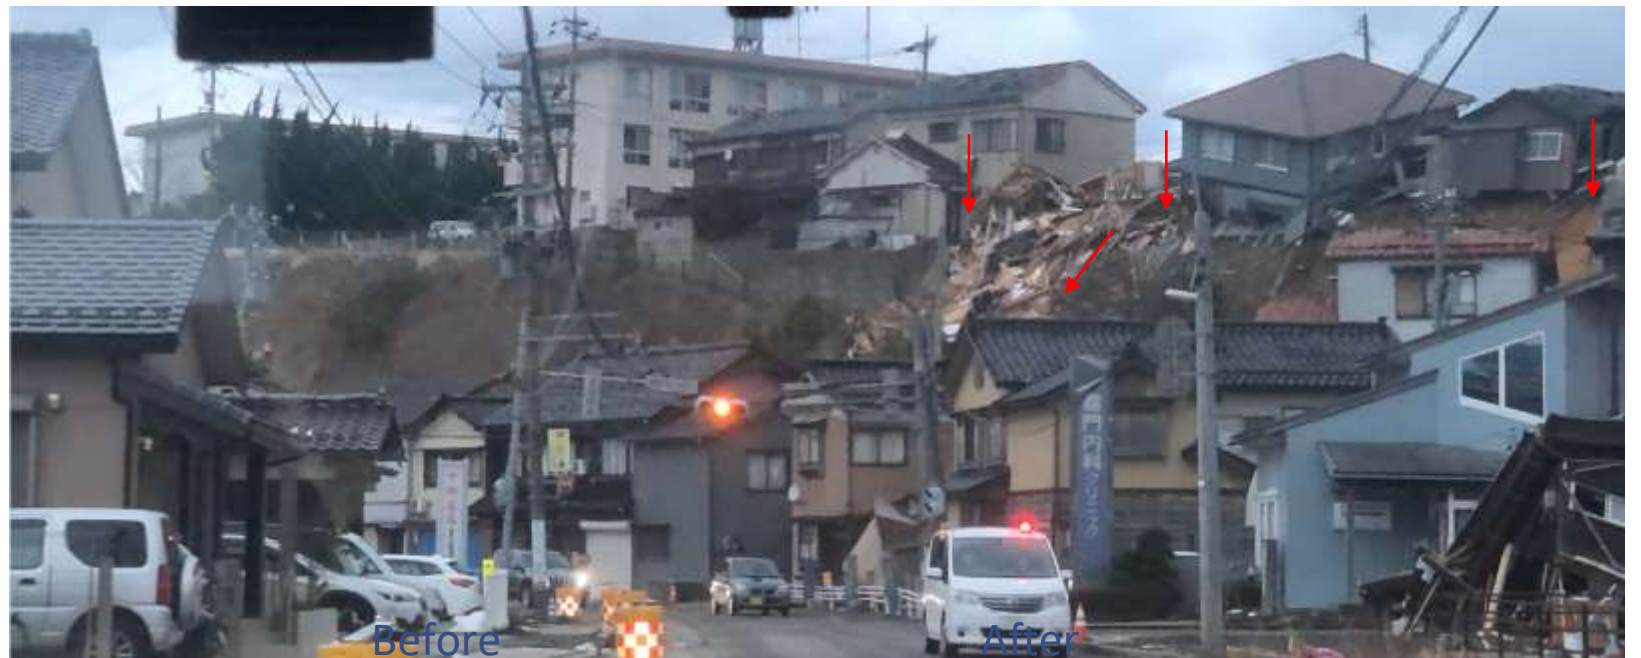
Wajima

9. Houses collapsed due to seismic landslide

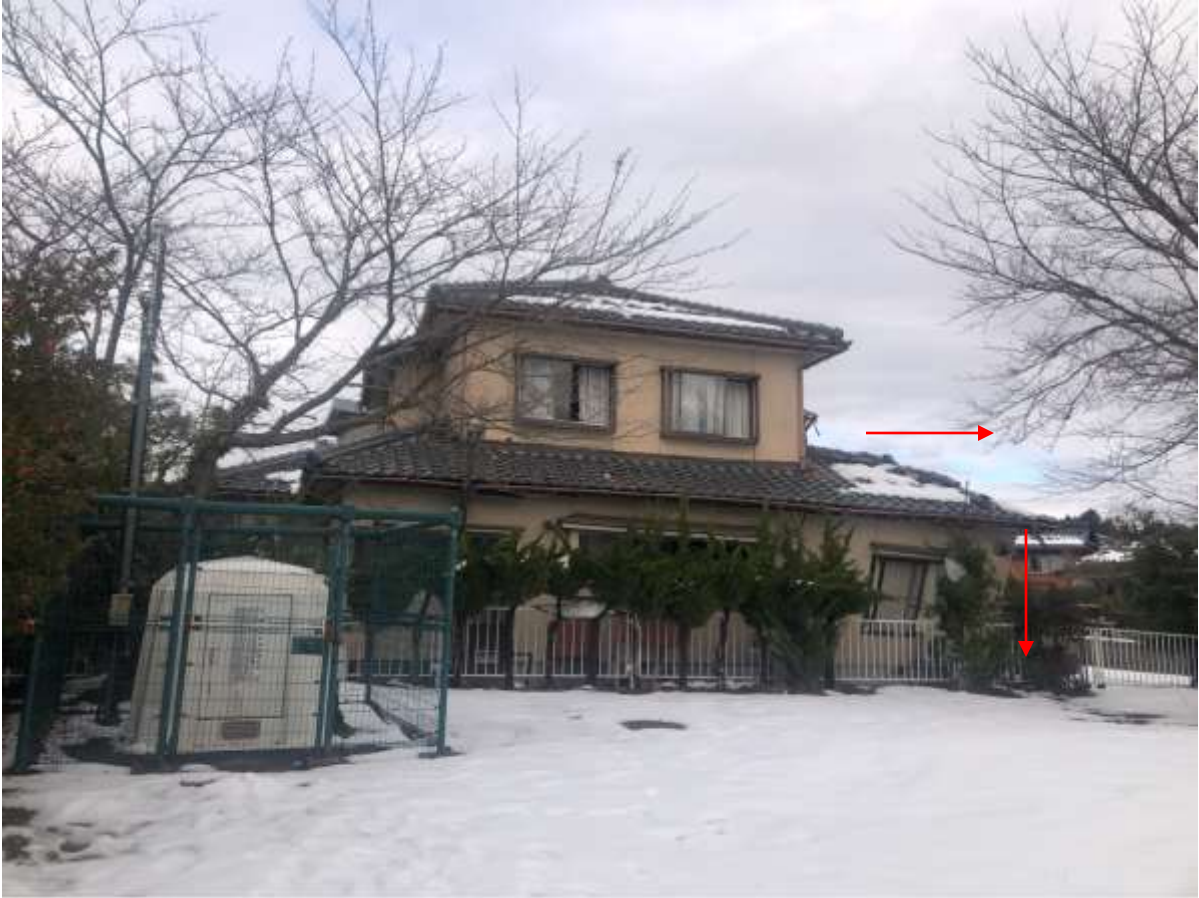
ISK005 Anamizu

1. House tilted and settled near ISK005

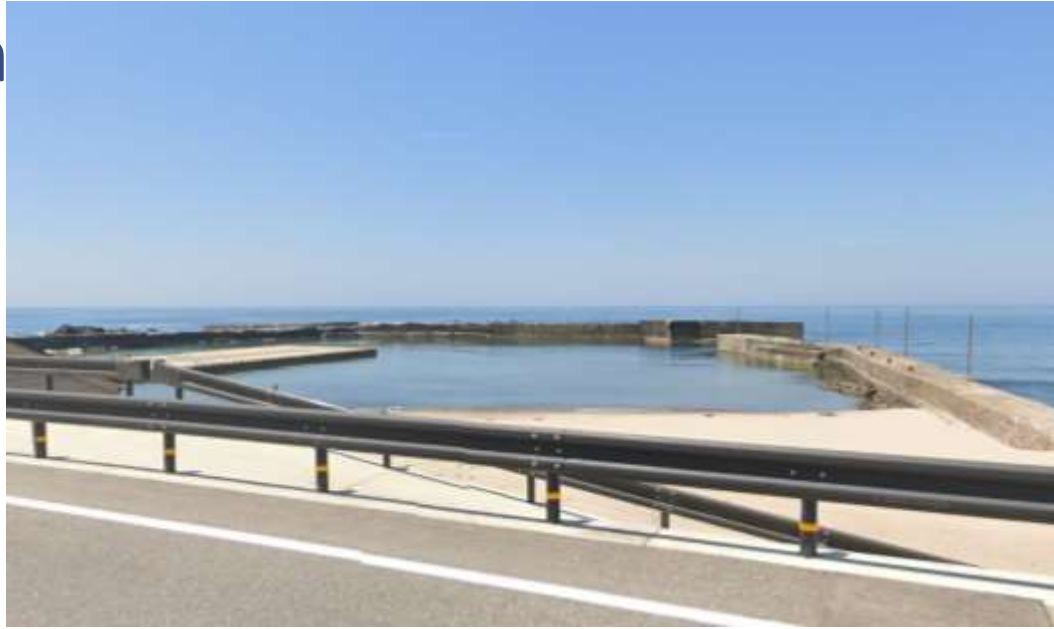
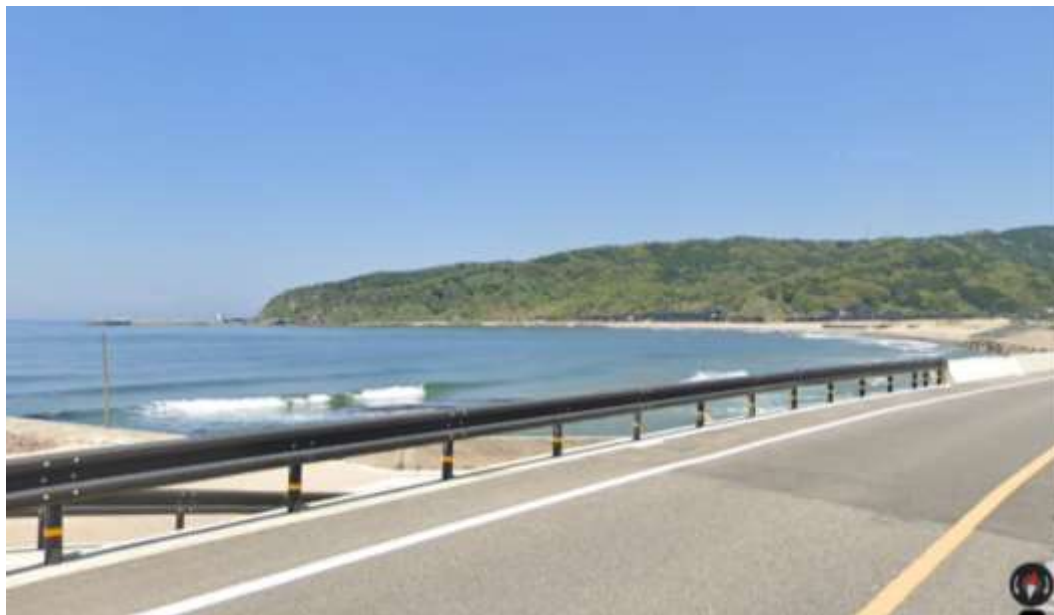
Wajima Monzen

3. Dry port and
Coast uplift
