StEER
STRUCTURAL
 EXTREME EVENTS
 RECONNAISSANCE

M 6.4 and M 7.1 Ridgecrest, CA Earthquakes VIRTUAL ASSESSMENT STRUCTURAL TEAM (VAST) REPORT

Released: July 8, 2019 | **NHERI DesignSafe Project ID:** PRJ-2444

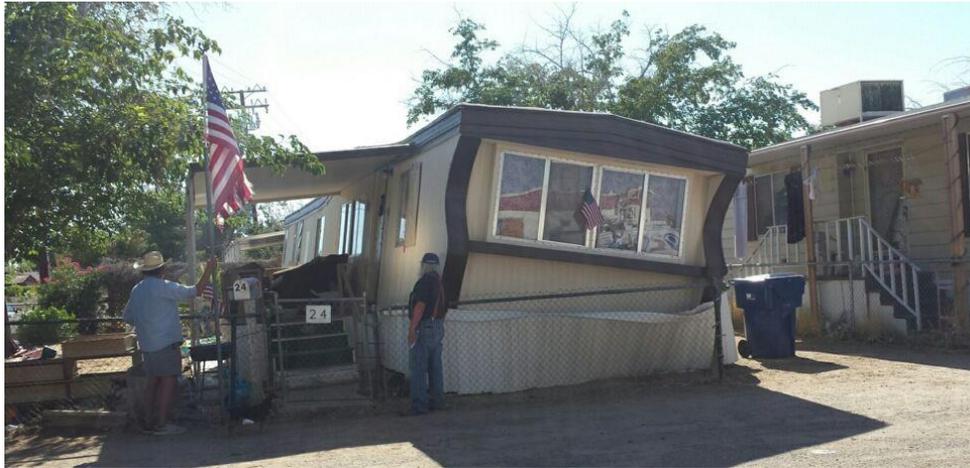
Damaged mobile home in Ridgecrest, CA during the M 6.4 earthquake. Photo by [Darla A. Baker / The Californian](#).

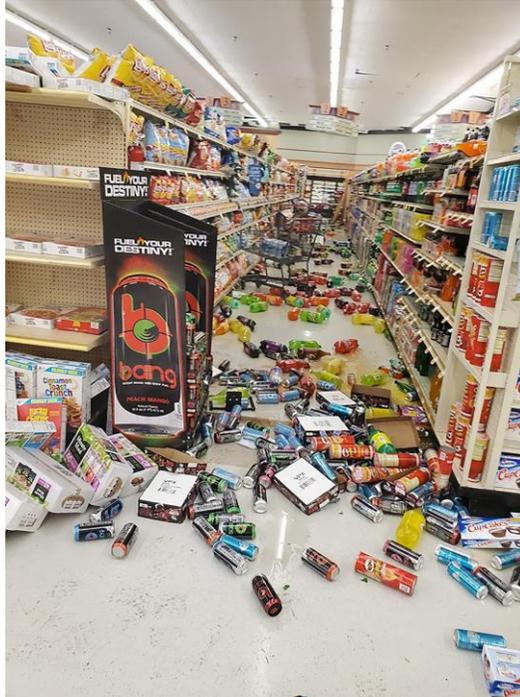
Figure 11. Items knocked from the shelves inside State Bros. Markets in Ridgecrest, California after the M 6.4 event (Source: CNN, 2019)

During the two earthquakes, many unsecured objects fell from shelves (Figures 11 to 13). Inside convenience stores aisles were flooded with broken liquor bottles and food items that had fallen off the shelves. There was also light to moderate non-structural component damage, such as collapse of suspended ceilings tiles/grids, concrete, glass and masonry facades, etc. (Figures 14 and 15). As with residential construction covered in the next section, several commercial masonry structures experienced various degrees of damage, Figure 16.

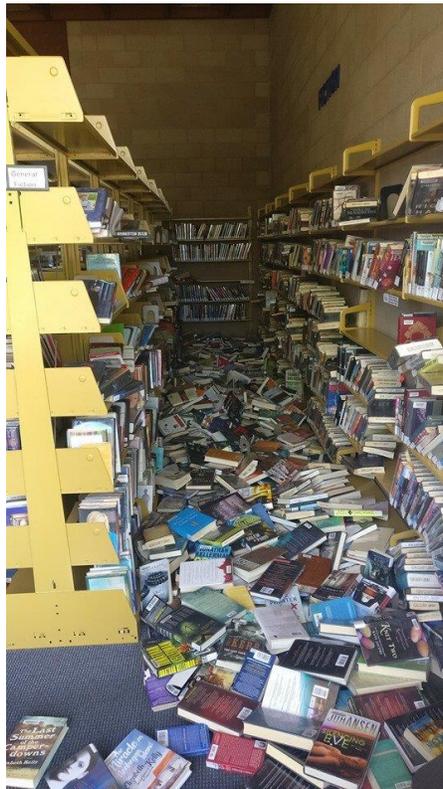
Figure 12. Books cover the floor at a Kern County Library in Ridgecrest after the 6.4 magnitude event (Credit: Richard Wagner, Source: KTLA, 2019)

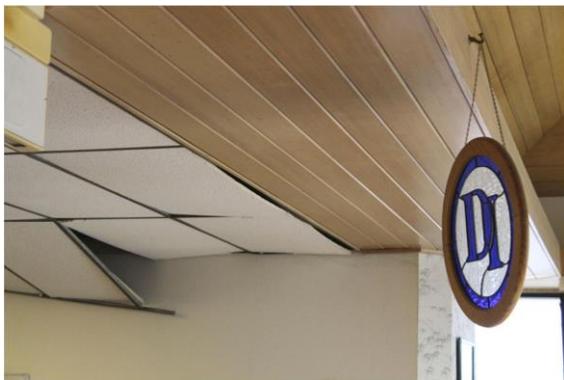
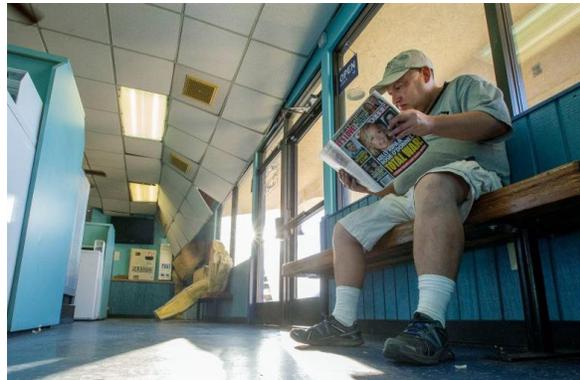
Figure 14. (a) The Daily Independent Newspaper office ceiling damaged during the M 6.4 event (Jessica Watson, AP); (b) Suspended ceiling partial failure at a laundromat in Ridgecrest after the M 6.4 event (Photo by Terry Pierson, The Press-Enterprise/SCNG)

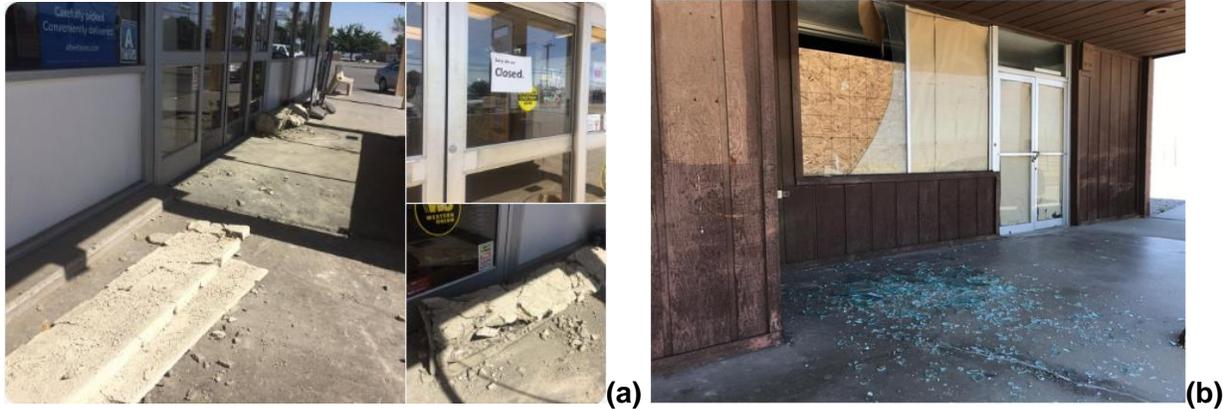
Figure 15. (a) Fallen concrete panels at a building in North Ridgecrest (Source: [Karen Hua via Twitter](#)); (b) Glass facade damage in retail building due to M 6.4 event (Source: AP)

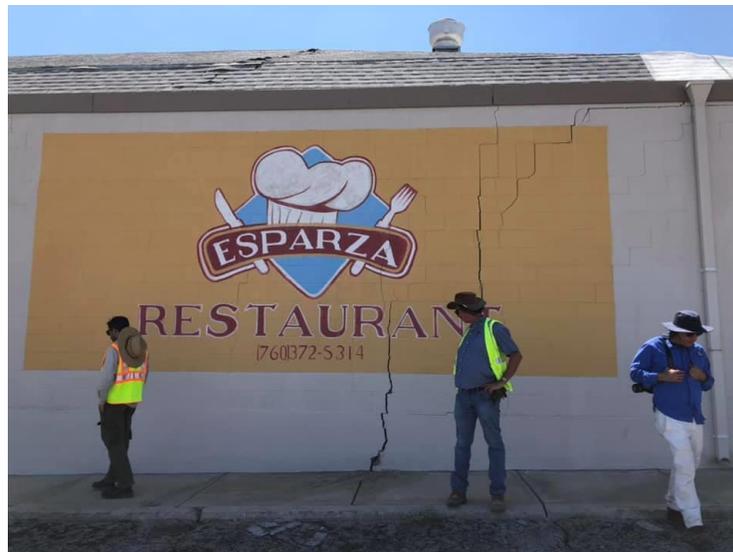
Figure 16. Cracks in masonry walls in Trona following the M 7.1 event (Photo by Christine Goulet, SCEC)

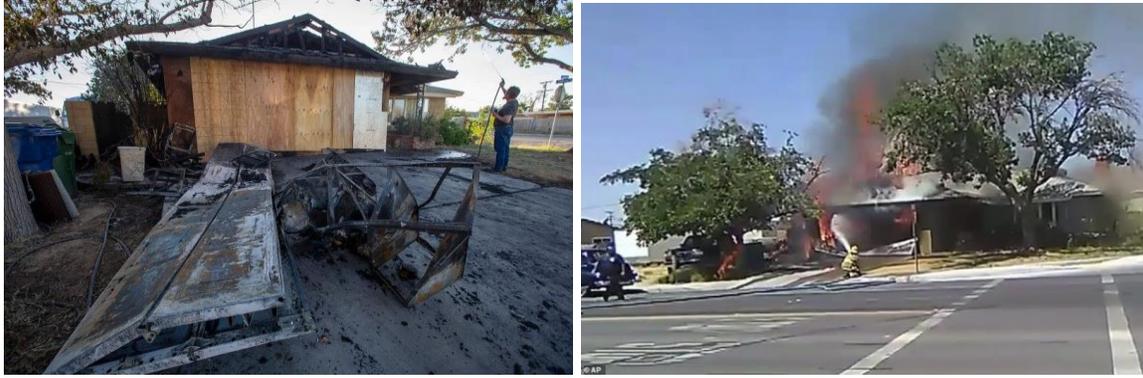
At least two residential houses in Ridgecrest caught fire after the M 6.4 event most probably due to broken gas pipes. One house on the corner of Sunland Street and East California Avenue had the garage and part of the main roof burnt by fire (Figure 17a). Another house was heavily damaged by fire, after the M 6.4 event (Figure 17b). Figure 18a shows a collapsed chimney and the upper brick layers that fell from a masonry wall. A house was damaged with diagonal and vertical cracks in exterior walls (Figure 18b). Other buildings with failed chimneys or damaged walls are shown in Figures 19 to 24. Many unreinforced masonry chimney failures were observed in Trona after the M 7.1 event. Preliminary reports cite significant damage in Trona after the M 7.1, pending more information from field teams. Typical damage to timber framed homes is shown in Figure 22, while damage to items in a cafeteria named "My Enchanted Cottage" at 214 W Ridgecrest Blvd Ridgecrest, CA 93555, are shown in Figure 25.

Figure 17. Two houses caught fire in Ridgecrest after the M 6.4 event (San Bernardino Sun, 2019; AP News, 2019)

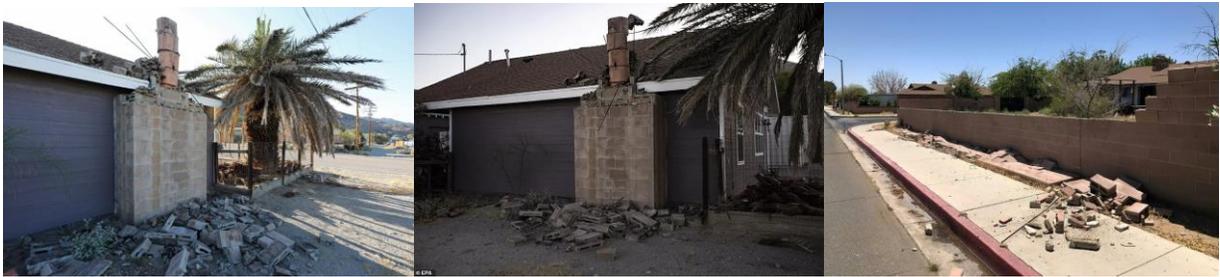
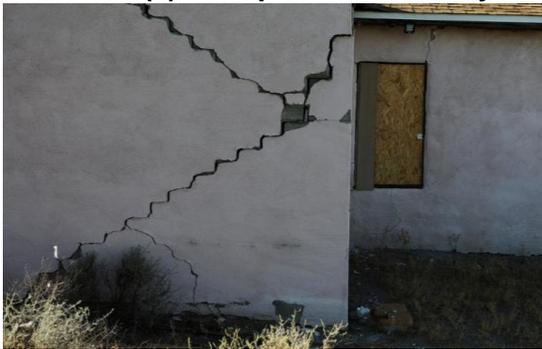
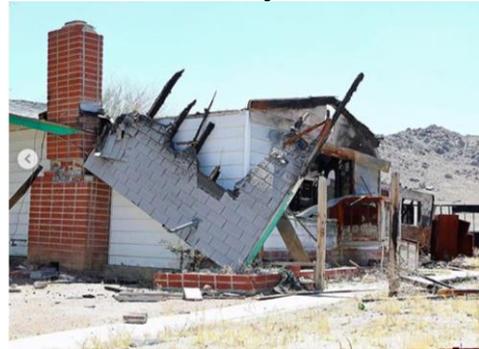
(a) Collapse of a chimney and upper section of a masonry wall

(b) Cracks in exterior walls

(c) Fire damage after M 7.1 event

Figure 18. Damage to masonry structures (Sources: (a) Reuters, 2019; (b) Yahoo, 2019, and (c) [themegaagency](#), Instagram, 2019)

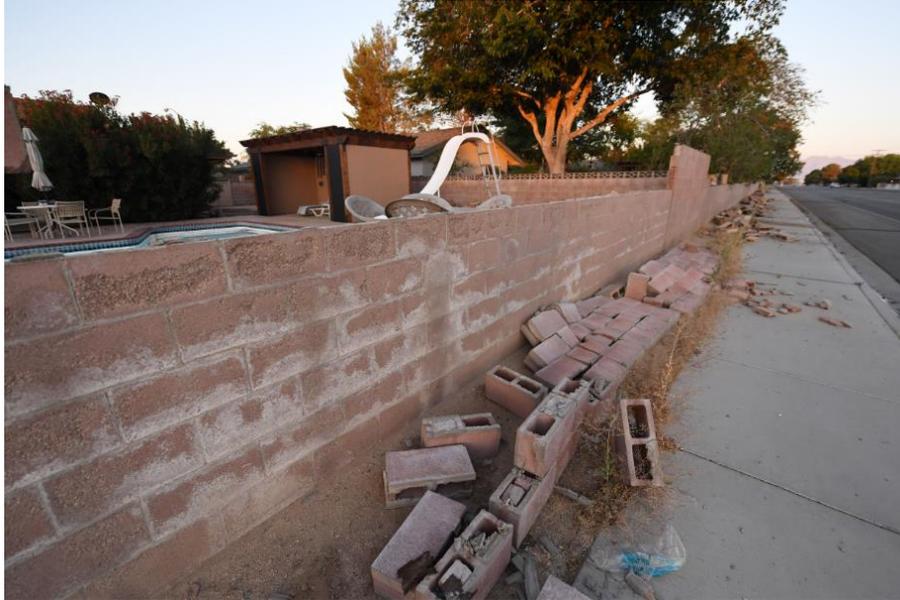
Figure 19. A cinderblock wall partially destroyed in Ridgecrest following the magnitude 7.1 Earthquake (CNN, 2019)

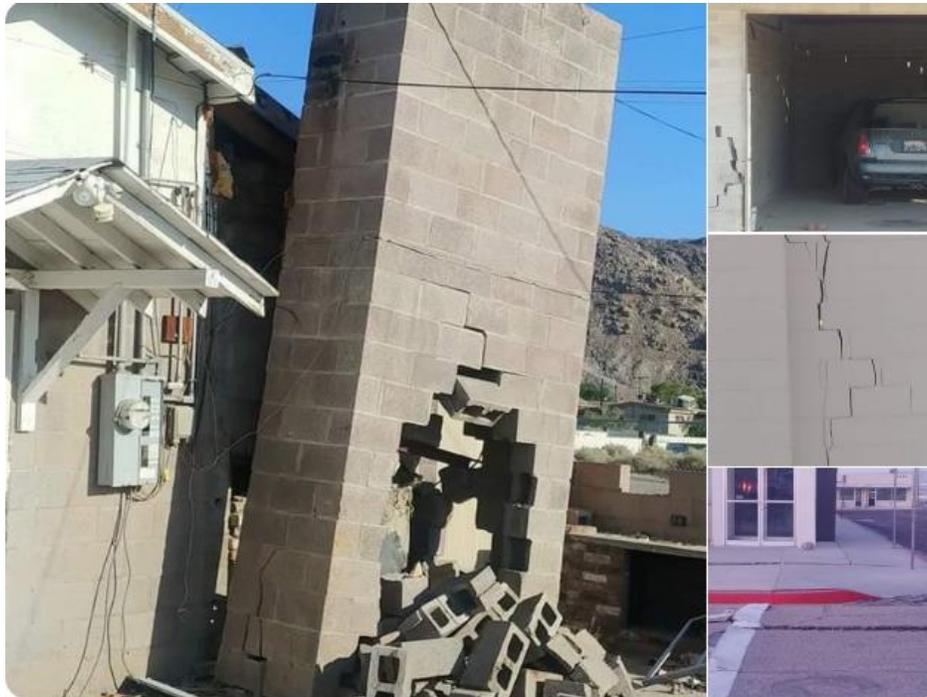
Figure 20. Damage to a masonry house in Trona after the M 7.1 earthquake (Source: [Eytan Wallace](#) via Twitter)

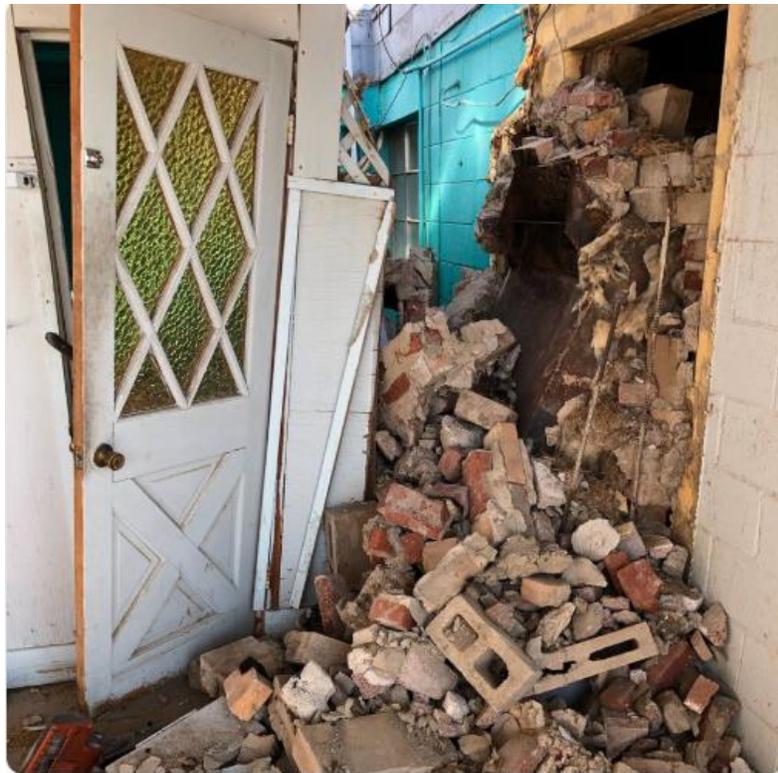
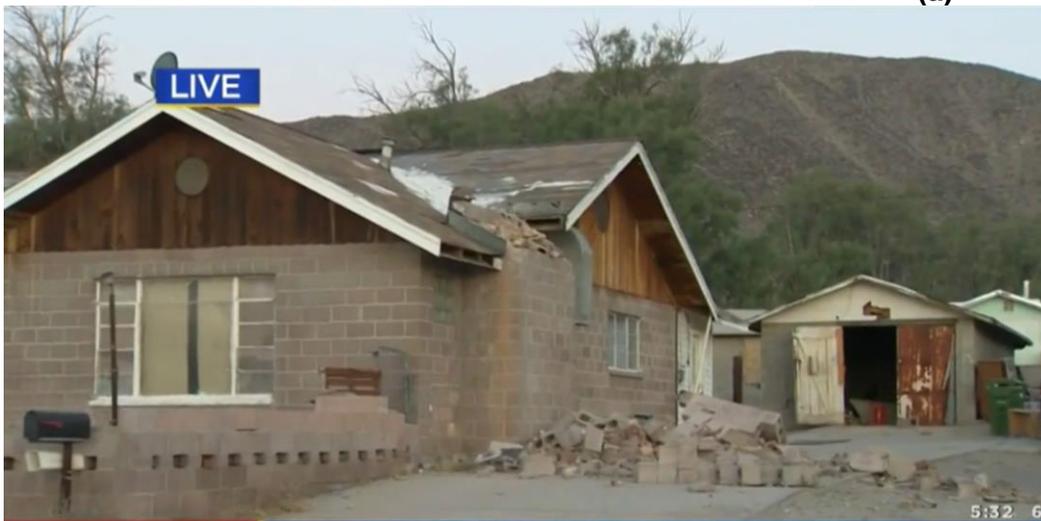
Figure 21. Damage to a masonry houses in Trona after the M 7.1 earthquake (Sources:a) [Rob Mcmillan](#) via Twitter, b) CBS Los Angeles)

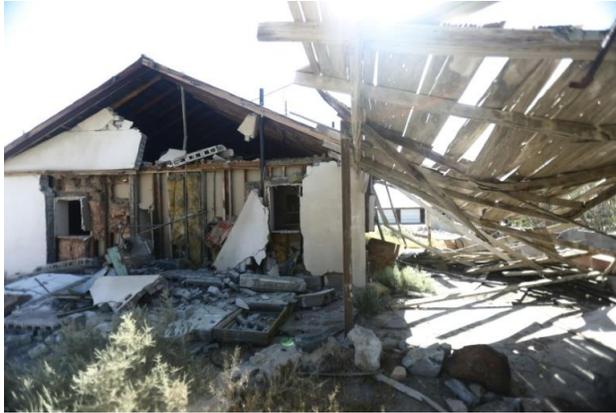
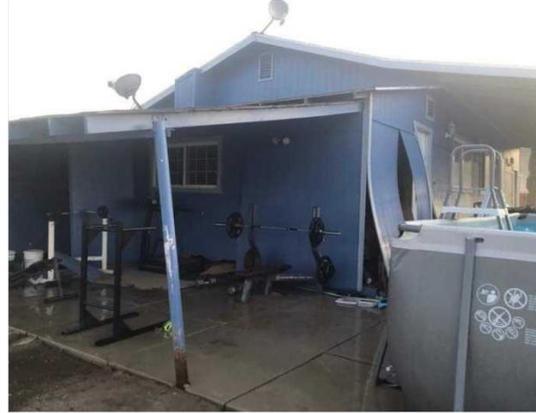
Figure 22. (a) Damaged house in Trona after the M 7.1 event (credit: Mario Tama, AFP); (b) Damaged walls of a home in Trona (Source: @23ABCNews via Twitter)

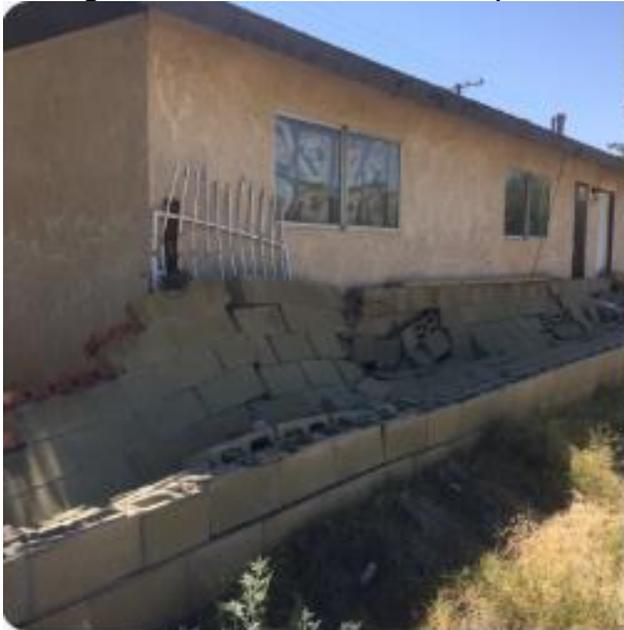
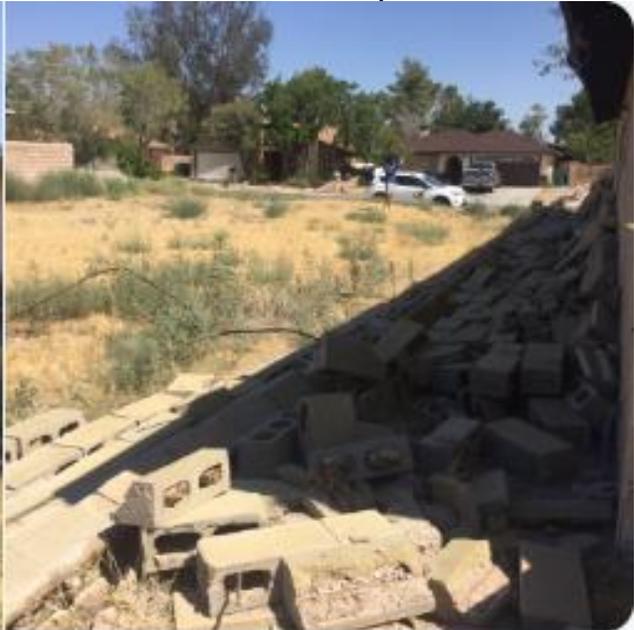
Figure 23. Collapsed cinder block walls of a masonry house (Source: [Karen Hua](#) via Twitter)

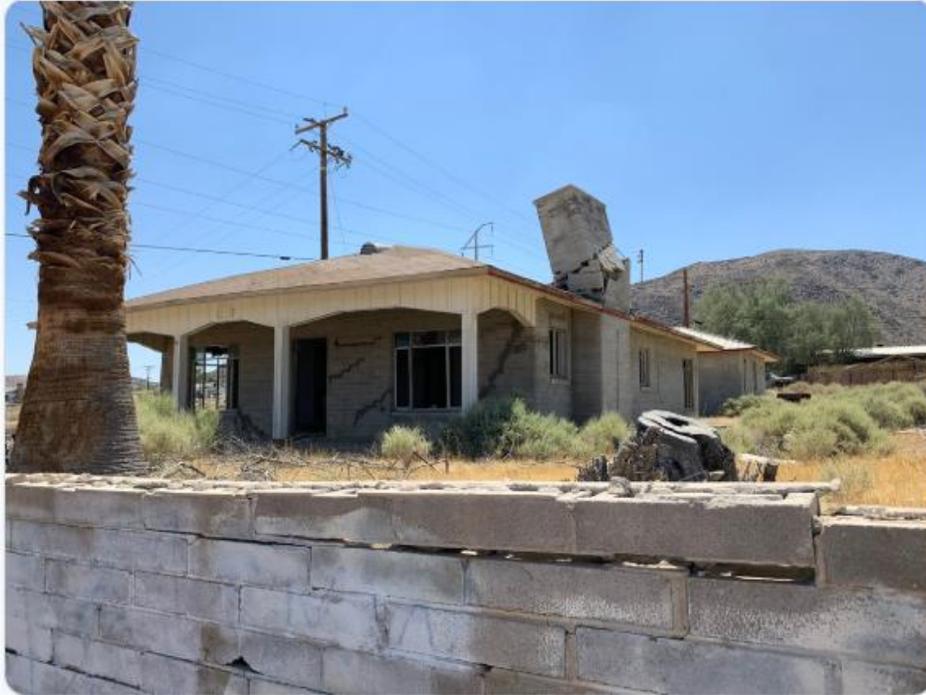
Figure 24. Broken masonry chimney and damaged masonry walls (Source: [Ken O'Doll](#) via Twitter)

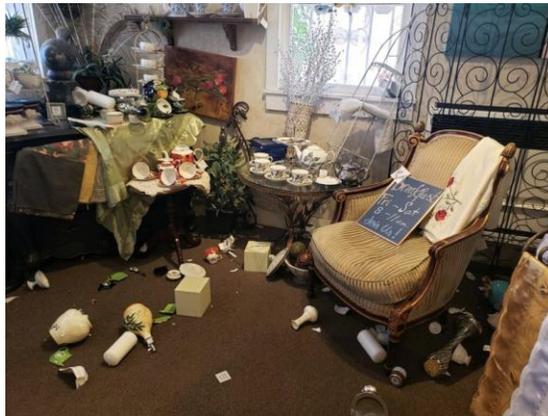
Figure 25. Contents damage in a cafeteria due to the M 6.4 event (AP News, 2019)

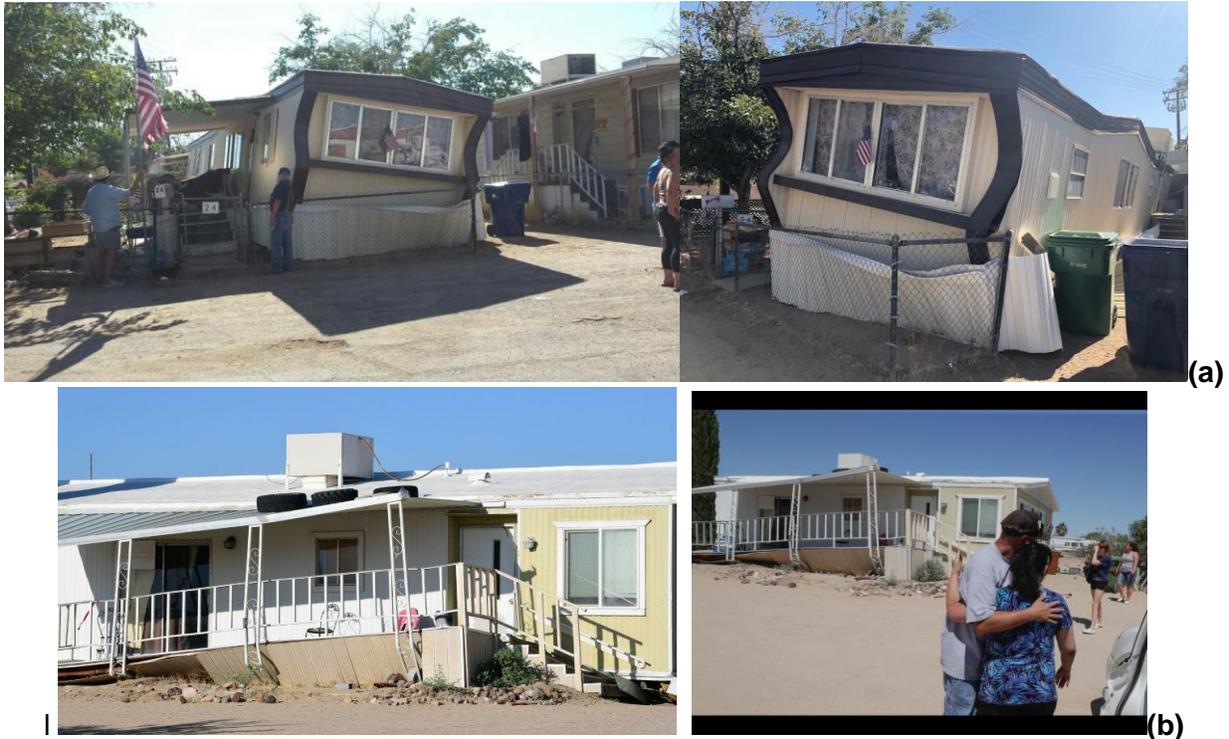
At least two mobile homes were damaged during the M 6.4 event. One is at Trousdale Estates at 210 W. Ward Ave. in Ridgecrest where a woman and her child were inside the building when the earthquake occurred but were unharmed, Figure 26(a). The mobile home appears to have been displaced off its supports, resulting in damage to the skirt surrounding the trailer chassis. Another mobile home also appears to have fallen off its supports resulting in damage to the metal columns supporting the roof over the porch, Figure 26(b). Out of 193 mobile homes in three mobile home parks north of Ridgecrest, eight mobile homes collapsed; none of which were tied down or had seismic braces (Keith Porter from the field.) It appears that most of these collapses were due to the M 7.1 event. According to Jonathan Stewart from the field: there are damaged structures in Trona, in many cases this is from the effects of ground failure. Following the M 7.1 event, Trona seems to be largely abandoned, due to loss of water (it is served by the water pipes ruptured by

Figure 26. Damage to mobile homes in Ridgecrest area due to the M 6.4 event (a) Source: Bakersfield News, 2019; (b) Source: Yahoo News, 2019

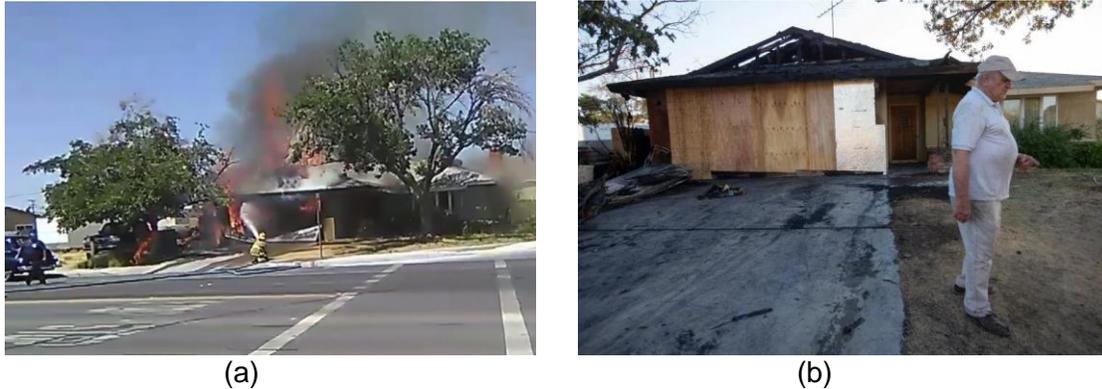
The M 6.4 earthquake caused two structural fires, a brush fire, and a few vegetation fires. This section will focus on the fires caused in structures. The structural fires occurred in Ridgecrest, CA and in Bakersfield, CA and were reported by the Kern County Fire Department. It is unknown at the time as to the cause of the fires, but multiple gas leaks were also reported after the earthquake. Figure 28(a) shows an active fire in Ridgecrest and Figure 28(b) shows the post-fire

Figure 28. Fire following M 6.4 event in Ridgecrest (a) active fire conditions (ABC, 2019), and (b) post-fire condition (Source: San Bernardino Sun, 2019)

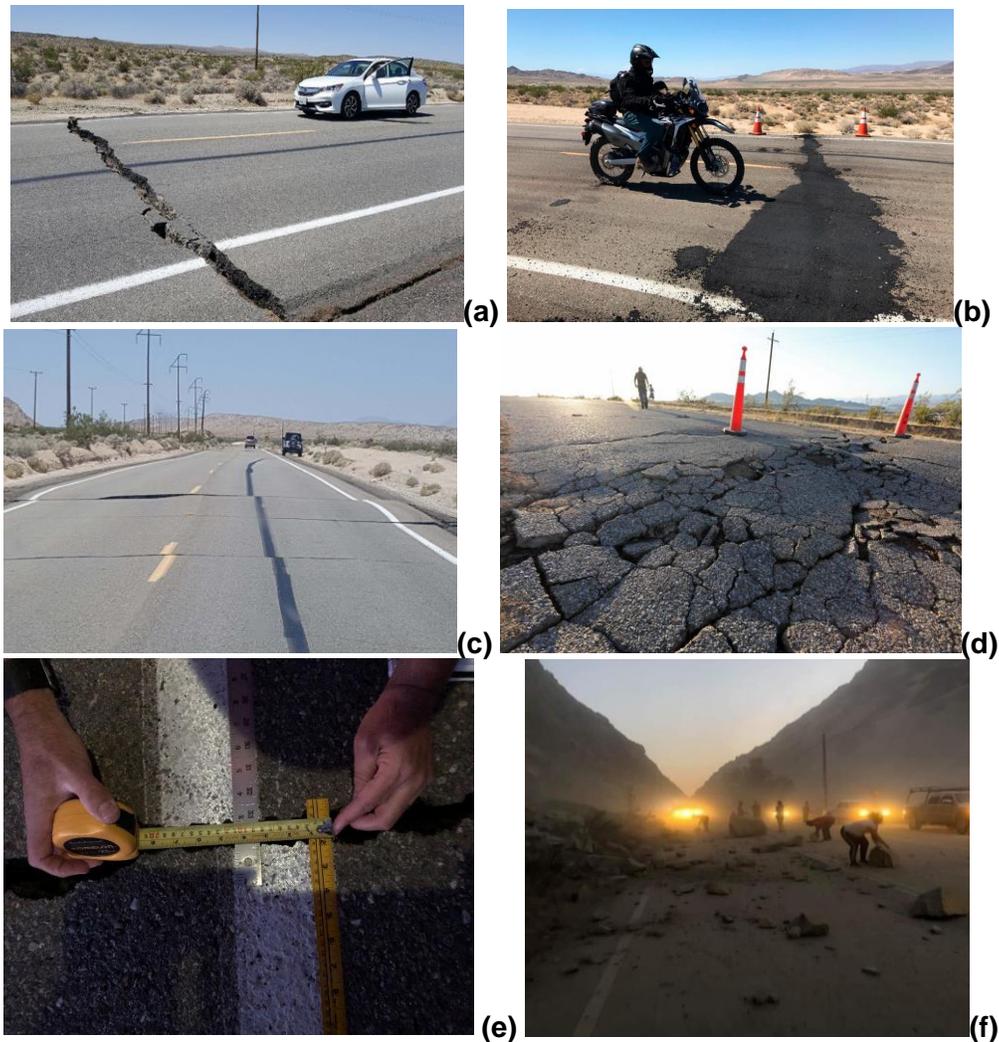
A large crack has formed in a highway near Ridgecrest following the earthquake event on July 4, 2019. The road damage included a 12-inch (305 mm) crack across Highway 178, about two miles west of Trona Road. Moreover, several cracks formed on the SR 178 between Trona and Ridgecrest after the M 7.1 event. The roads have been closed for repairs and were quickly repaired by Caltrans crews (KTLA, 2019, Figures 31 to 33). After the M 6.4 event, highways in San Bernardino County remained open. However, after the M 7.1 event, the SR 178 between Trona and Ridgecrest was closed for repairs. No damage to bridges and airports was reported.

Figure 31. Damage reported in Highway 178 (a) Large crack formed near Trona²⁰ (b) a motorcyclist rides over a temporarily repaired part of the damaged highway in Ridgecrest one day after the earthquake, demonstrating the rapid response of repair crews; (c) damage reported in Ridgecrest during the M 6.4 event²¹; (d) surface cracks near Ridgecrest following the M 6.4 event²² (AP Photo/David McNew) (e) Crack length near Ridgecrest after the July 4th event²³; (f) rockslides cause closure of the highway from the M 7.1 event on Friday night; announced clear Saturday at 1 AM by Kern Country²⁴

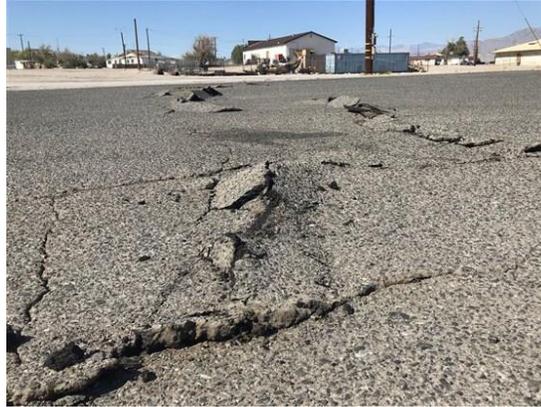
Figure 32. A road in Trona slightly damaged during M 6.4 event (AP Photo/M. Hartman²⁵)

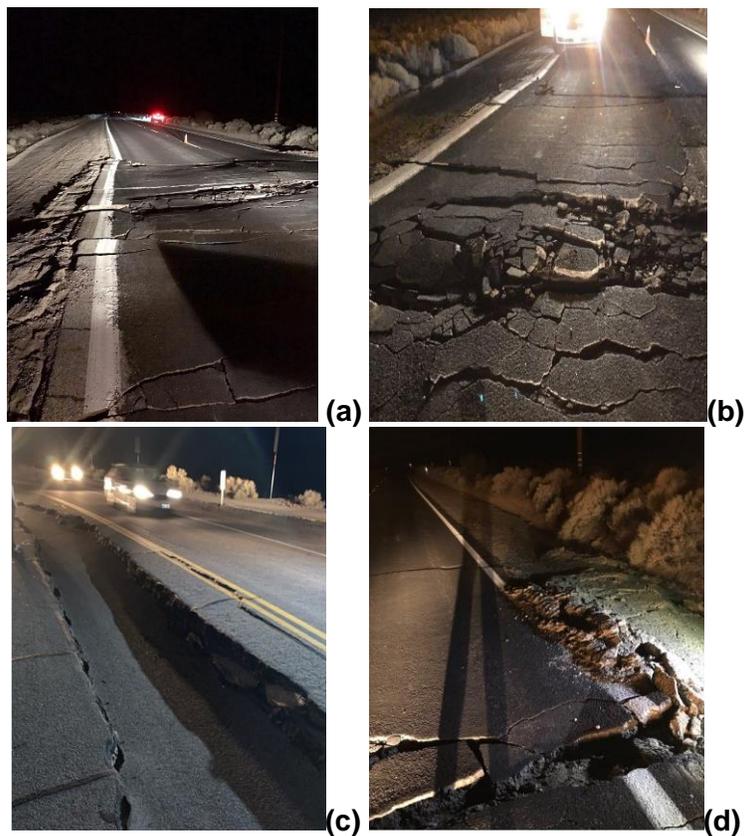
Figure 33. (a) Several cracks on the SR 178 WS between Trona and Ridgecrest after the M 7.1 event. The road was closed for repairs; (b) Details of the cracks²⁶; (c) Other picture of the cracks²⁷; (d) Rockfall cleared on SR 178 between Trona and Ridgecrest but route still closed for temporary repair²⁸

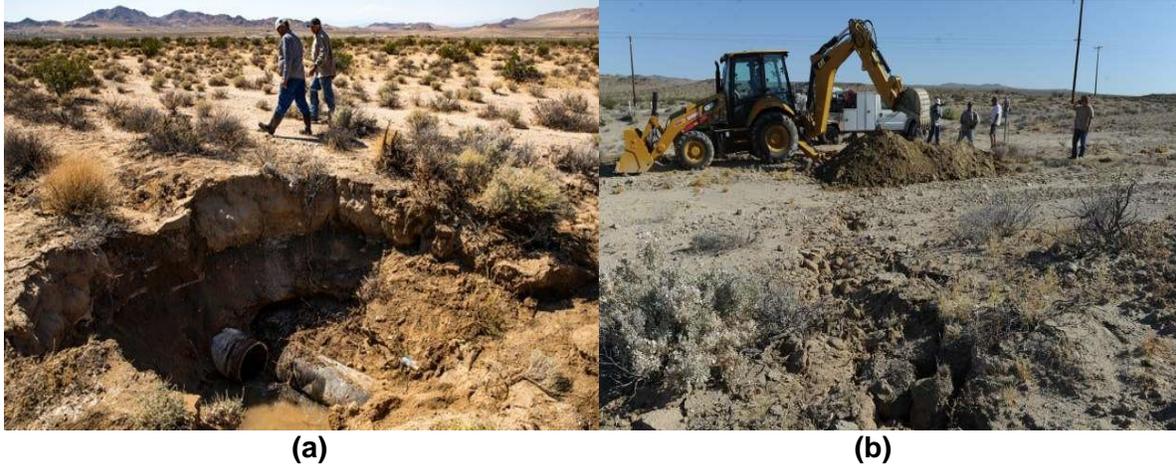
Figure 40. (a) Exploded water pipe reported during the M 6.4 event, consequently forming a crater near Ridgecrest (Source: AP Photo/Etienne Laurent, EPA-EFE³⁶; (b) Crews dealing with a water main that ruptured during the earthquake³⁷

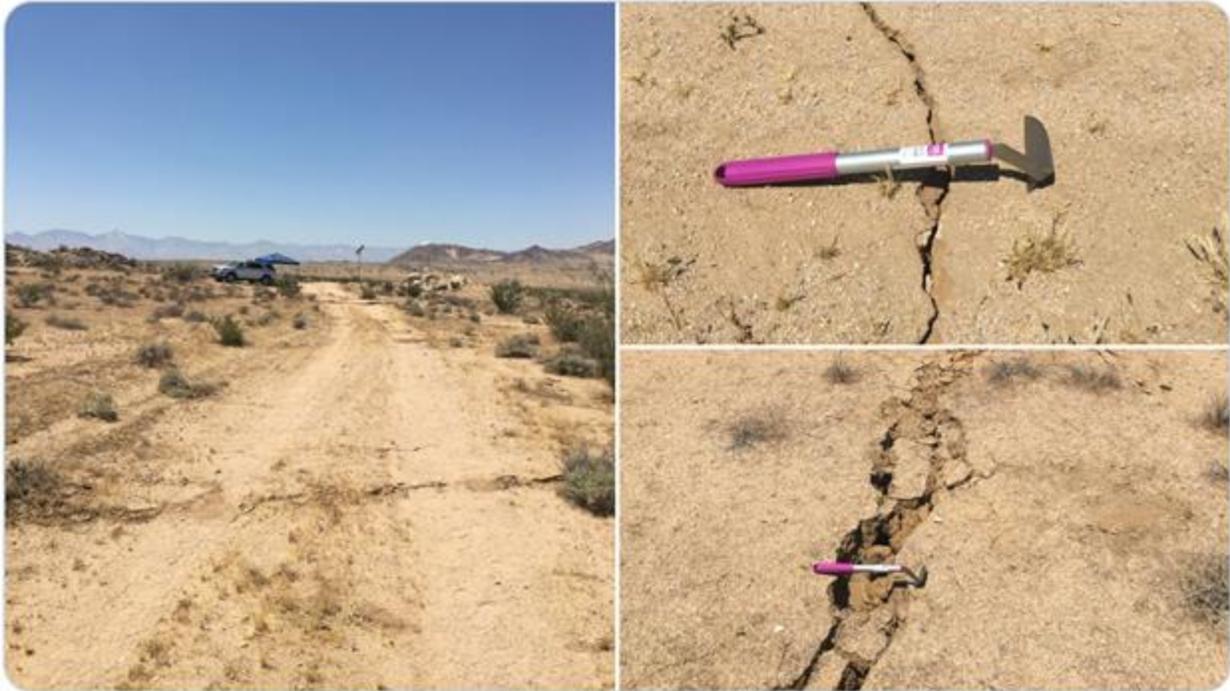
Figure 43. 100 ft (30.48 m) wide zone of parallel ruptures showing left lateral (LL) and some dilation along the Ridgecrest surface rupture reported by Danielle Verdugo Madugo⁴²

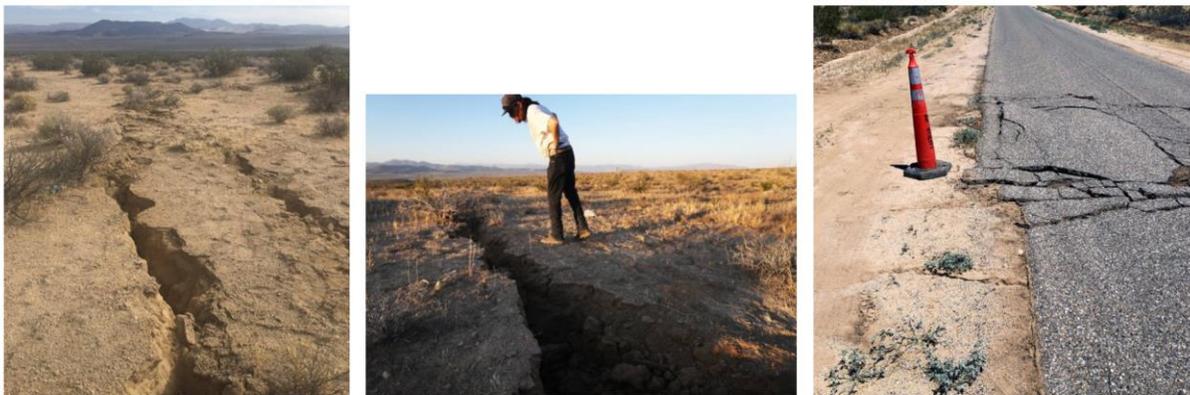
Figure 44. Surface Fault Rupture following M 6.4 Ridgecrest earthquake (a) Off the road rupture (reported by Emily Guerin⁴³), (b) Ground crack near Ridgecrest⁴⁴, (c) fault rupture across Randsburg Wash Road to the south of State Route 178, measured offset of approximately 1.5 feet (457 mm) (Source: Brian Olson Twitter page⁴⁵). All images reported in the VERT report, Appendix B.

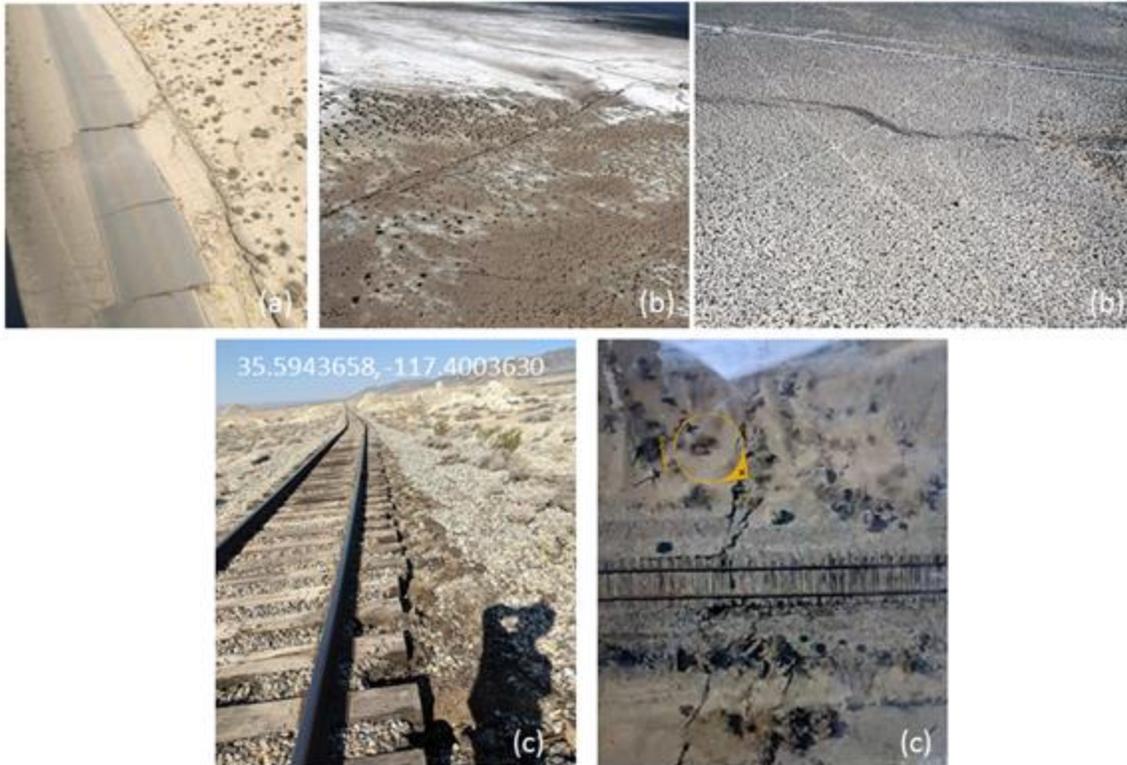
The M 7.1 earthquake caused geotechnical damage in the form of surface fault rupture (e.g. offset, ground fissures etc.), rockfalls, and liquefaction-induced failures (e.g. lateral spreading). A North-West trending fault rupture measured up to 6 feet (229 mm) of right-lateral offset on the China Lake NWS base⁴⁷. A right-lateral offset of about 6.5 feet (248 mm) and a vertical offset of about 3 feet (114 mm) were reported⁴⁸. A surface rupture across State Route 178 caused a right-lateral offset, likely related to the North-West trending conjugate fault⁴⁹, photo taken from the VERT report, Appendix B. Fault rupture also bended railroad tracks and caused damage to the nearby road; a 3-feet (114 mm) right lateral offset was reported⁵⁰.

Figure 46. (a) Aerial view of the faulted road on the China Lake NWAS base, about 6.5 feet (248 mm) right lateral (RL) and 3 feet (114 mm) vertical offset⁵¹, (b) North-West trending fault rupture measuring 6 feet (229 mm) of right-lateral offset on the China Lake NWAS base⁵², and (c) Bent railroad track due to the fault rupture , close to 3 feet (114 mm) of RL offset⁵³

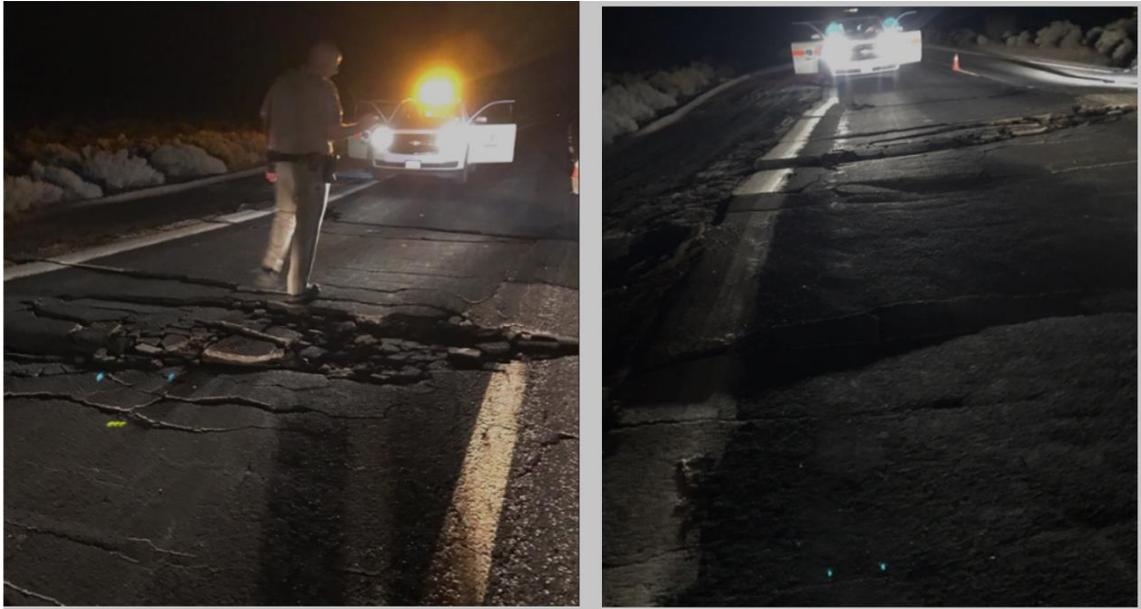
Multiple ground cracks along State Route 178 near Post Mile 8.5 were patched before opening the road to traffic (the duration of closure is now known at this time). According to the Caltrans District 8 Twitter page, Caltrans started permanent construction repairs on State Route 178 approximately six miles east of Ridgecrest. The repairs were done in three separate areas within four mile stretch along the State Route 178. All bridges and highway structures have been evaluated by Caltrans engineers and they have been determined safe for normal operations⁵⁴.

Figure 48. Multiple ground cracks along SR 178 (Source: Caltrans8 Twitter page⁵⁶, taken from the VERT report, Appendix B)

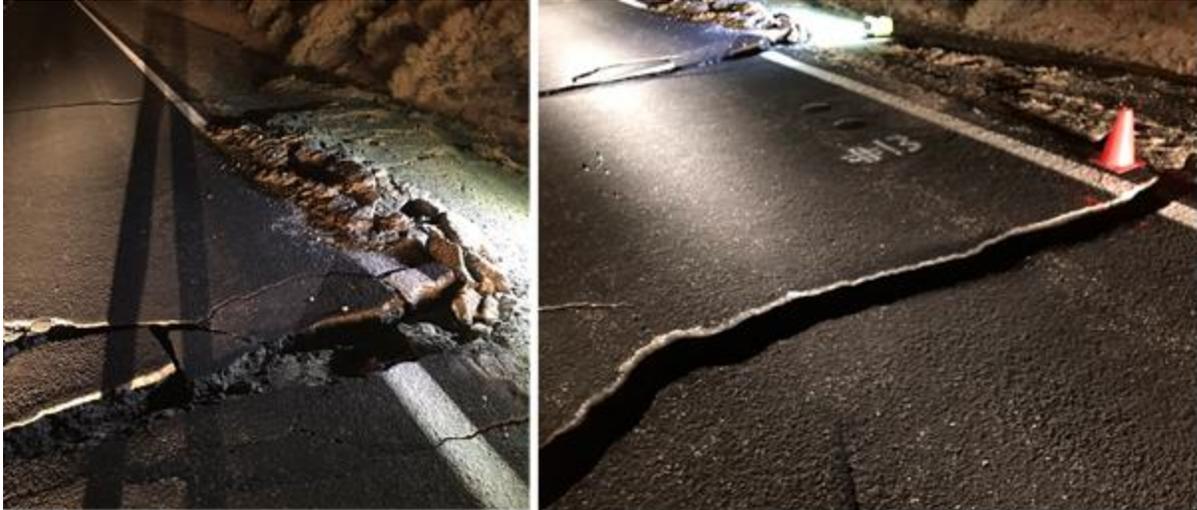
Figure 49. SR 178 near PM (post mile mark) 8.5 Caltrans crews making repairs to patch road before open to traffic⁵⁷ (picture taken 12:53am 07/06/2019)

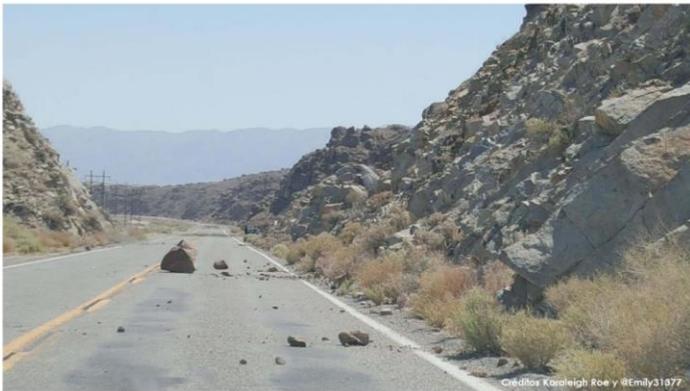
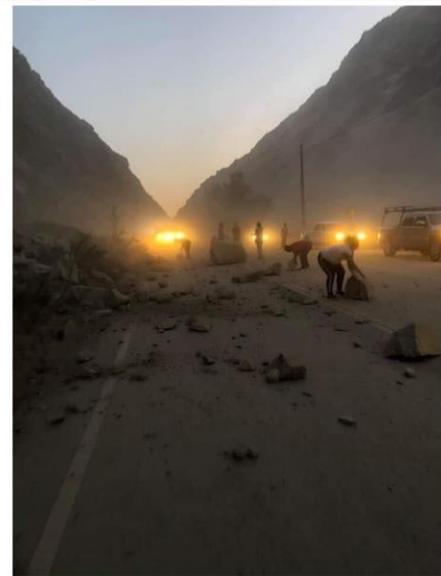
Rockfall caused road closure in State Route 178 between Bakersfield and Lake Isabella. This road was later opened to traffic. Rockfall in State Route 178 between Trona and Ridgecrest caused traffic closure; the rockfall was later cleared. Rockfall was also reported from State Route 190 Townes Pass and State Route 127 near the Tecopas Hot Springs turnoff⁵⁸.

Figure 50. Rockfall damages in Ridgecrest⁵⁹ (left) and Trona⁶⁰ (right). All images reported in the VERT report, Appendix B.

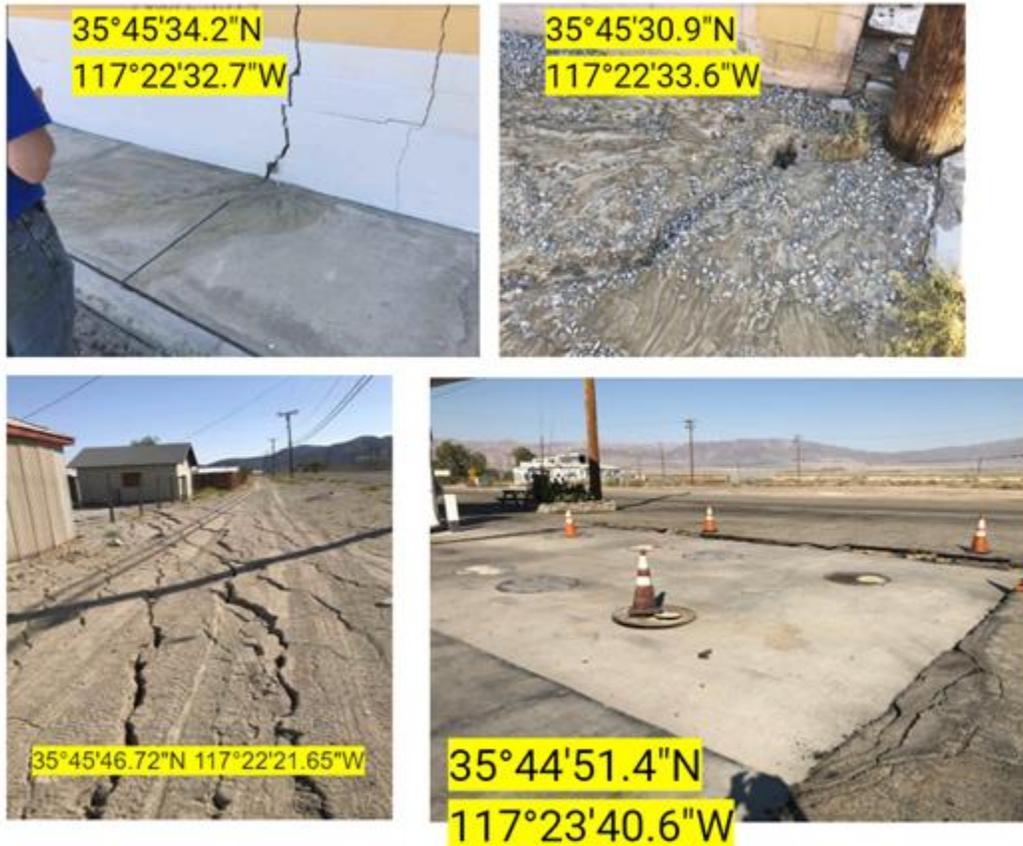
Figure 51. Liquefaction induced lateral spreading and sand boils causing damage to the roadway, and infrastructure in the Trona area (source for all: courtesy of Kenneth Hudson, one of EERI field investigation team members) [clockwise from top left: Esparza restaurant commercial building distance from – closest distance to Searles Lake 0.6 mile; US Post Office Building – closest distance to Searles Lake 1.0 mile; corner of California Street and Argus Avenue; Shell gas station – closest distance to Searles Lake 1.0 mile].

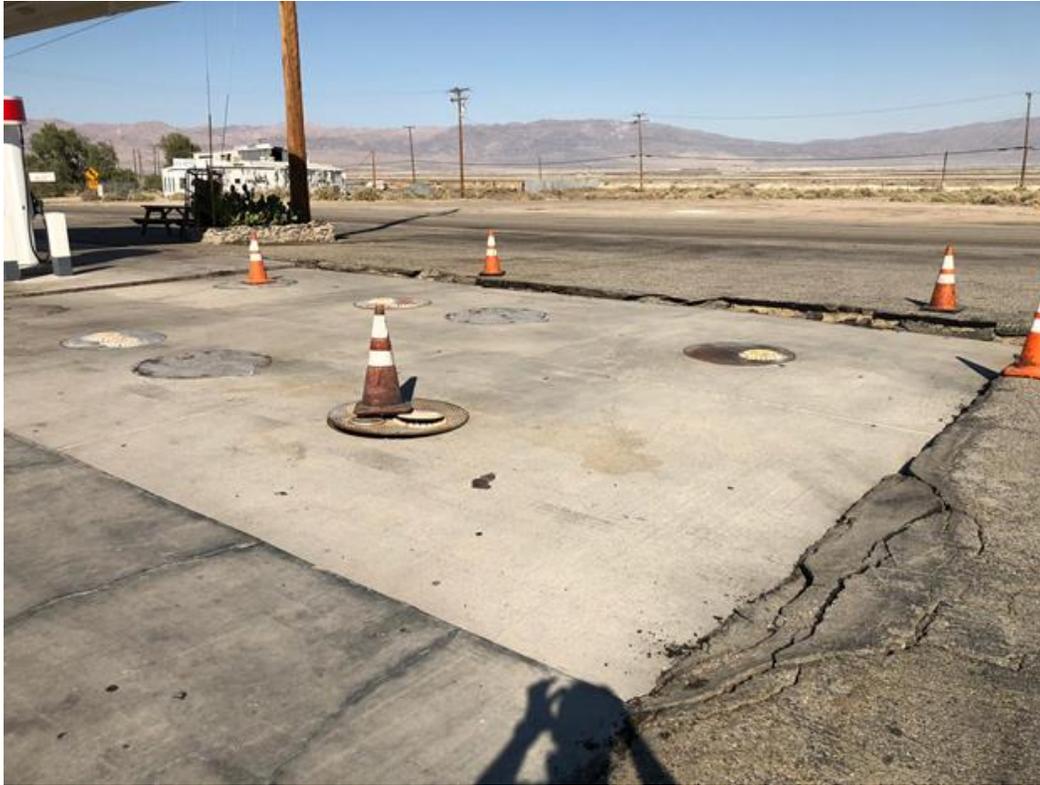
Figure 52. Closer look at ground failure observed at underground storage tank at Shell gas station on Trona Road (Source: courtesy of Kenneth Hudson, one of EERI field investigation team members).
