<b>StEER</b> <b>STRUCTURAL</b> EXTREME EVENTS RECONNAISSANCE		<b>EVENT BRIEFING</b>	
		Event:	Typhoon Hagibis and Oct. 12, 2019 Earthquake
		Region:	East Asia
Authors:	Selim Günay, Pacific Earthquake Engineering Research Center, University of California, Berkeley David O. Prevatt, Engineering School of Sustainable Infrastructure & Environment Ian N. Robertson, University of Hawaii at Manoa Khalid M. Mosalam, Pacific Earthquake Engineering Research Center, University of California, Berkeley		
Editors:	Tracy Kijewski-Correa, University of Notre Dame David Roueche, Auburn University		
DesignSafe Project #	PRJ-2577	Release Date:	October 17, 2019

Typhoon Hagibis + Earthquake | Released October 17, 2019

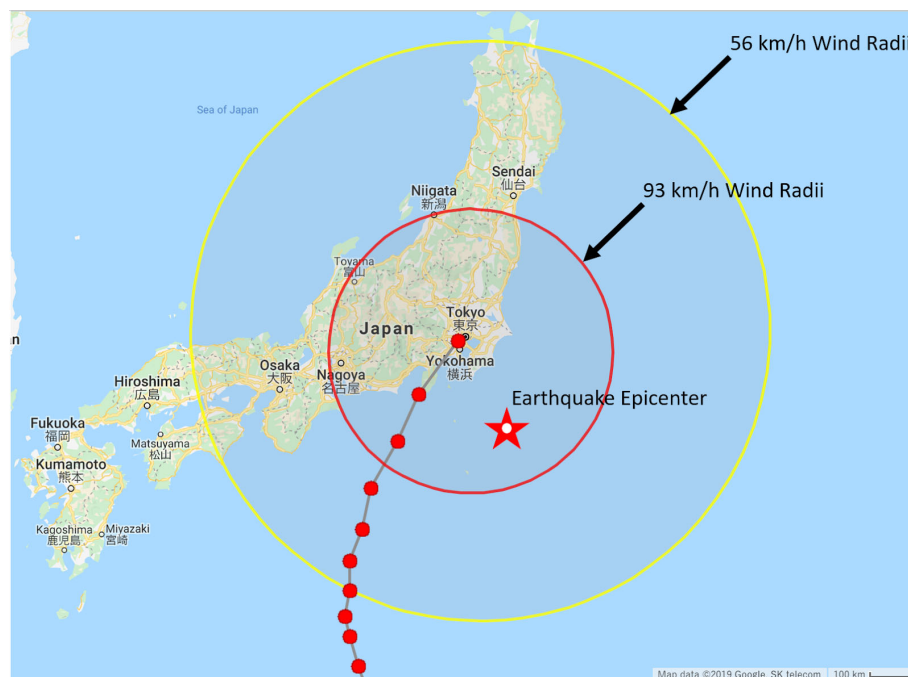
**Figure 1.** Visualization of typhoon track relative to earthquake epicenter (star). Red (inner) circle shows radius of Typhoon (Class 5) winds and green/yellow (outer) circle shows radius of Tropical Storm (Class 3) winds. (Source: Digital Typhoon, 2019).

Around 20 minutes later, at approximately 6:22 pm local time, a magnitude 5.3 earthquake, with a depth of 59.5 km, struck 55 km south east of Katsuura, the nearest city to the epicenter on land (USGS, 2019). Although this earthquake had only moderate intensity, simultaneous occurrence of wind storms and earthquakes in the same local (Fig. 1) is a unique occurrence and opportunity to explore structural performance under simultaneous multi-hazards.

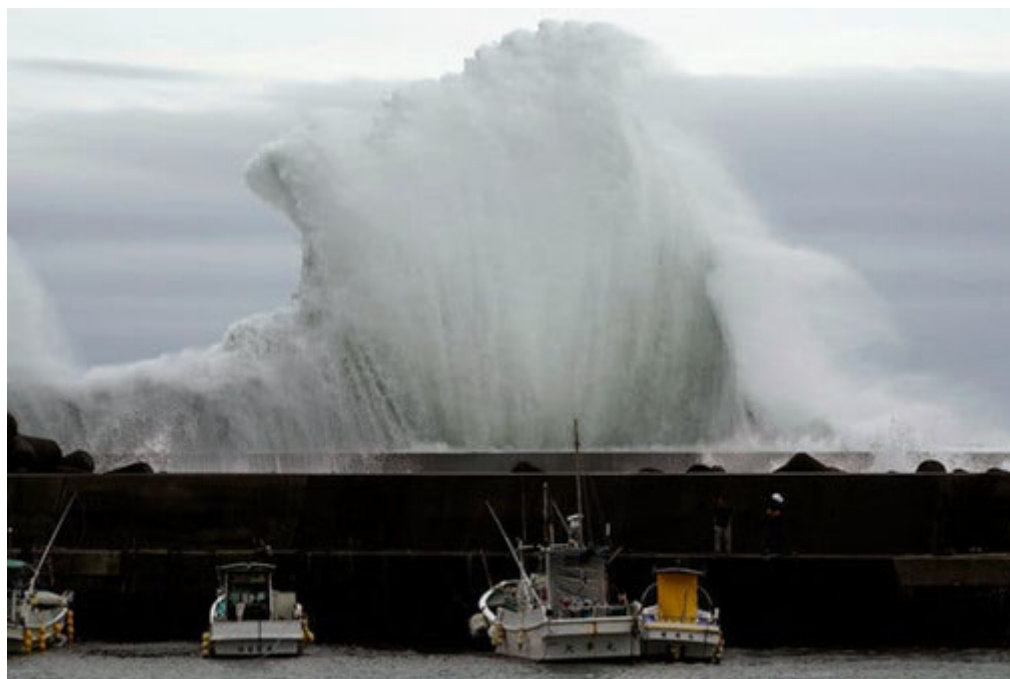
**Figure 3:** Wave striking breakwater in Kiho, Japan (Source: Toru Hanai/Associated Press; New York Times, 2019).

In addition to hurricane force winds, Hagibis brought storm surge and waves to the South and East shores of Honshu Island. Because Japan has a history of typhoons and tsunamis, many shorelines and river estuaries are protected by breakwaters and concrete walls or earthen levees. These appear to have been effective at limiting damage to coastal ports and harbor facilities (Fig. 3); however, the storm also brought extremely high rainfall (Fig. 4). The combination of elevated sea level and wave runoff, plus extreme riverine flow due to the heavy rainfall may have contributed to some river channels being overtopped. Extensive flood damage resulted in a number of river valleys, impacting homes (Figs. 5 and 6). According to the Fire and Disaster Management Agency of Japan, 9,962 houses had been flooded across the country (CNN, 2019a). The heavy rain also caused 146 landslides across the country.

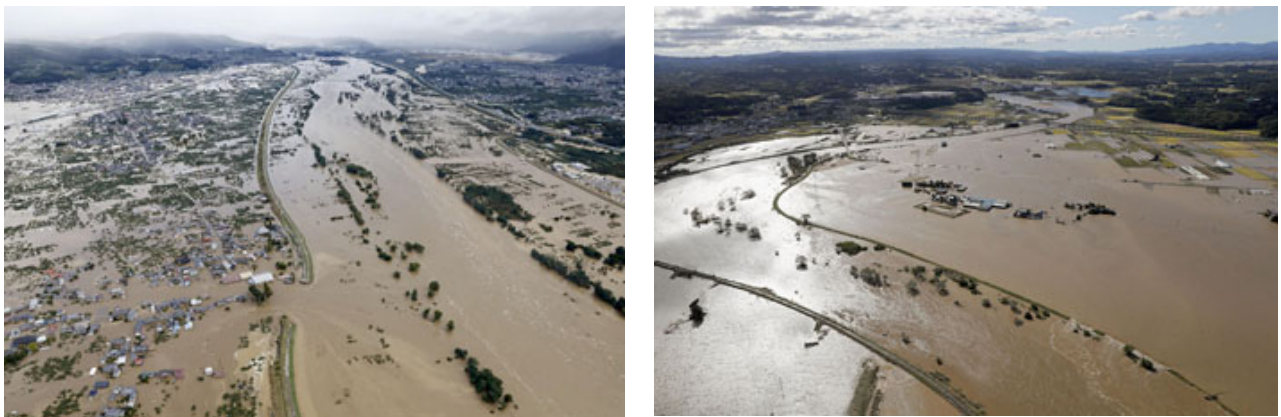
**Figure 5:** Flooding due to levee failure along the Chikuma River in Nagano, Central Japan (left, Source: Aljazeera, 2019), areas flooded by the Abukuma River following Typhoon Hagibis in Tamagawa town, Fukushima prefecture (right, Source: The Atlantic, 2019).

Infrastructure damage due to the typhoon included trains and railway structures (Fig. 10) as well as power distribution systems, resulting in more than 270,000 households losing power. Levee failures (Fig. 5) were also reported.

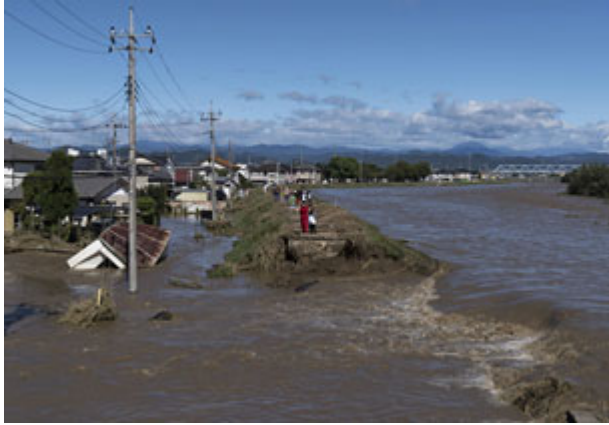
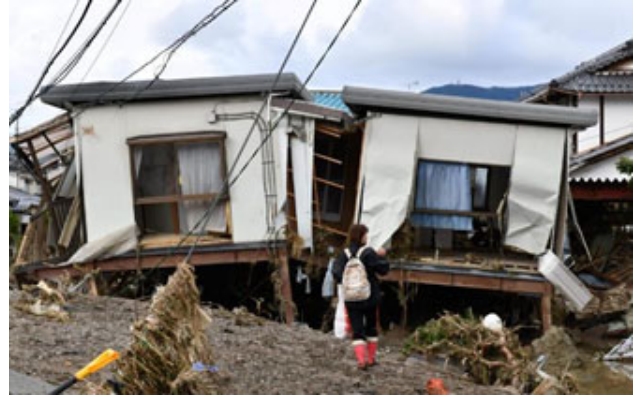
**Figure 6:** Floodwater flow through a break in the riverbank of the Akiyama River in Sano, Tochigi (left, The Atlantic, 2019), flood-damaged homes in Nagano (right, CNN, 2019a).

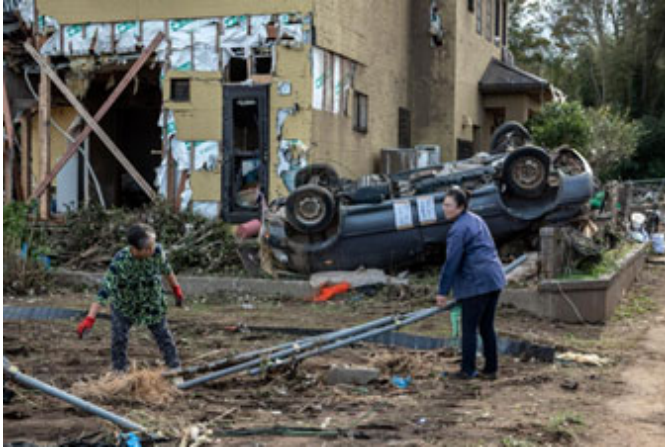
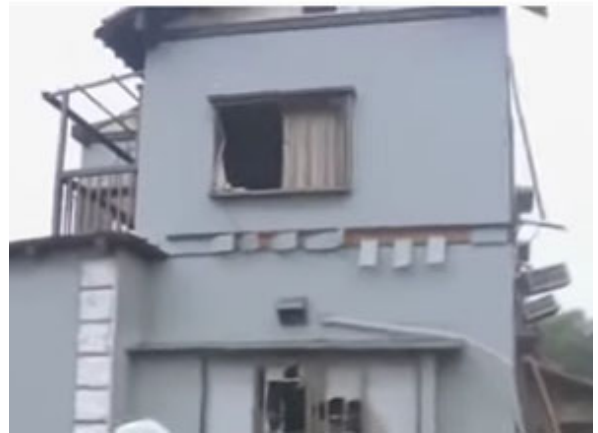
**Figure 8:** Buildings with damaged façade (Source: Forbes, 2019; CBS News, 2019).

There was significant wind damage to structures, both to the nonstructural components, such as façades and glazing, and to the structural components, including complete collapse (Figs. 8 and 9).

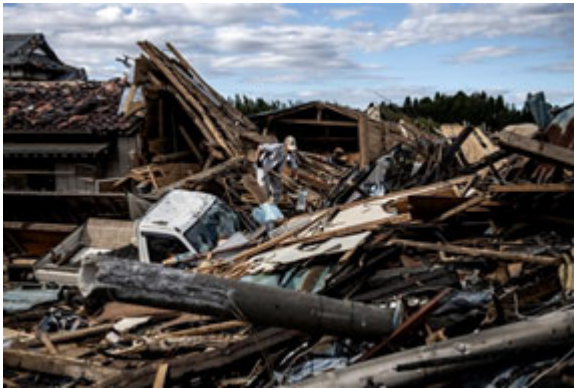
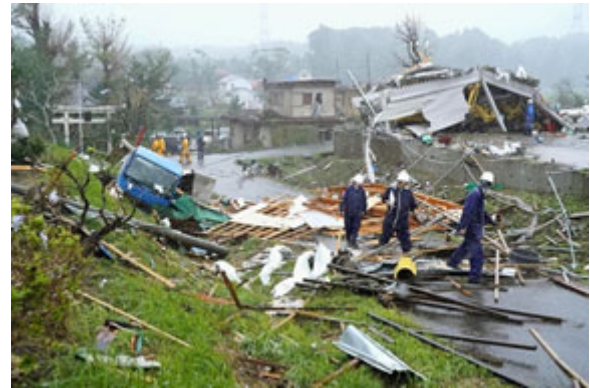
**Figure 9:** Significantly damaged/collapsed buildings; image on the right may have been due to a tornado spawned by the typhoon (Source: CNN, 2019b; ABS-CBN, 2019).

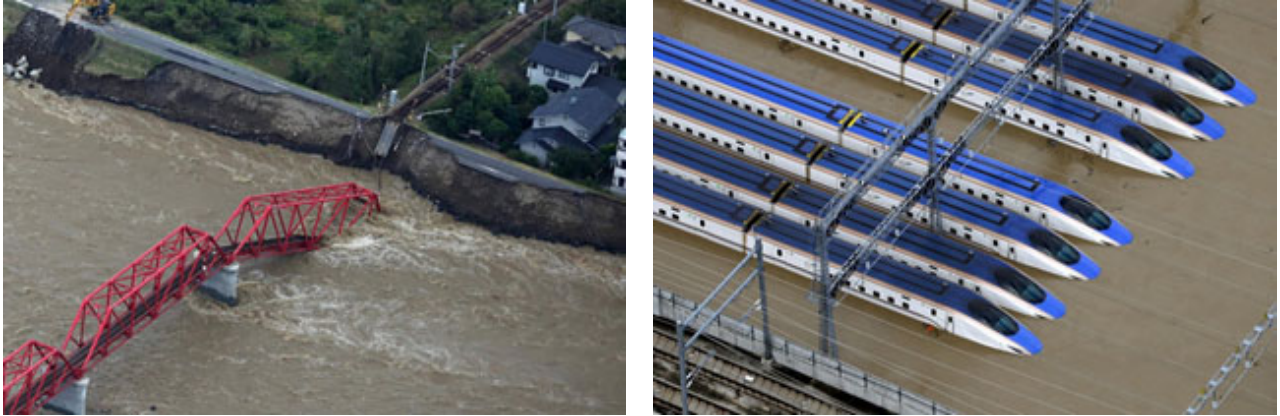
**Figure 10:** Damage to a railway bridge and high-speed trains (Source: Forbes, 2019).
