StEER
STRUCTURAL
EXTREME EVENTS
RECONNAISSANCE

HURRICANE DORIAN

Released: September, 10, 2019
NHERI DesignSafe Project ID: PRJ-2549

PRELIMINARY VIRTUAL RECONNAISSANCE REPORT (PVRR)

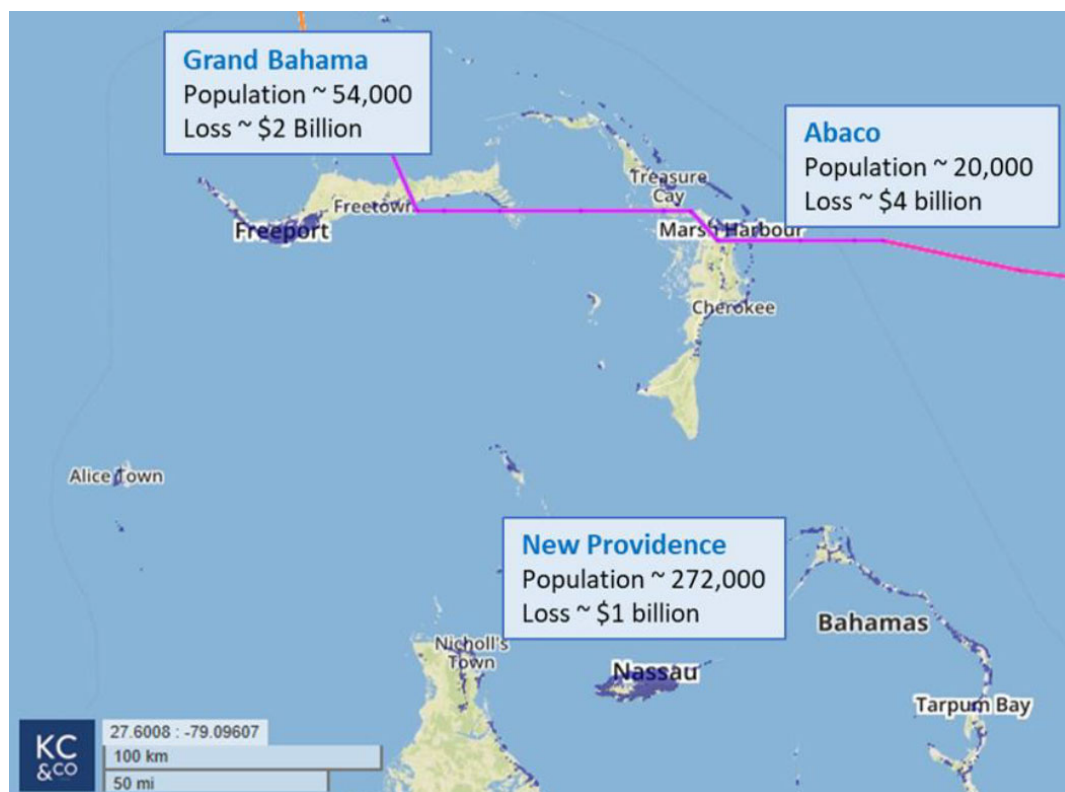
Figure 1.2. Preliminary loss estimates: total (insured and uninsured) losses to residential, commercial and industrial properties. Infrastructure and auto losses not included (KCC, 2019).

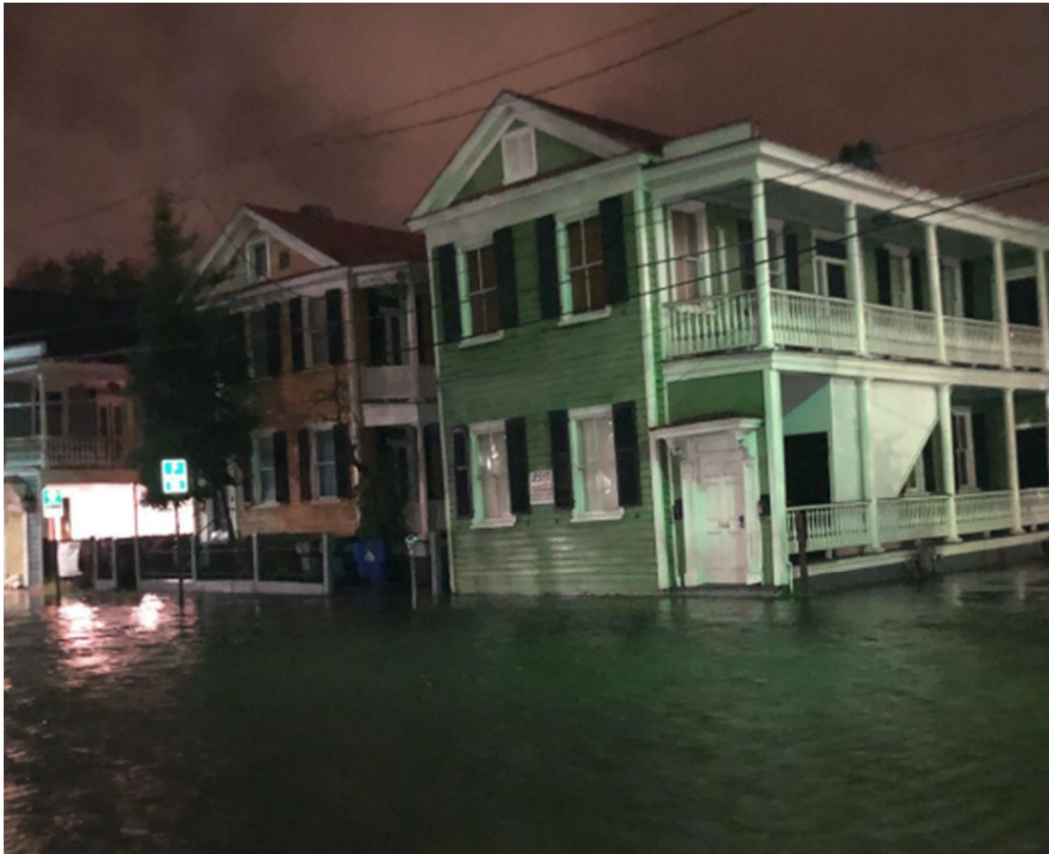
Figure 1.3. Flood damage to buildings in Charleston, SC (Source: <https://www.instagram.com/p/B2BMAqYhfyl/>).

tornadoes. The coastal city of Charleston, SC, with an elevation of 20 feet above sea level and frequently afflicted with nuisance flooding, reported widespread flooding due to Dorian's rains and storm surge (Fig. 1.3). The Spatially Generalized Hurricane Power Outage Model (Guikema et al., 2014) predicted that 4 million US citizens lost power in Hurricane Dorian, with the spatial distribution of outages provided in Figure 1.4.

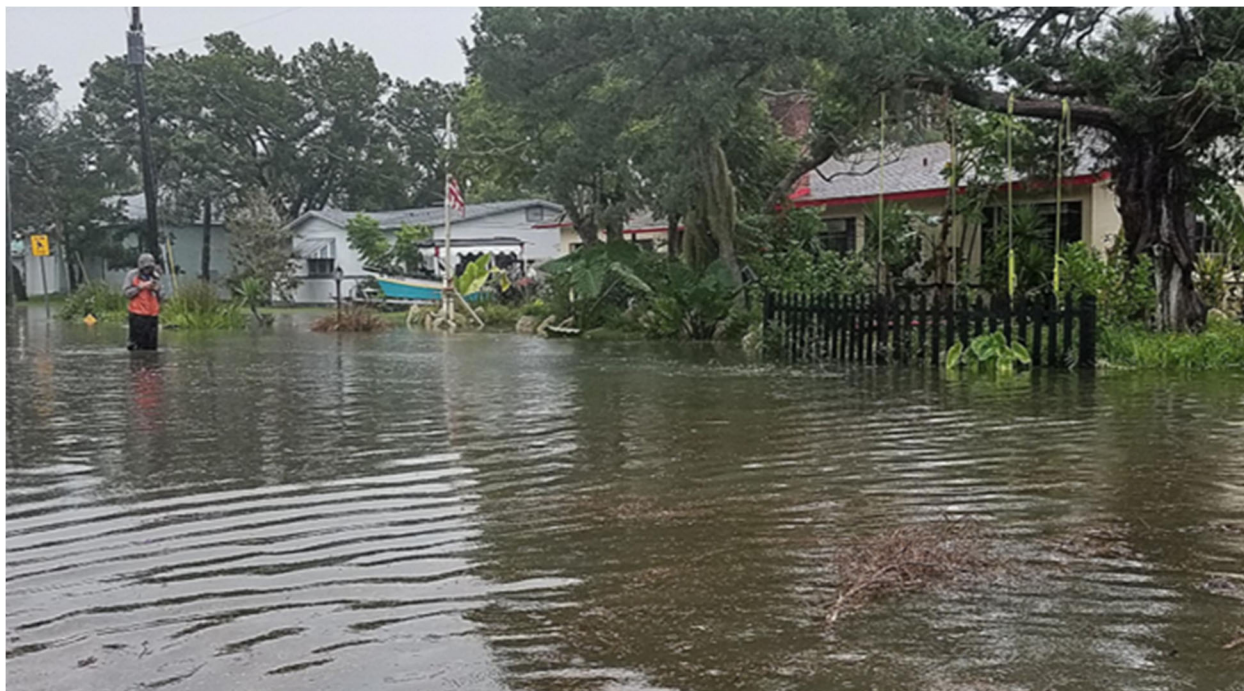
Fig. 2.15. Flooding in Davis Shores, FL, a community on Anastasia Island (Gardner, 2019).

Hurricane Dorian's northward track brought considerable storm surge-related flooding to coastal counties in Florida, Georgia, and the Carolinas. Figure 2.13 shows the NHC's storm surge advisory forecast from 1100 EDT on 4 September 2019. Maximum water levels (conditioned on the coincident occurrences of peak storm surge and high tide) were projected to reach depths above ground between 2-8 (0.6-2.4 m) from northeastern Florida to Virginia. Figure 2.14 shows the CERA projected peak water levels in Florida, Georgia, South Carolina, and North Carolina based on NHC Advisories 45, 48, and 50. As suggested by Fig. 2.14, southeast Florida was spared from extreme coastal flooding due to Hurricane Dorian. Neighborhoods in St. Johns County, including the St. Augustine neighborhoods of Davis Shores, Lincolnville, the Castillo de San Marcus, and King and Granada Streets, experienced minor flooding (Fig. 2.15).

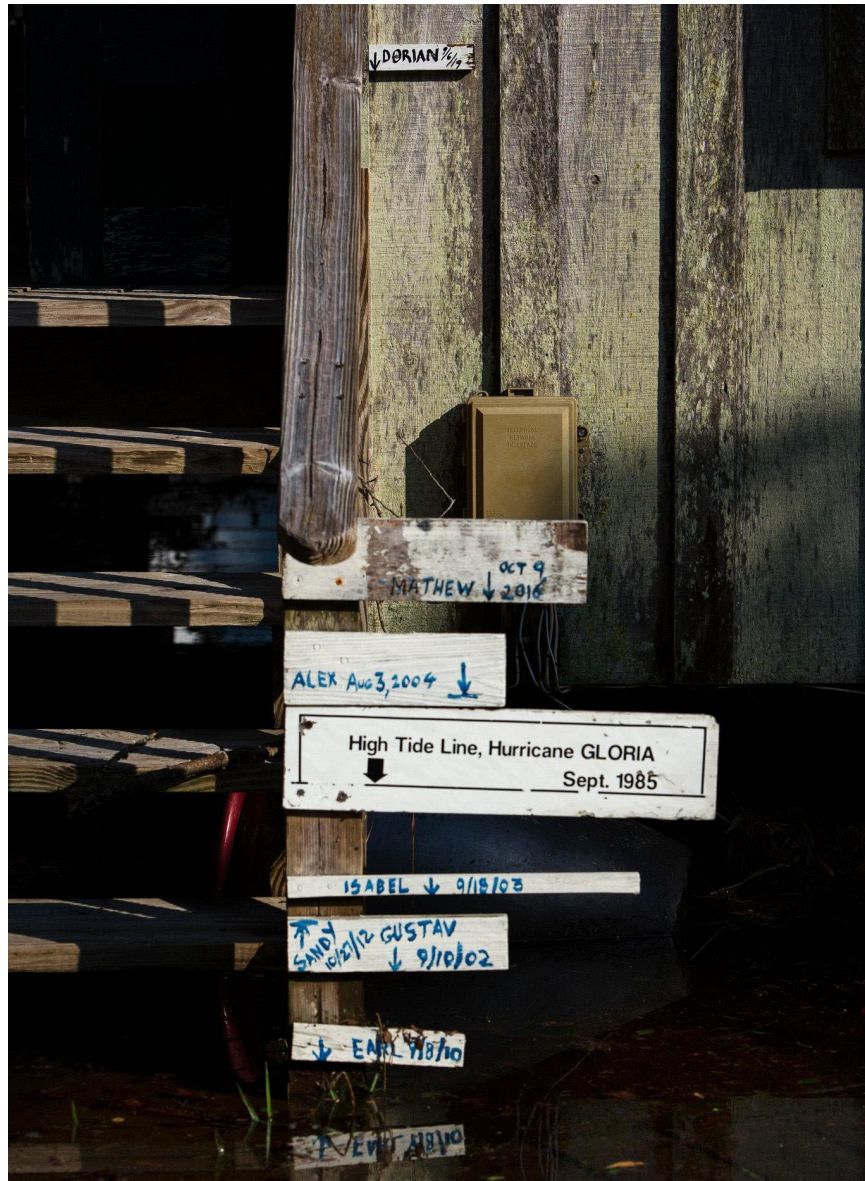
Figure 2.18. High water marks representing historic flood events on Ocracoke Island (Source: [Scott McIntyre/New York Times](#)).

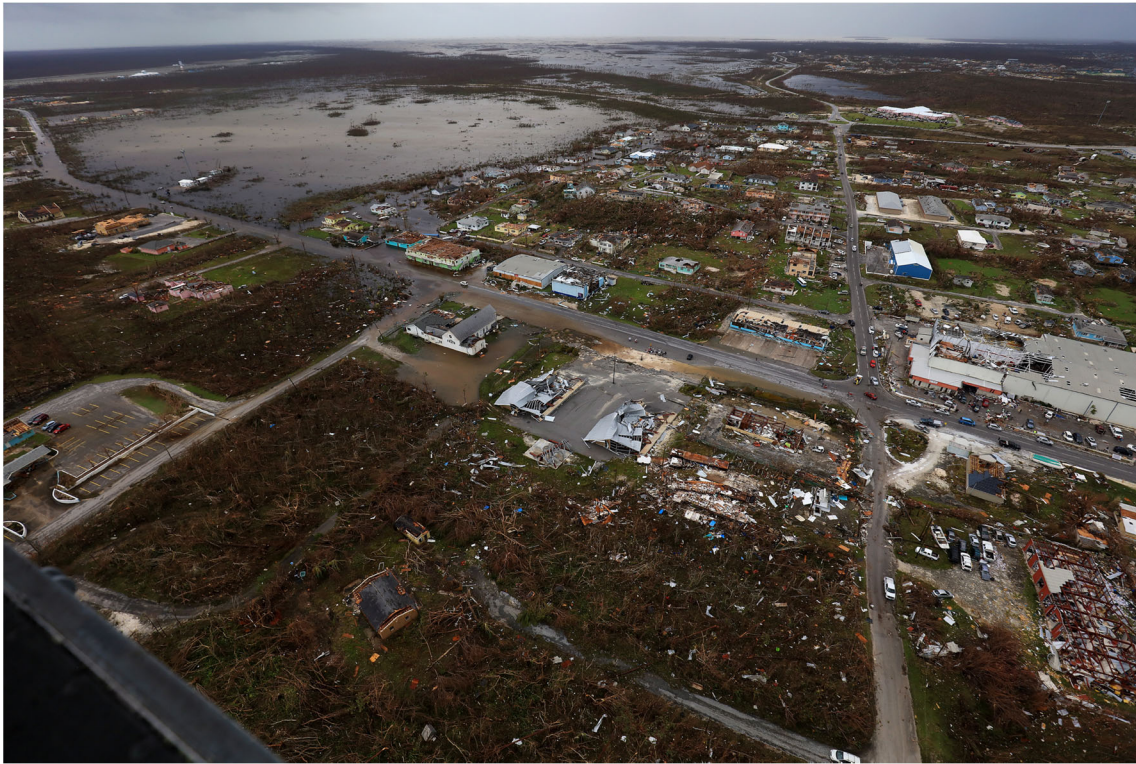
Figure 4.2. Aerial photo of the damage from Dorian at Marsh Harbour on Great Abaco Island. The center of the photograph is located at approximately [26.531406, -77.063431], taken facing West. (Source: [CNN](#))

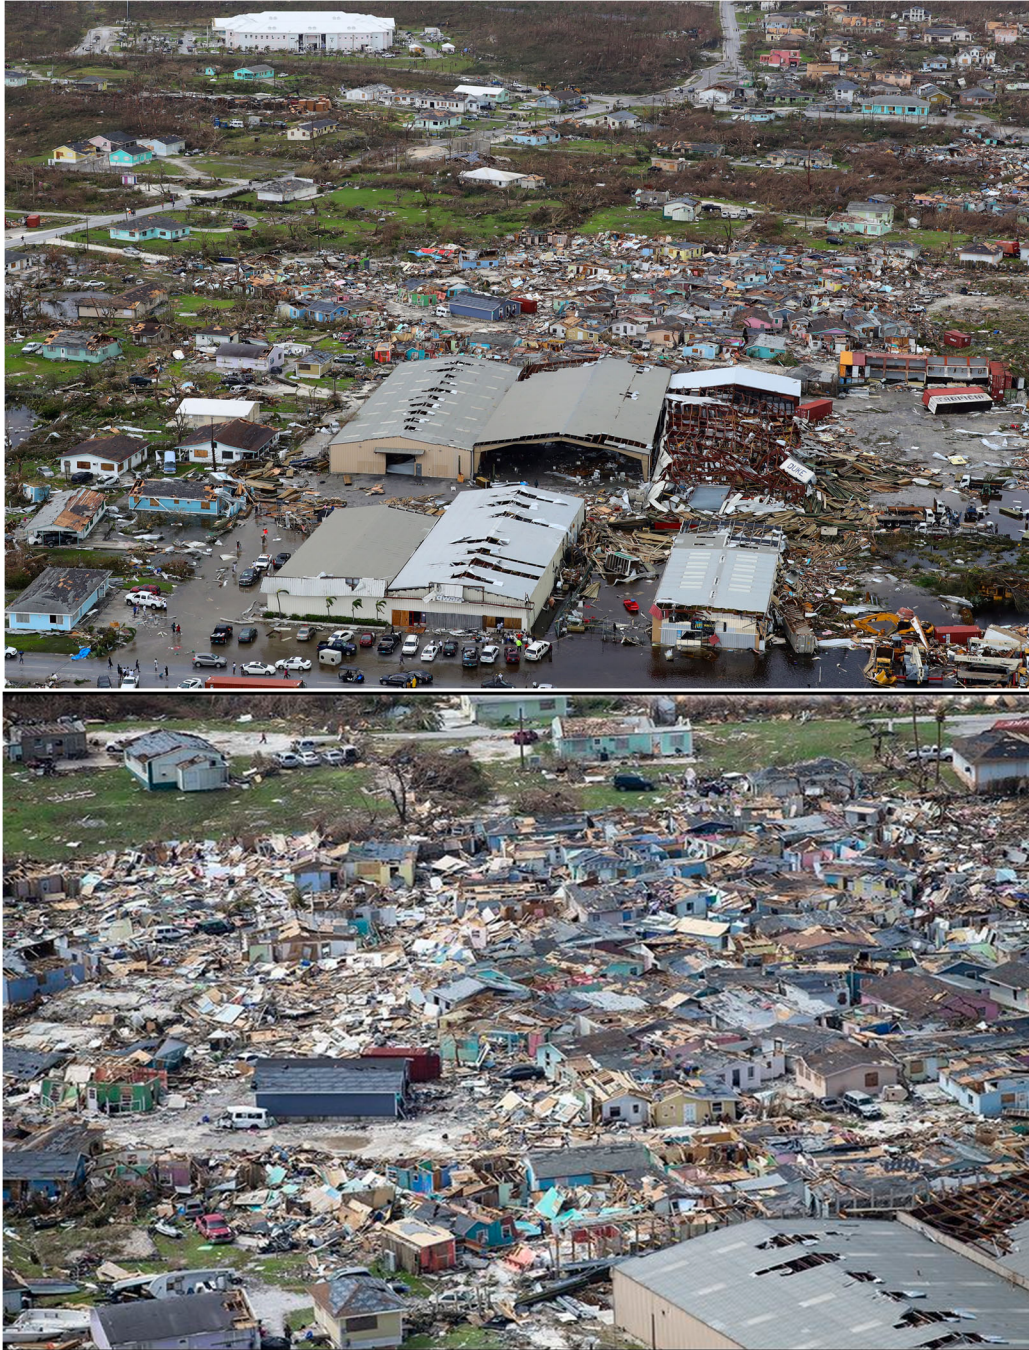
Figure 4.3. (top) Aerial photo of the damage from Dorian in Marsh Harbour, Great Abaco Island showing the performance across a range of building occupancy classes including metal building systems [Approximate Location: 26.537017, -77.063145 (Looking West)] (Source: [CNN](#)); (bottom) Closer view of the Pea, informal settlement located behind the metal buildings at the center of the top image (Source: [Orlando Sentinel](#))

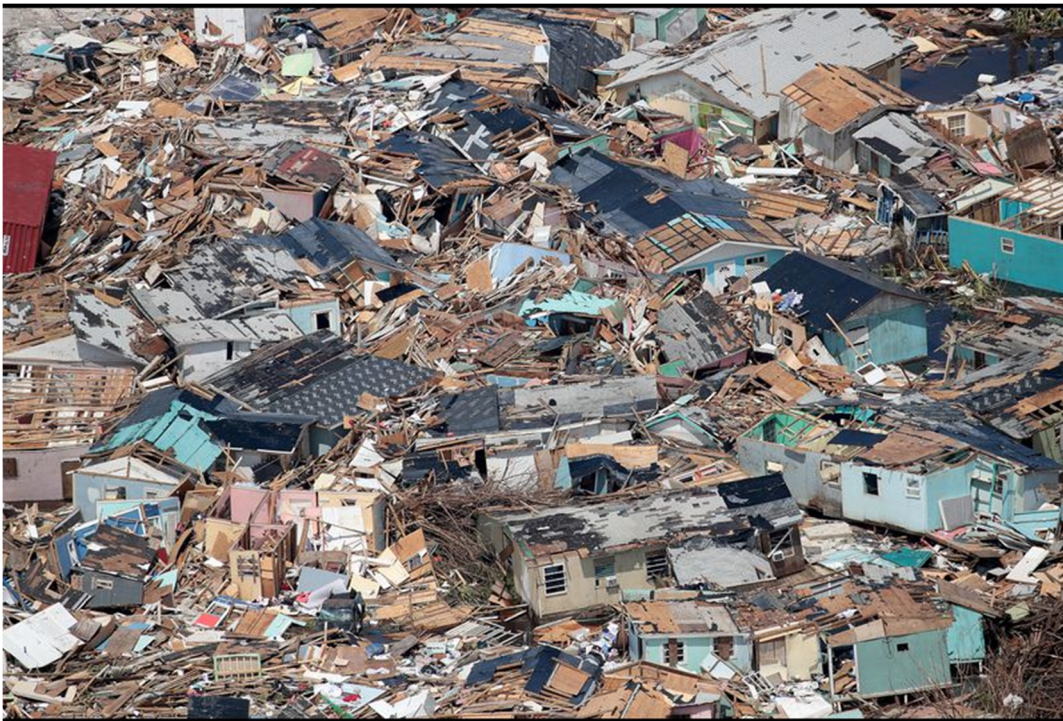
Figure 4.4. Aerial photo of debris field of largely residential construction destroyed by storm surge in Marsh Harbour in Great Abaco Island, Bahama (Source: [Orlando Sentinel](#))

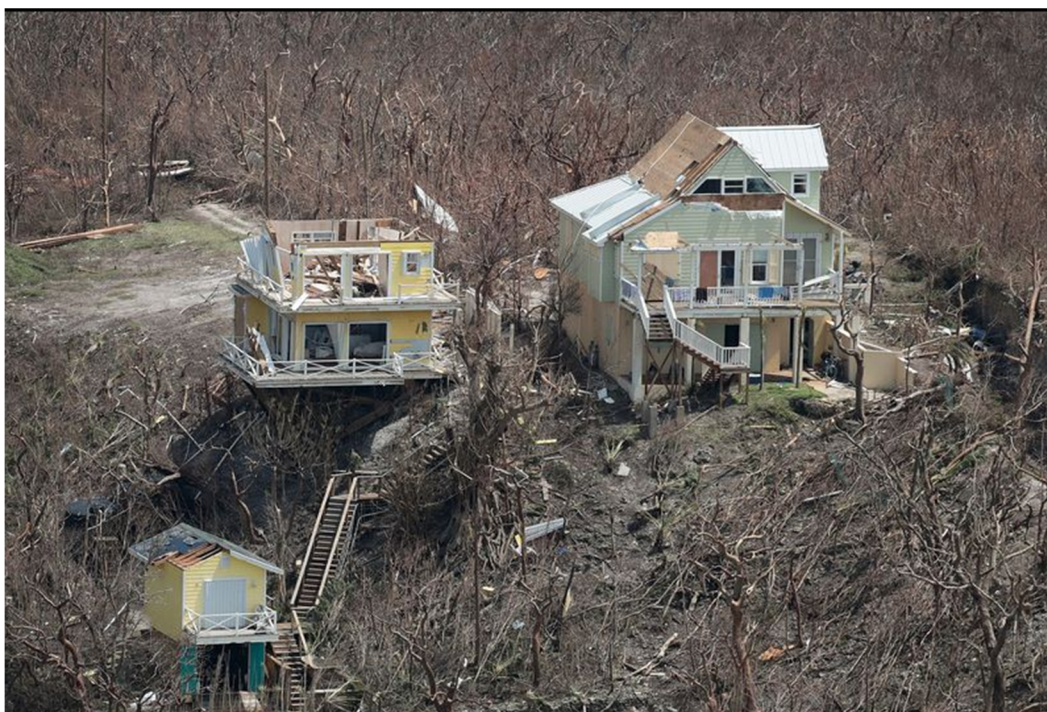
Figure 4.5. Damage to roof and walls of a pair of homes at an upper elevation on Great Abaco Island (Source: [Orlando Sentinel](https://www.orlandosentinel.com))

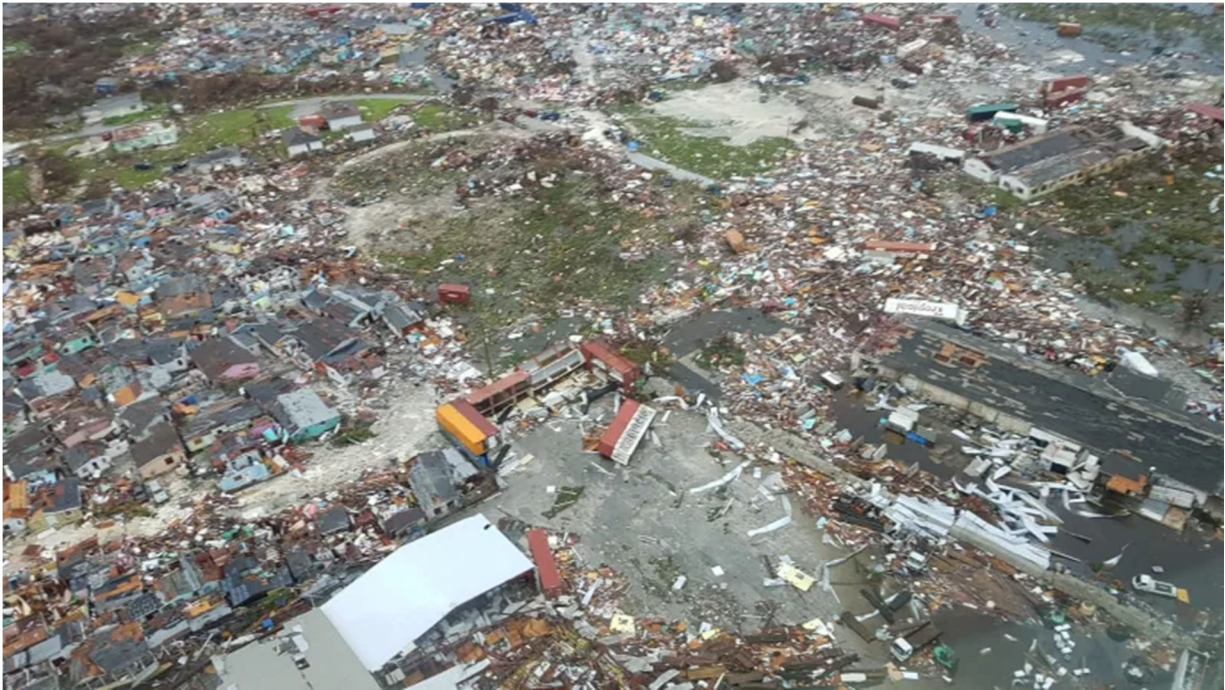
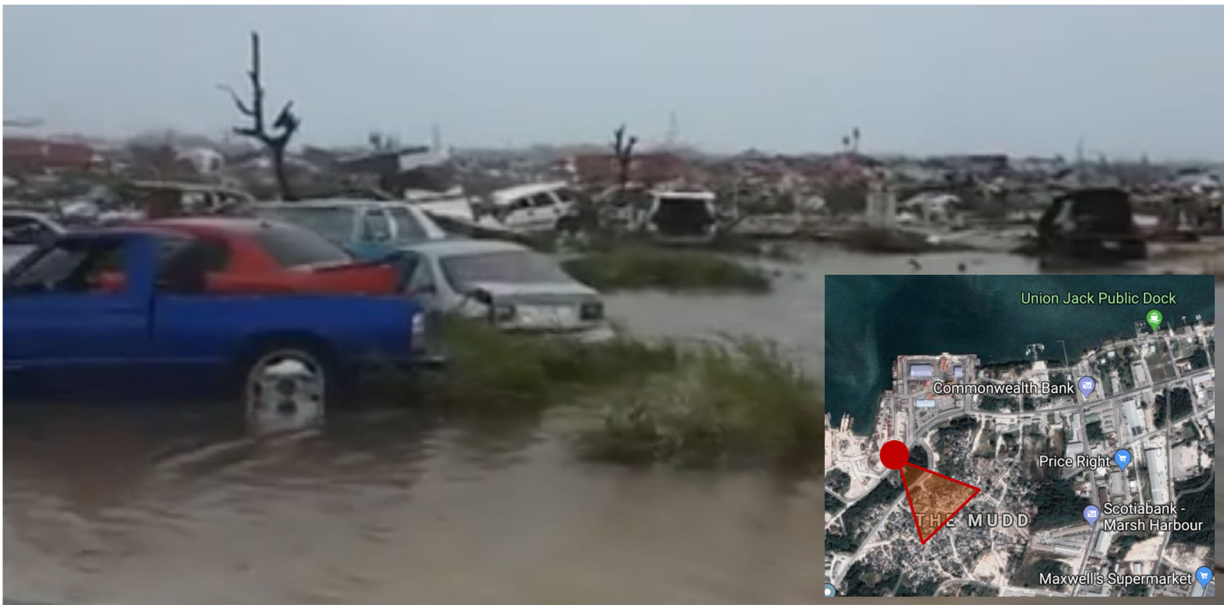
Figure 4.6. Aerial imagery of The Mudd and Pigeon Pea on Great Abaco following the passage of Hurricane Dorian (Source: [Our News Bahamas](#)); (bottom) view looking inland towards The Mudd, (Source: still frame taken from a video by [Seaport Secrets Cafe and Seafood Market](#) with Google Maps overlay).

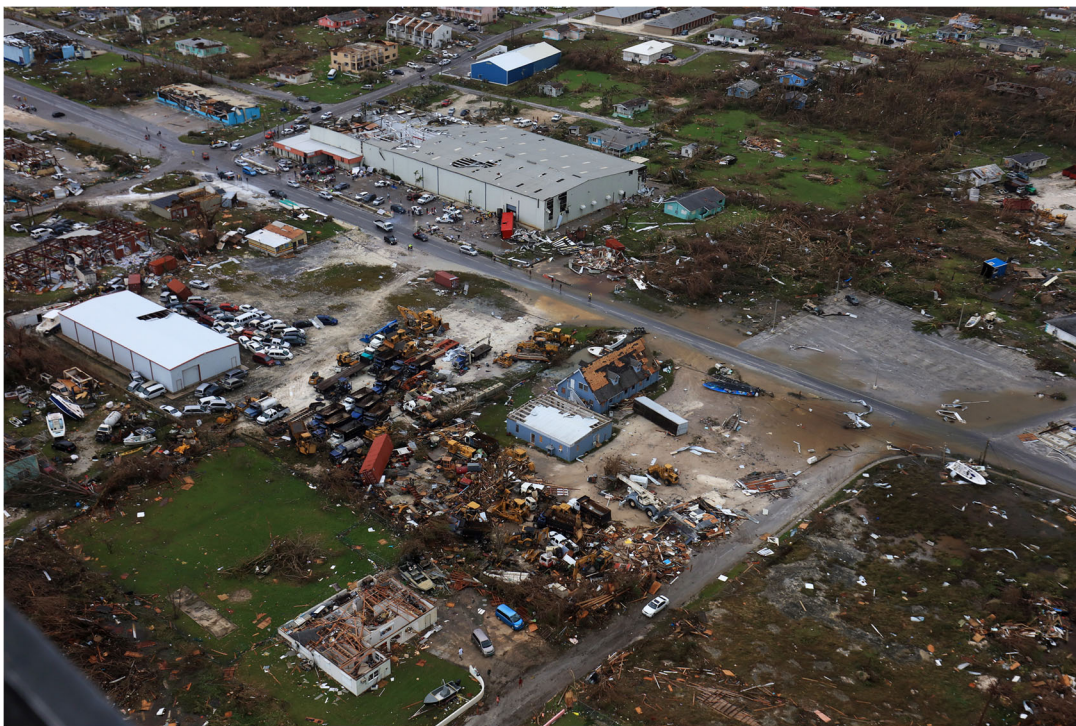
Figure 4.7. Aerial photo of the damage from Dorian at Marsh Harbour on Great Abaco Island, Bahamas. Note the surviving commercial and industrial buildings with minor roof damage. [The large building in the center is located at 26.532695 / -77.062676]. The photo was taken facing SW. (Source: [CNN](#))

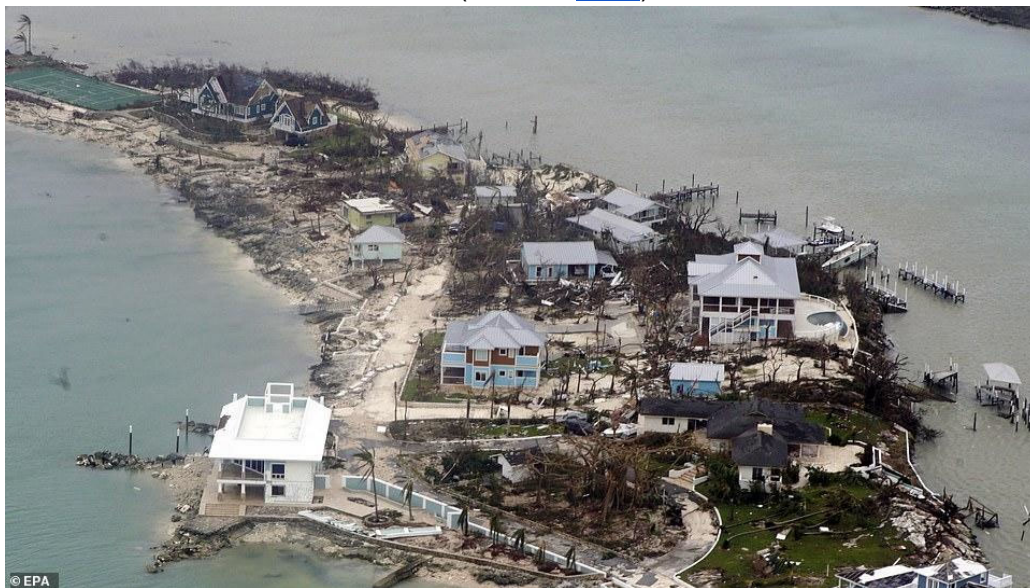
Figure 4.8. Aerial photo with a number of larger residences with minimal exterior signs of damage in Marsh Harbour on Great Abaco Island. [The blue home at the center of the photo is located at 26.555458, -77.023363], with the photo taken facing East. (Source: [Daily Mail UK](#))

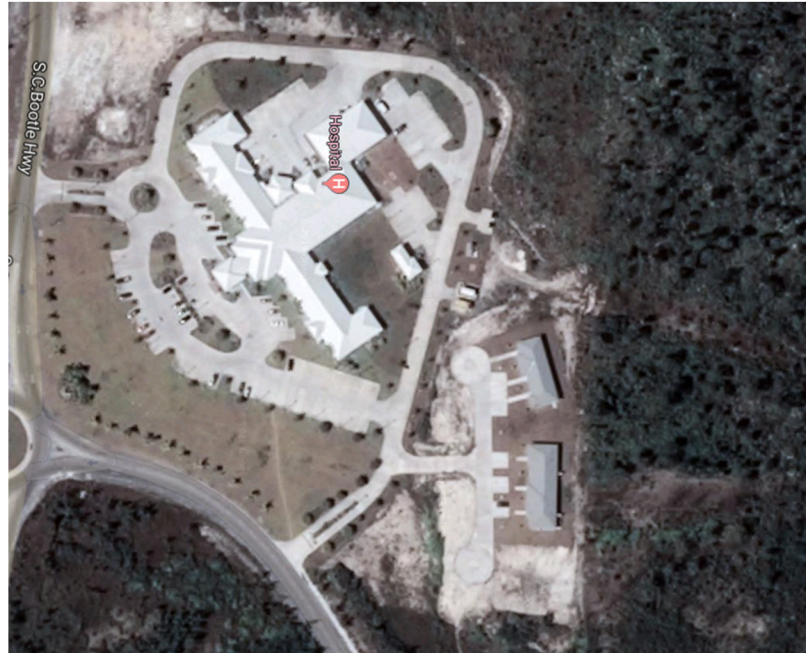
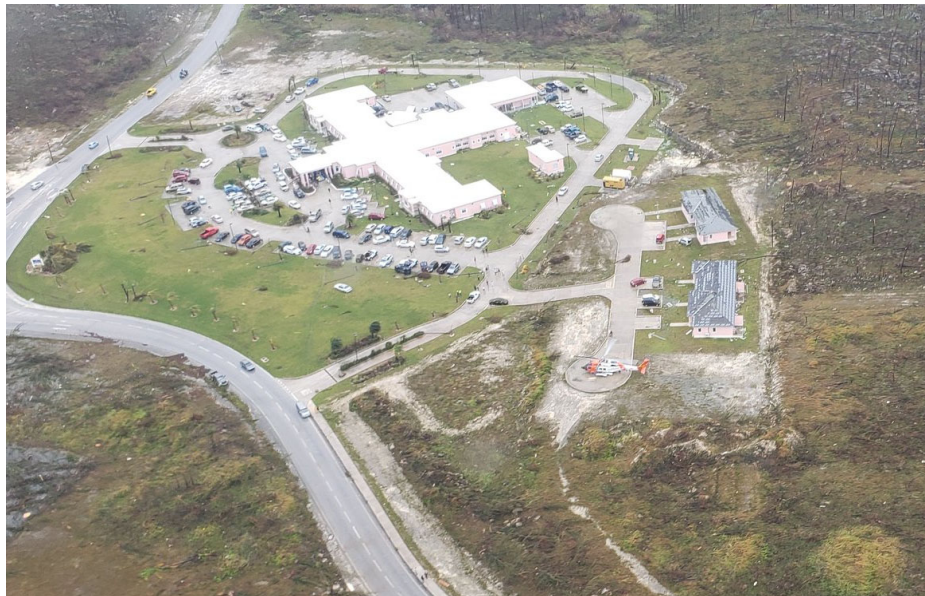
Figure 4.9. Aerial view of Marsh Harbour Healthcare Center [Located at 26.534, -77.070] and accessory buildings (a) before Hurricane Dorian and (b) afterward, exhibiting no significant structural damage. Nearby trees are debarked. (Source of pre-event image: Google Maps; Source of post-event image: [U.S. Coast Guard](#))

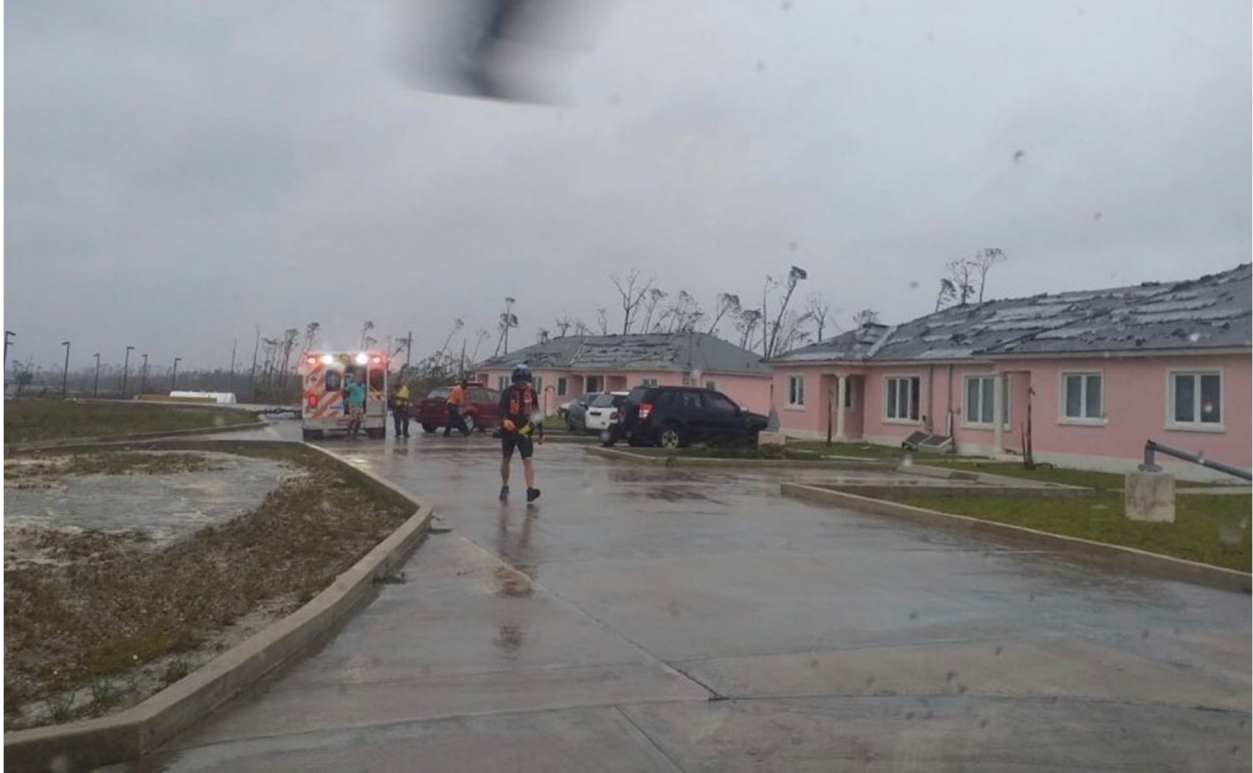
Figure 4.10. Roof cover loss at accessory buildings at Marsh Harbour Healthcare Center accessory structures [Located at 26.534, -77.070]. Note the snapped light pole in the foreground (Source: <https://twitter.com/StevenCejas/status/1168910504183652353>)

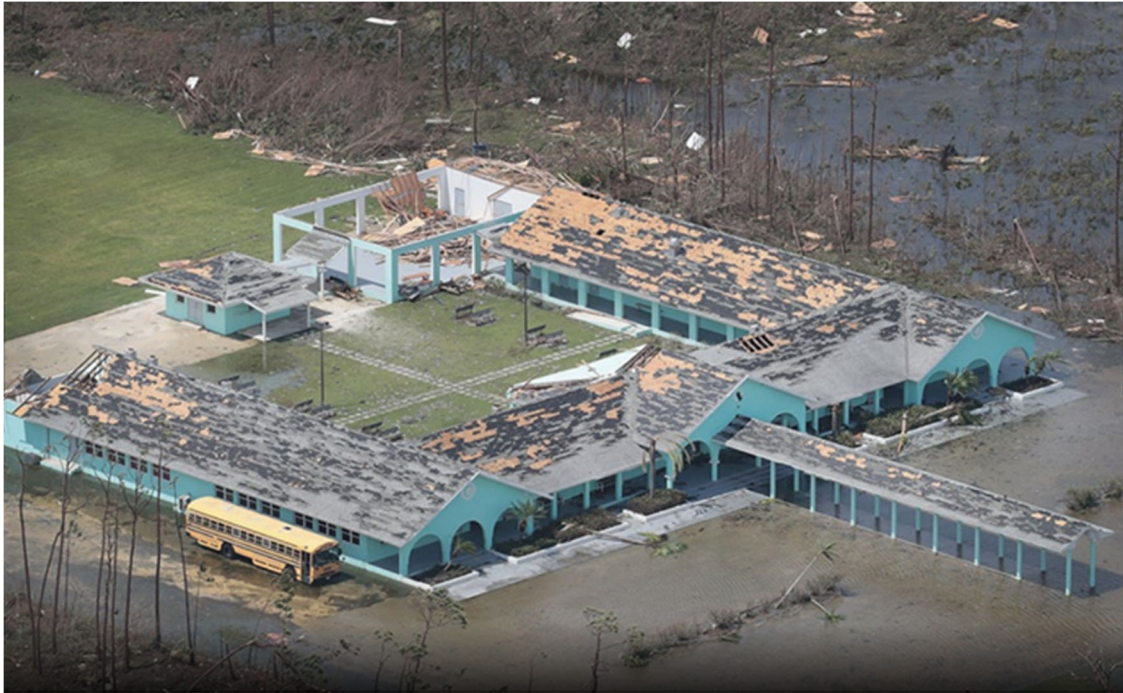
Examples of damage sustained to community buildings like the **Forest Heights Academy**, a private high school, and **St. Frances De Sales Catholic Church** in Marsh Harbour are shown in Figures 4.11 and 4.12, respectively. Forest Heights Academy (Fig. 4.11) experienced significant flooding, nearly complete loss of roof cover and structural damage. St. Frances De Sales Catholic Church (Fig. 4.12) does not have visible structural damage, with the exception of some roof cover loss.

Figure 4.11. Aerial view of Forest Heights Academy, a private high school in Marsh Harbour [Located at 26.517871, -77.070266] (Source: [Weather Channel](#))

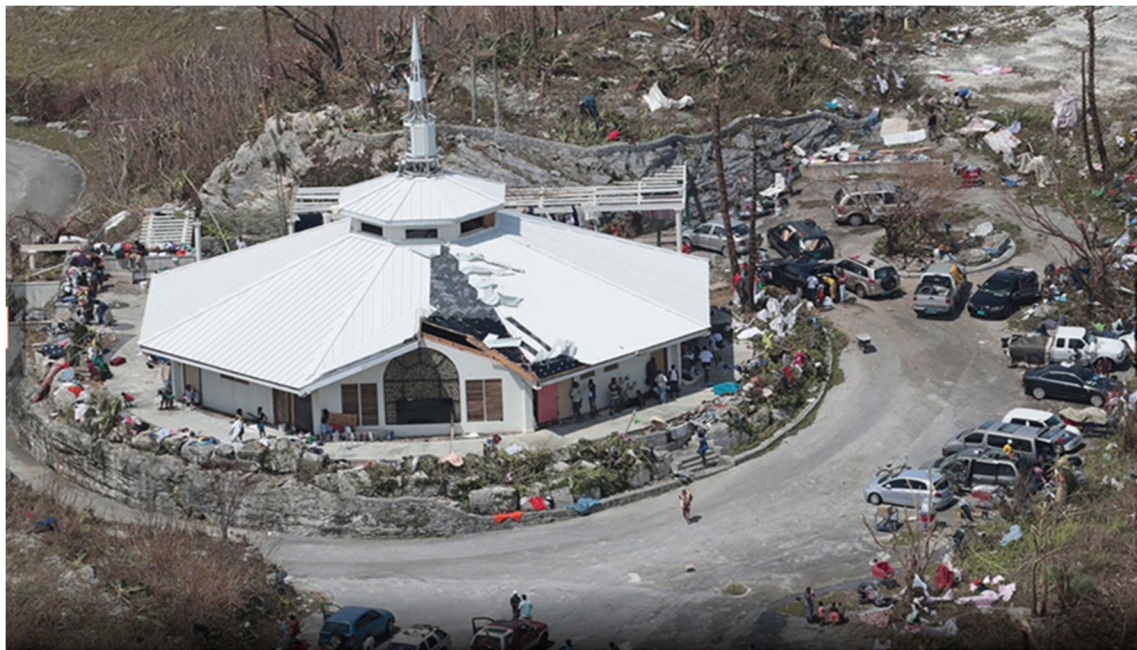
Figure 4.12. Aerial view of St. Frances De Sales Catholic Church in Marsh Harbour [Located at 26.227, -77.0655] (Source: [Weather Channel](#))

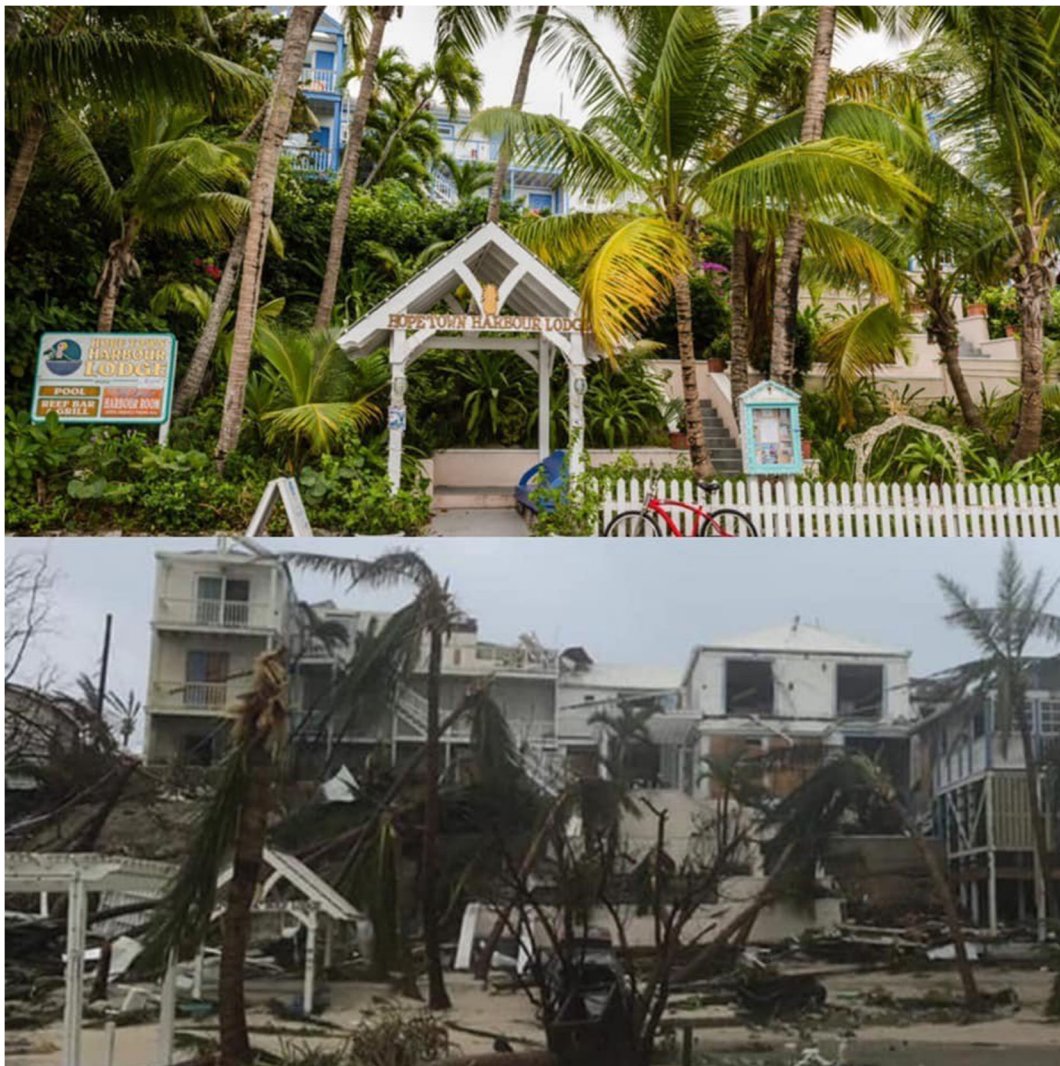
Figure 4.13. Before and after Photo of Hope Town Harbour Lodge [26.536, -76.958] on Elbow Cay (Source: <https://twitter.com/JohnMoralesNBC6/status/1168638139163906052/photo/1>)

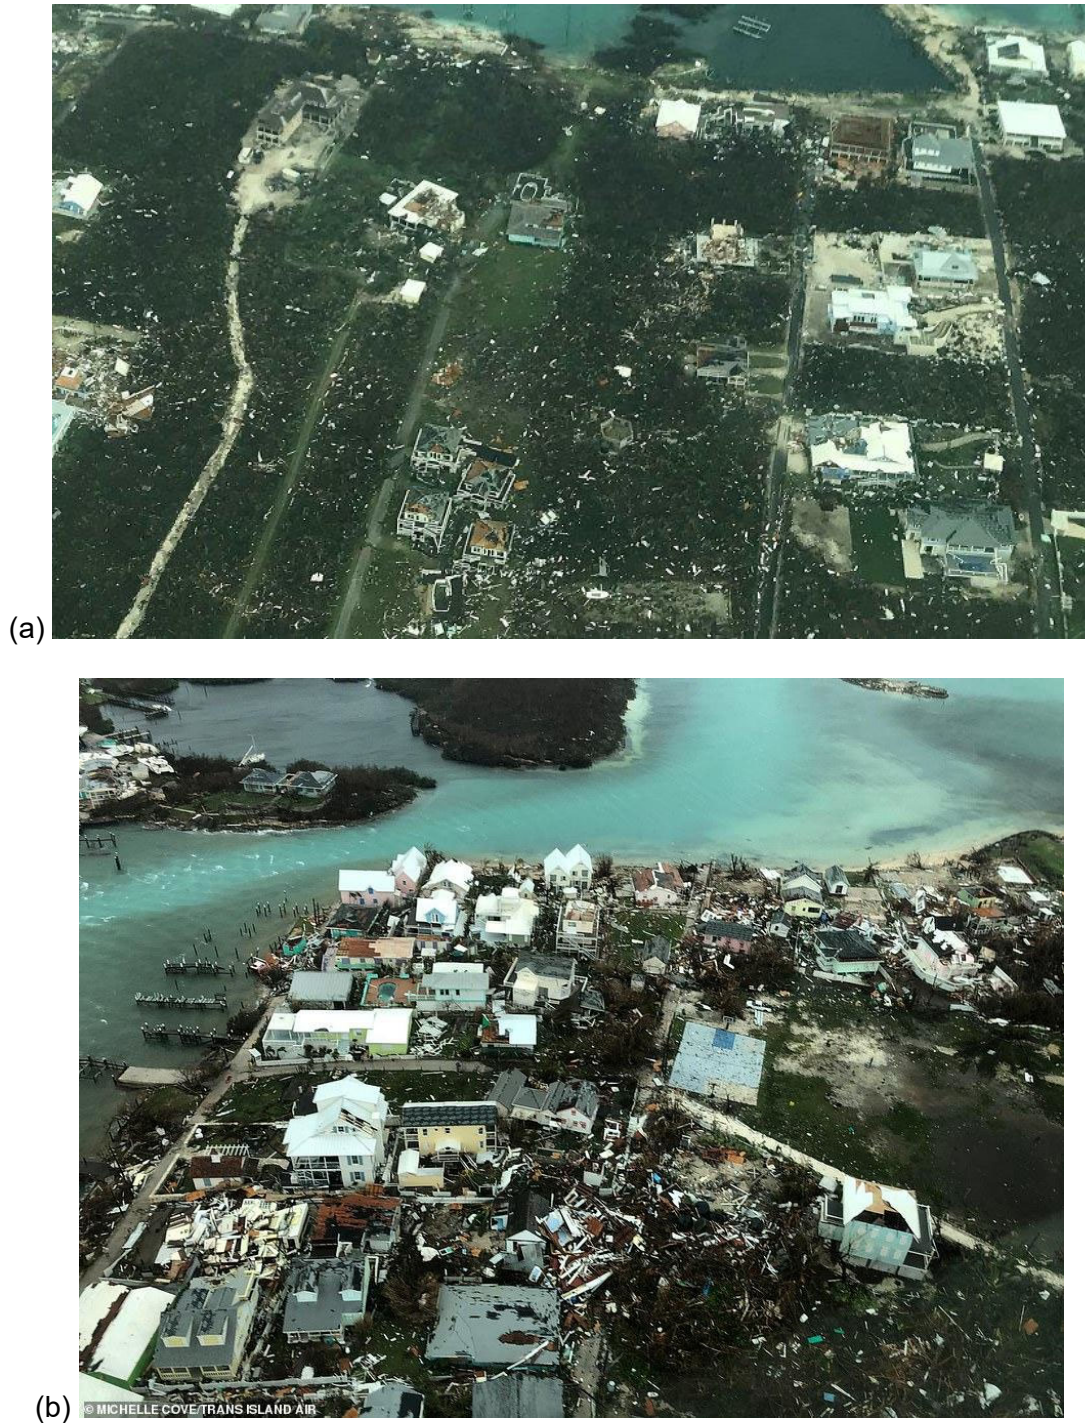
Figure 4.14. Aerial photos of extensive building damage in Elbow Cay. (a) This photograph is located at approximately (26.503268, -76.980198), facing West (Source: [Time.com](https://www.time.com)); (b) the pink house on the shore at the top left of this site near Hope Town is located at (26.540680, -76.960133), with the photo taken looking West. (Source: [UK Daily Mail](https://www.ukdailymail.com))

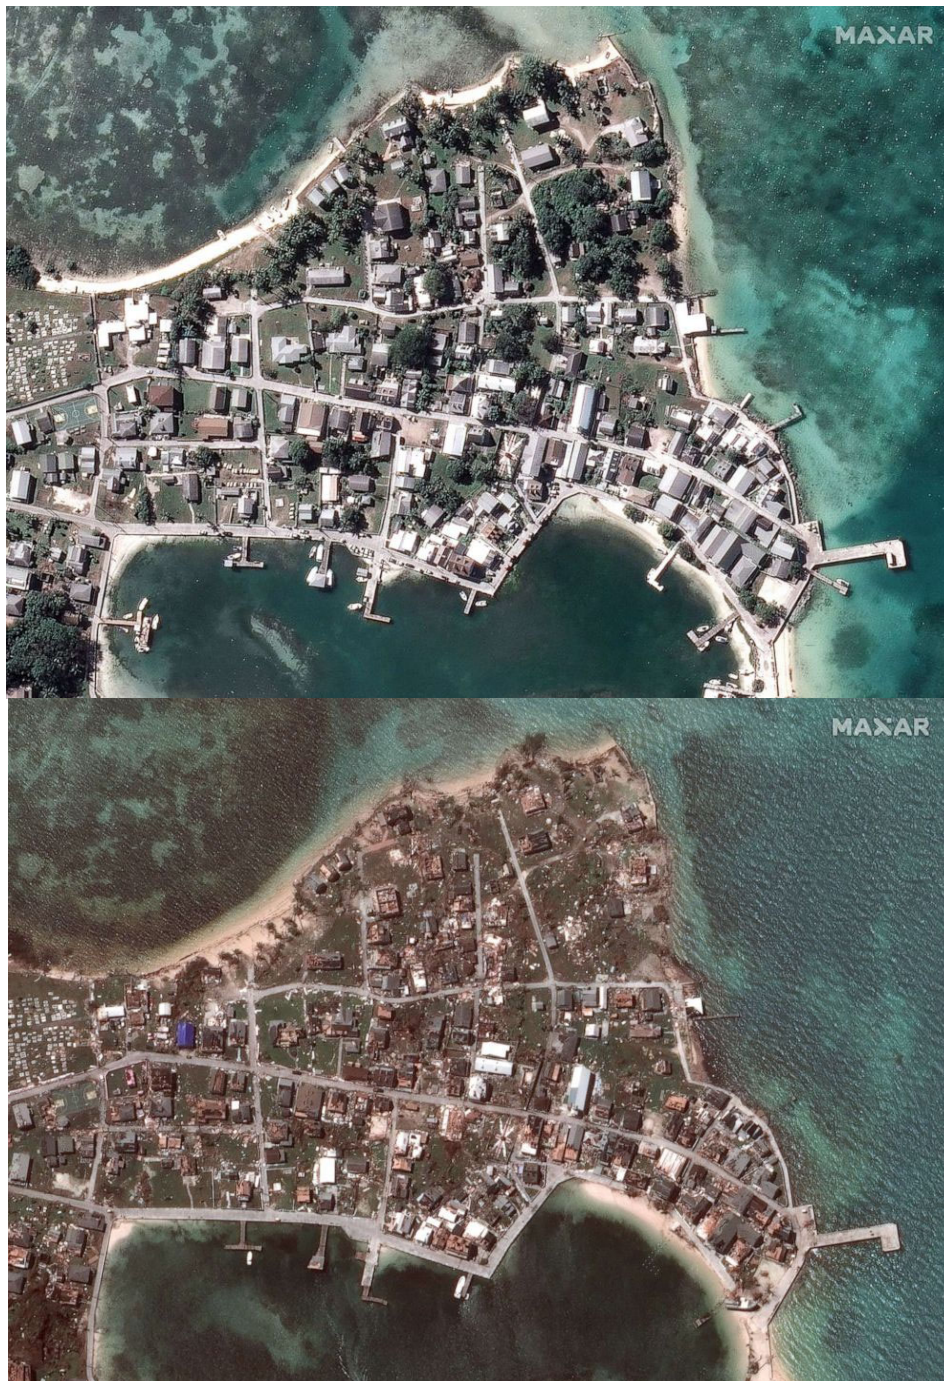
Figure 4.16. Before Hurricane Dorian struck Green Turtle Cay (satellite image taken Oct. 25, 2018) and after Hurricane Dorian struck Green Turtle Cay (satellite image taken Sept. 5, 2019). Images processed by Maxar Technologies via Reuters (Source: [ABC News](#))

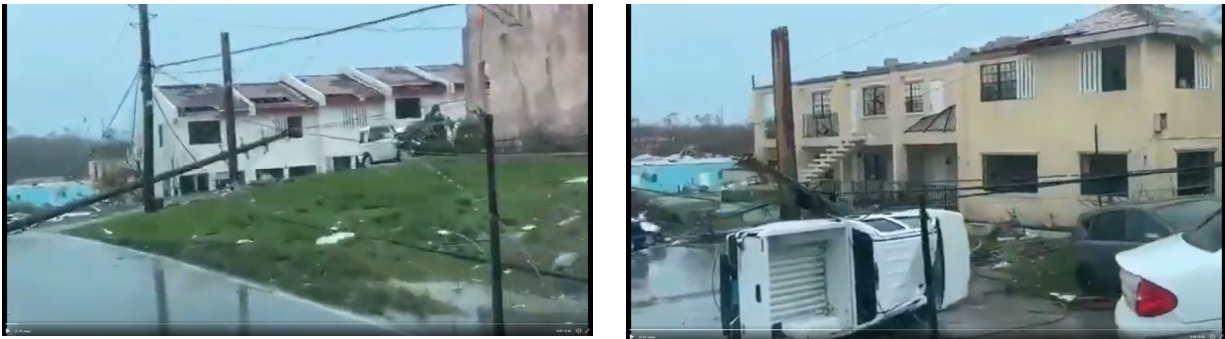
Figure 4.17. Damage to roofs of multi-family residential construction in Cooper's Town in North Abaco District of Abaco Island. (Source: <https://twitter.com/i/status/1168701649847820289>, Footage by Amanda Degregory)

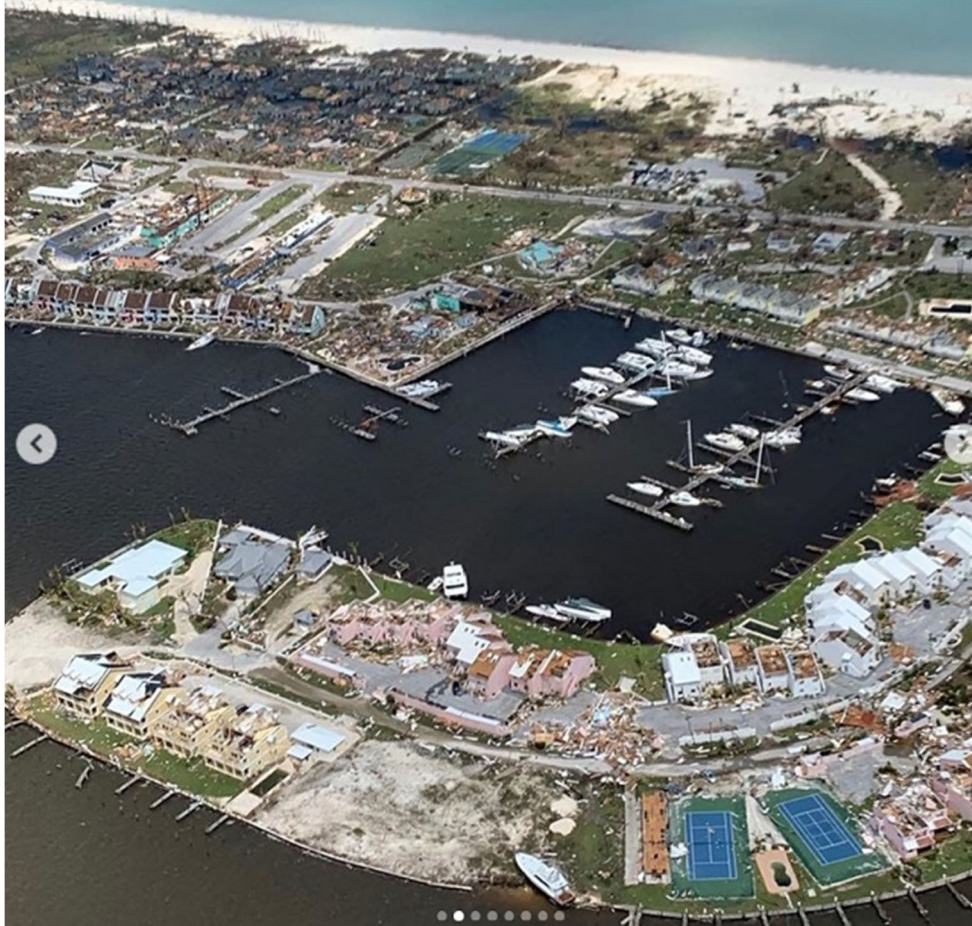
Figure 4.18. Aerial view of damage in Treasure Cay showing varying levels of performance, from minor roof cover loss to complete collapse. Photo is taken looking north towards (26.672372, -77.279685). (Source: [Association of Bahamas Marinas](#)).

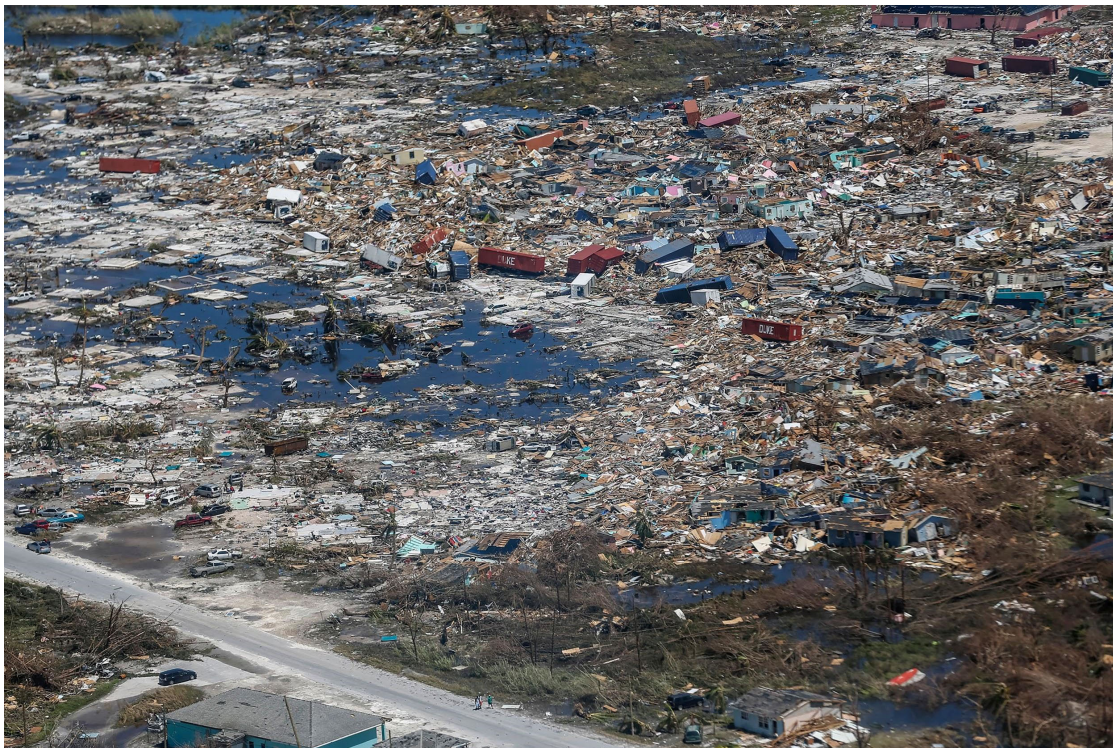
Figure 4.19. Aerial photo of severe flood-induced damage to buildings in Freeport, note the displaced shipping containers. (Source: [Adam DelGiudice/AFP/Getty Images/Vox](https://www.gettyimages.com/detail/photo/aerial-view-of-damaged-buildings-in-freeport-bahamas-after-hurricane-dorian-royalty-free-image/gettyimages)).

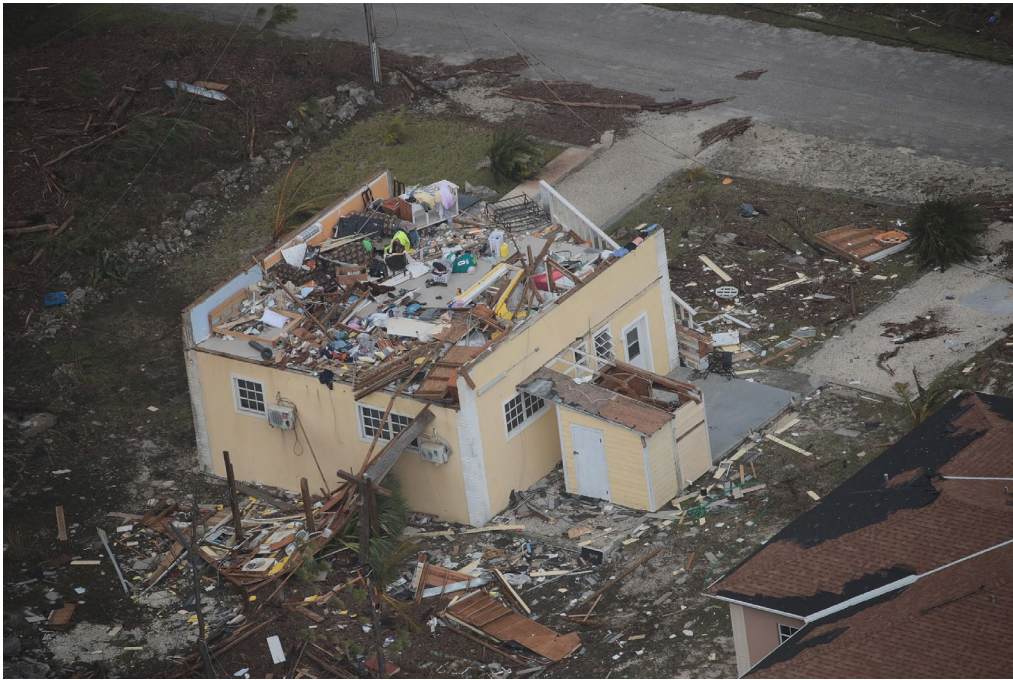
Figure 4.20. Failed roof and partial failure of upper story walls of residential structure in Freeport (Source: [Scott Olson/Getty Images/Vox](#))
