StEER
STRUCTURAL
EXTREME EVENTS
RECONNAISSANCE

HURRICANE DORIAN

Released: September, 10, 2019
NHERI DesignSafe Project ID: PRJ-2549

PRELIMINARY VIRTUAL RECONNAISSANCE REPORT (PVRR)

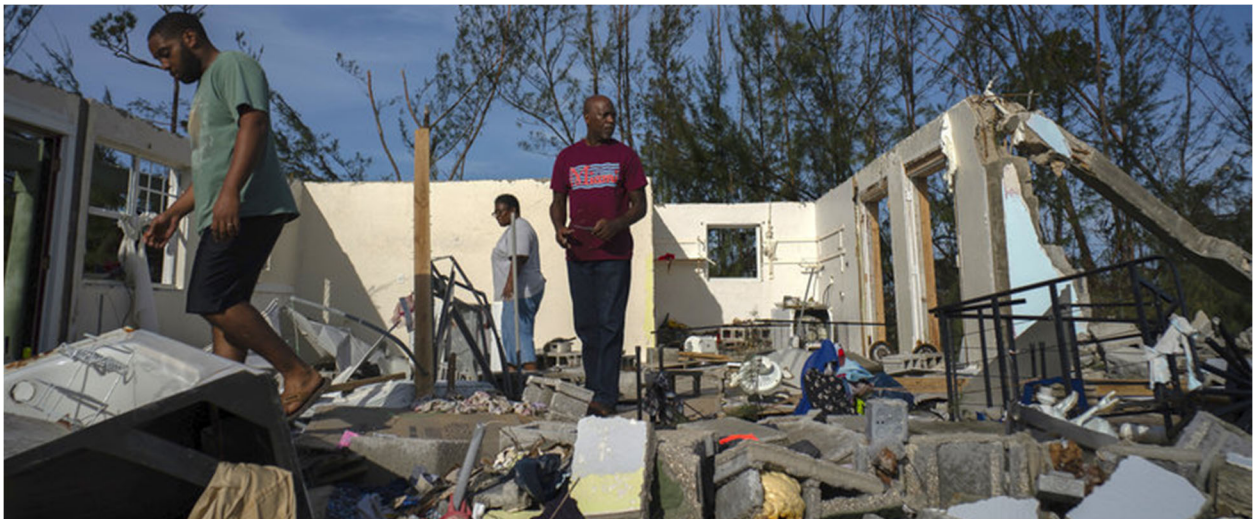
Figure 4.21. Remains of an unreinforced concrete block masonry single-family dwelling destroyed in the Pine Bay neighborhood of Freeport on Grand Bahama Island (Source: [NPR](#))

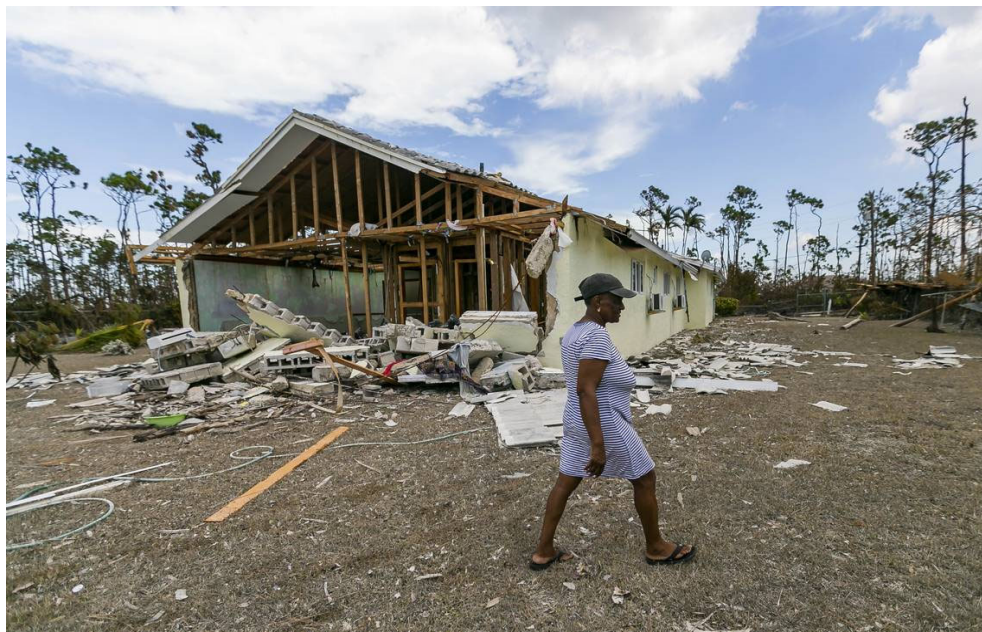
Figure 4.22. Unreinforced concrete block wall blowout in Freeport (Source: [Matias J. Ochner/Miami Herald](#)).

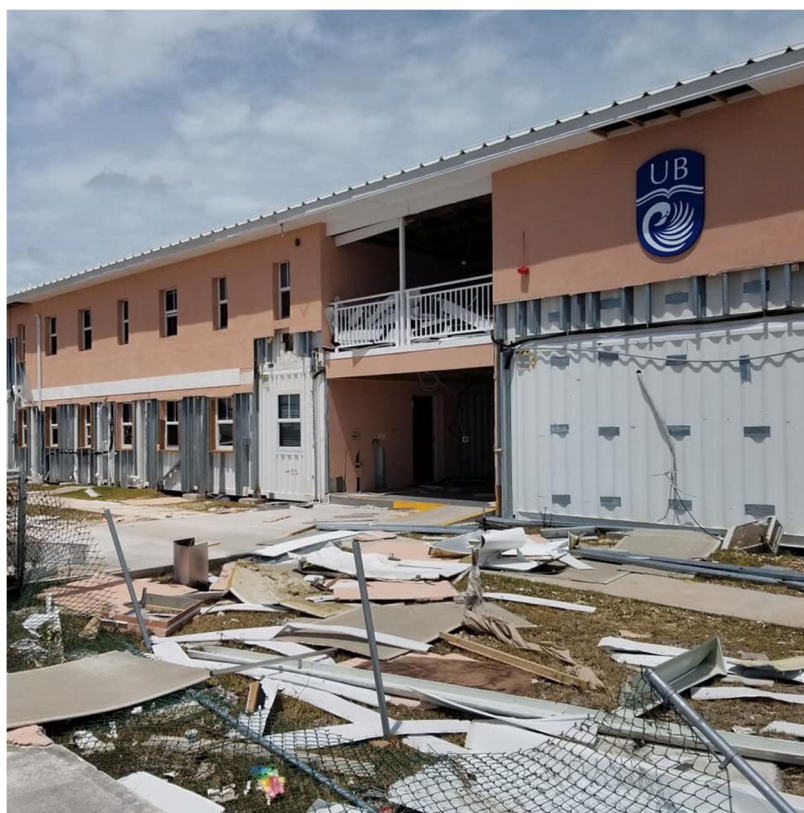
Figure 4.23. Wall cladding damage at the University of the Bahamas Northern Campus (Source: [Dorothy Hall St. James](#)).

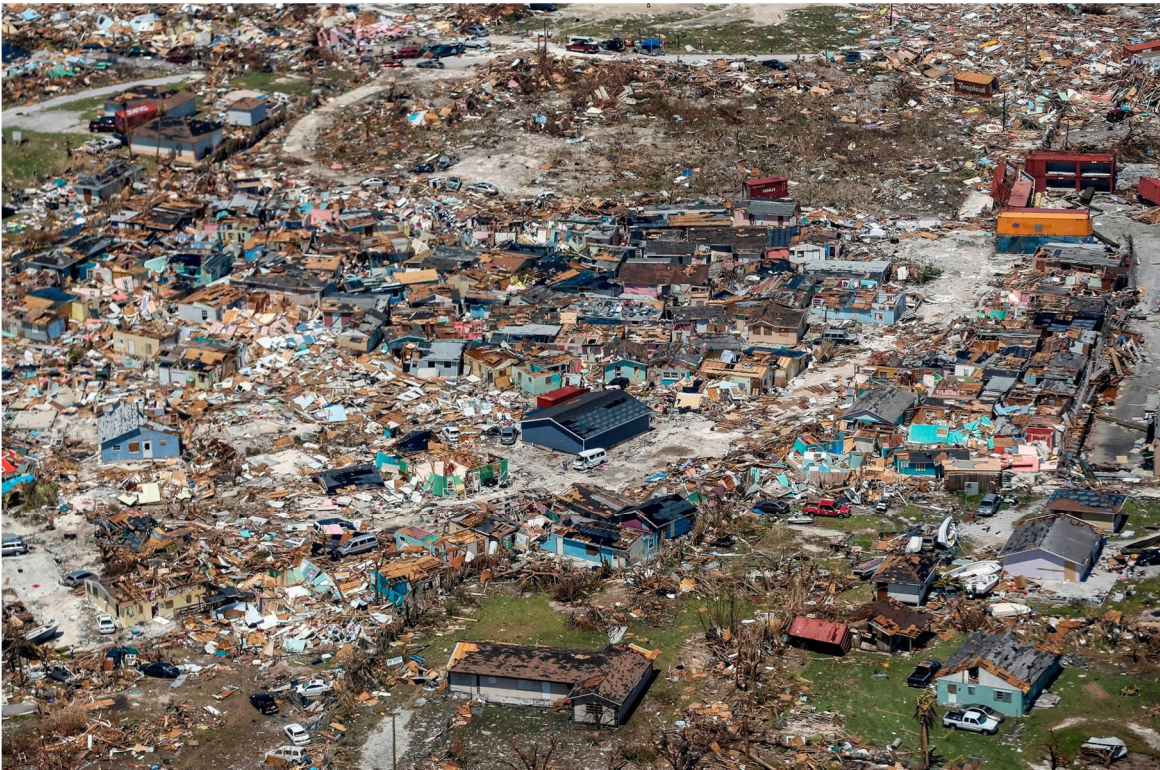
Figure 4.24. Aerial view of the damage to residential homes in Freeport (Source: [NY Times](#))

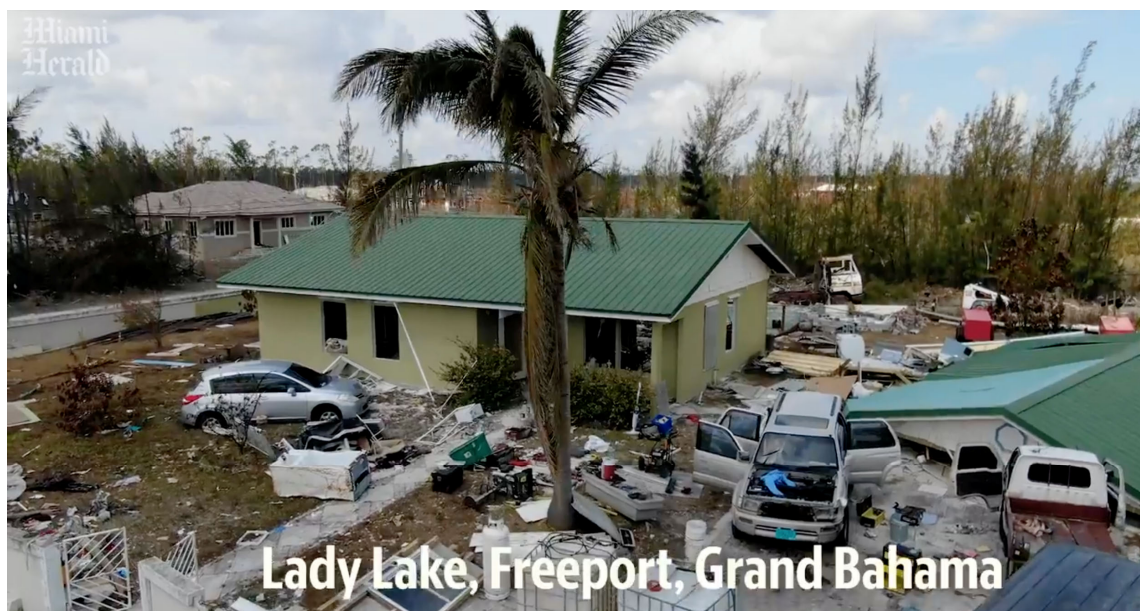
Figure 4.25. Varying levels of structural damage to residential homes in Lady Lake, Freeport (Source: [Miami Herald](#))

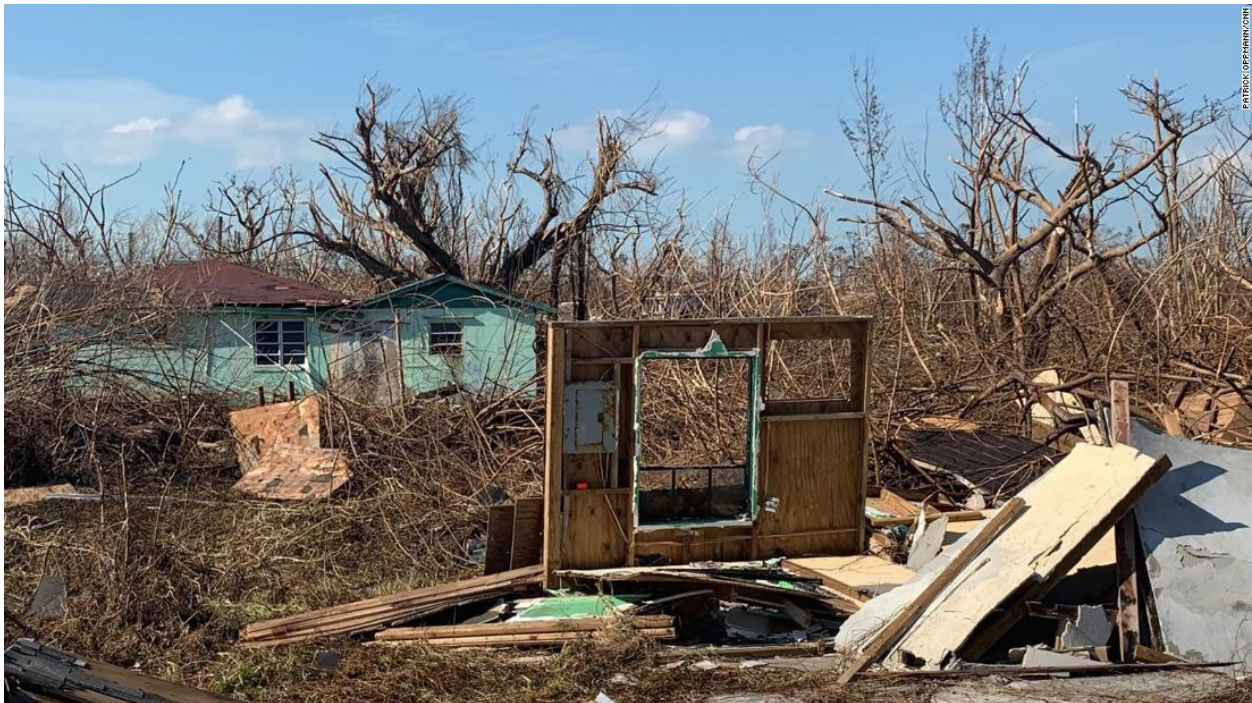
Fig. 4.26 Residential home in the East Grand Bahama Island (Source: [CNN](#))

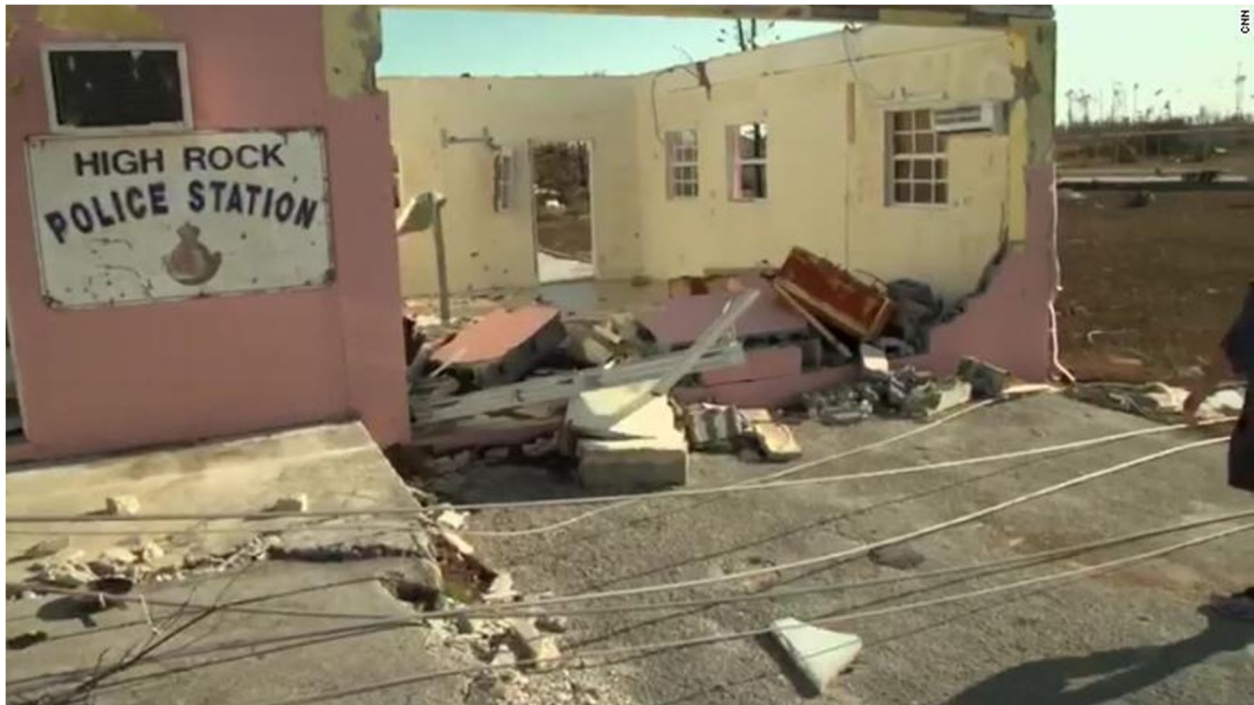
Fig. 4.27 Structural damage to the police station in High Rock, Bahamas. Source: [CNN](#)

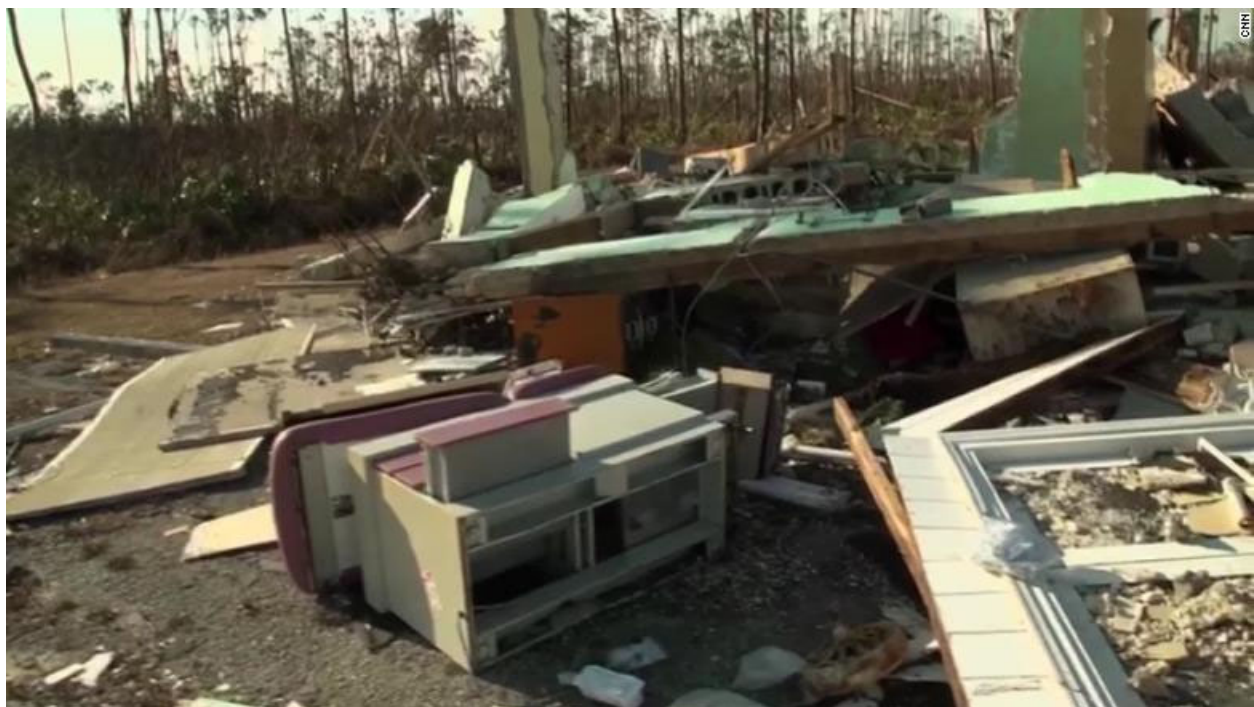
Fig. 4.28 Total building collapse of clinic in High Rock, Bahamas. Source: [CNN](#)

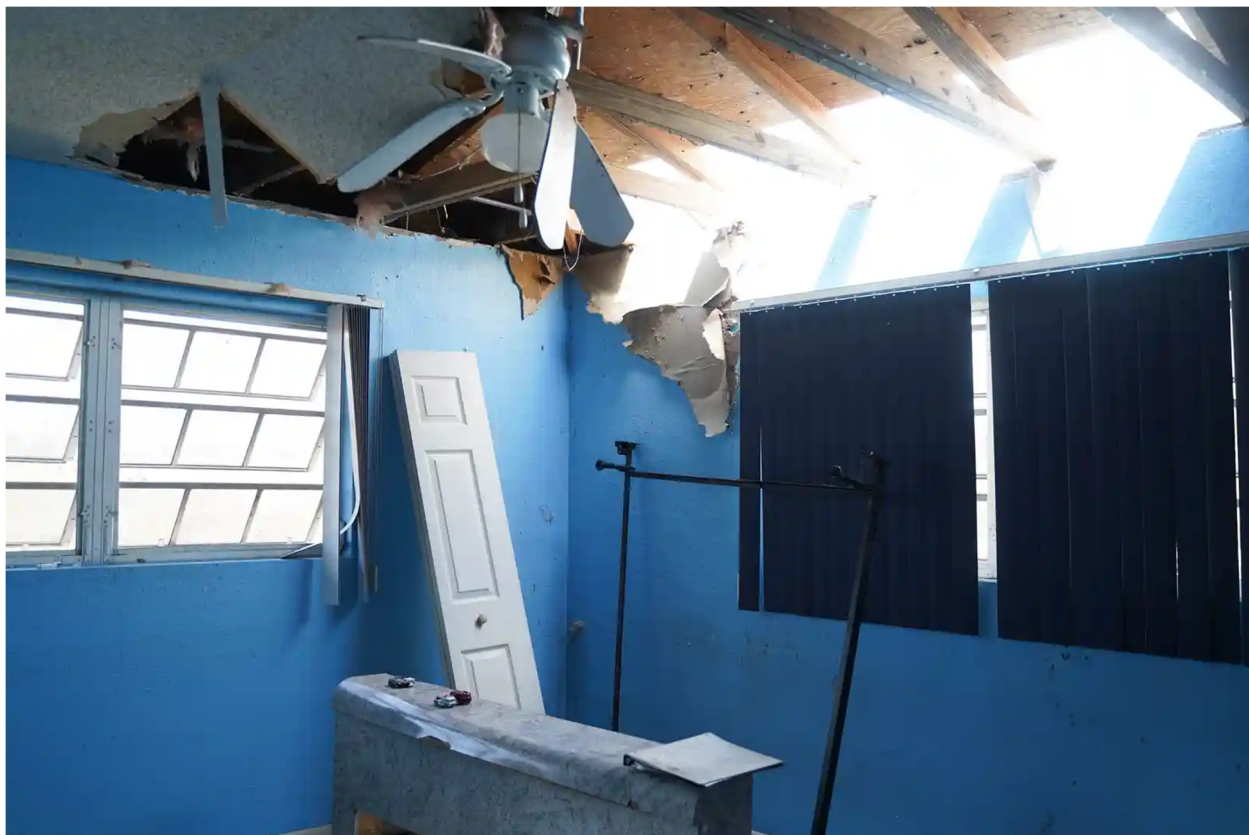
Figure 4.29. Inside view of home damaged in High Rock, Bahamas. (Source: [Angel Valentin and Oliver Laughland](#))

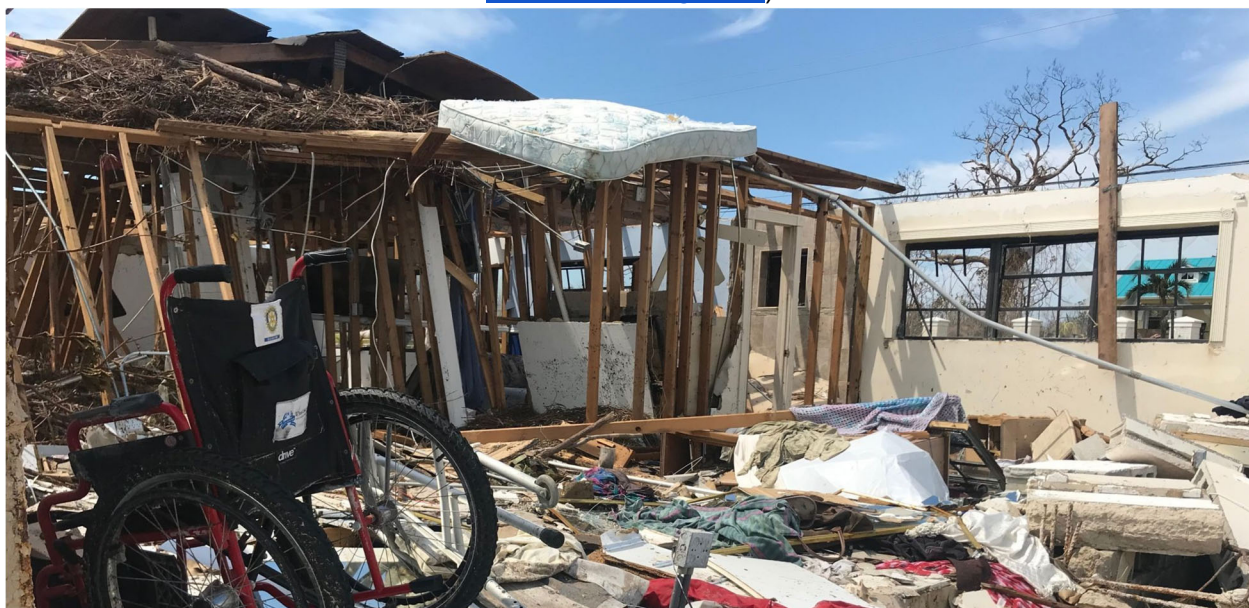
Figure 4.30. Wood-framed residential damage in High Rock, Bahamas. (Source: [SkyNews](#))

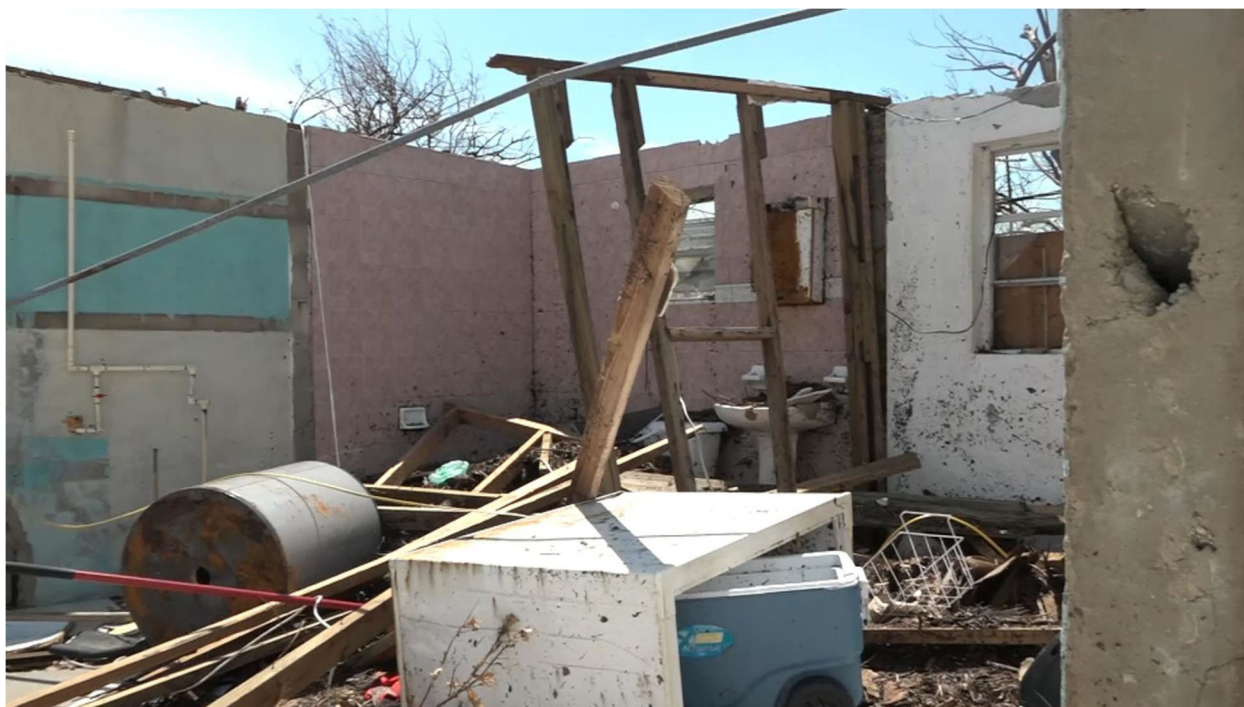
Figure 4.31. Damage to concrete/masonry residential construction in High Rock, Bahamas.
(Source: [SkyNews](#))

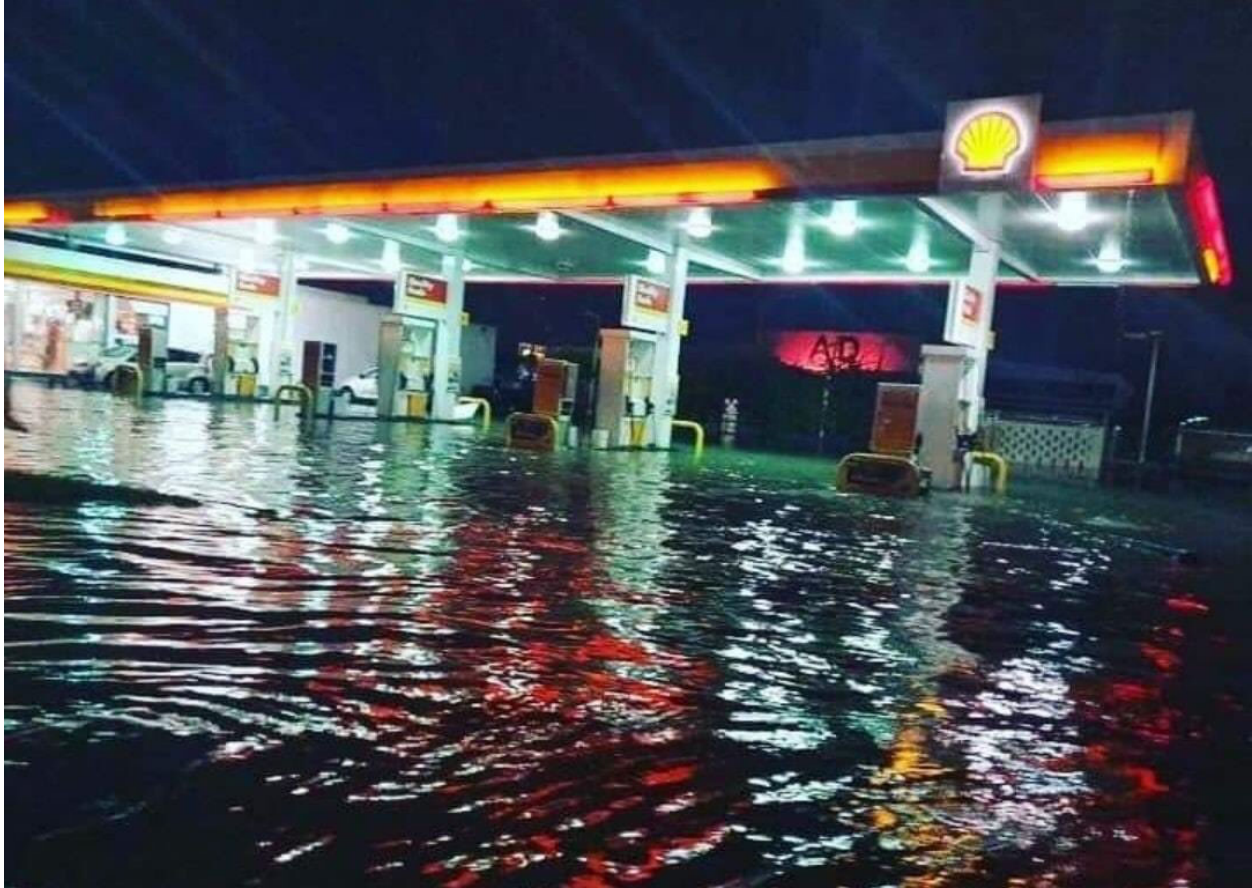
New Providence Island, which houses the capital of Nassau and is the most populous island with (246,329 reported in the 2010 census), did report flooding (Fig. 4.32). Flooding was also documented in Atlantis Resort in New Providence²⁰. Islands in the southeastern and central Bahamas were also spared by Hurricane Dorian. That includes the Exumas, Cat Island, San Salvador, Rum Cay, Long Island, Acklins/Crooked Island, Ragged Island, Mayaguana, and Inagua.

Figure 4.32. Flooded gas station [Located at 25.061413, -77.347805] on New Providence Island (Source: <https://twitter.com/mvp242/status/1168469847992426496>).

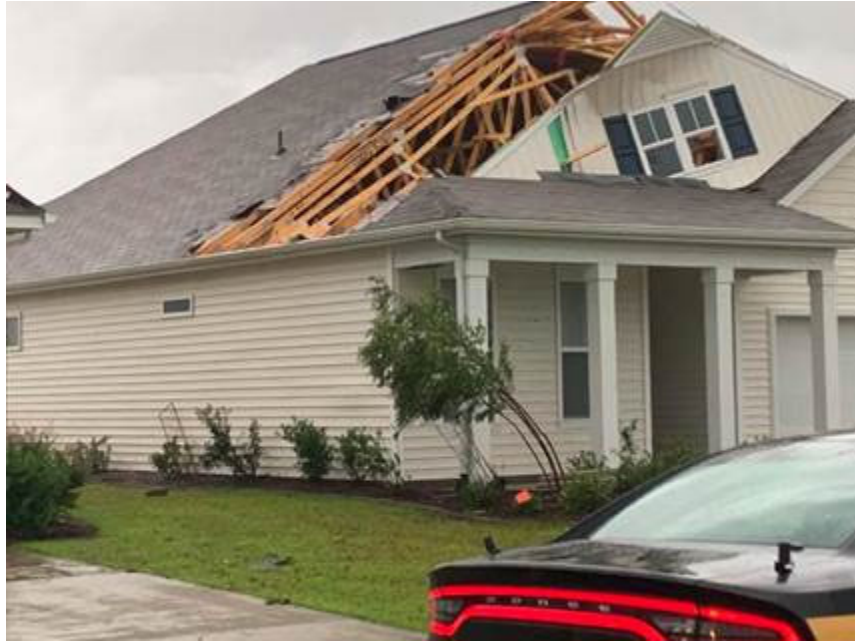
Figure 4.33. Failure of roof structure of single family home in Brunswick County, NC [Located approximately 33.921079, -78.576802] (Source: [CNN](#))

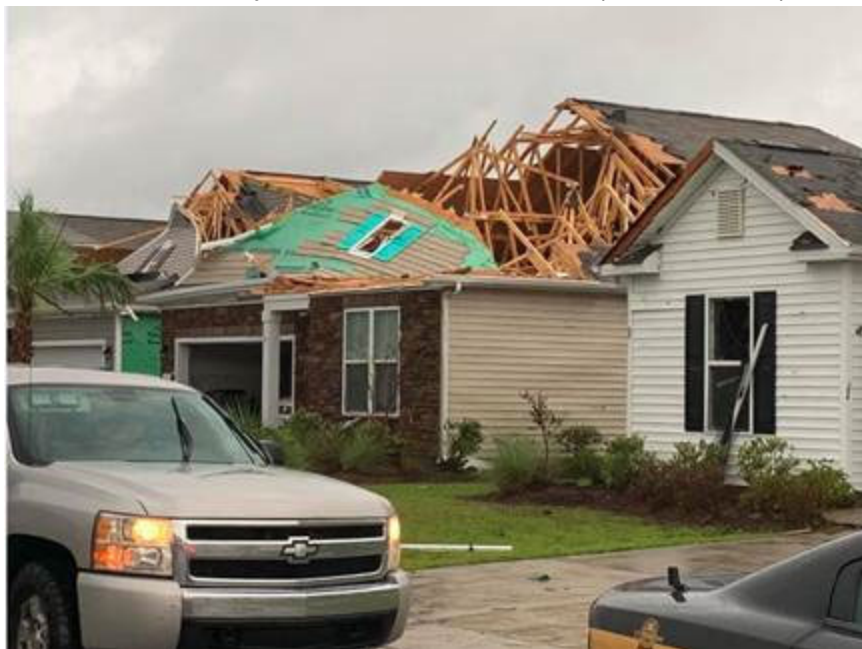
Figure 4.34. Envelope and structural damage to a row of single family homes in Brunswick, NC [Located approximately 33.921079, -78.576802] (Source: [CNN](#))

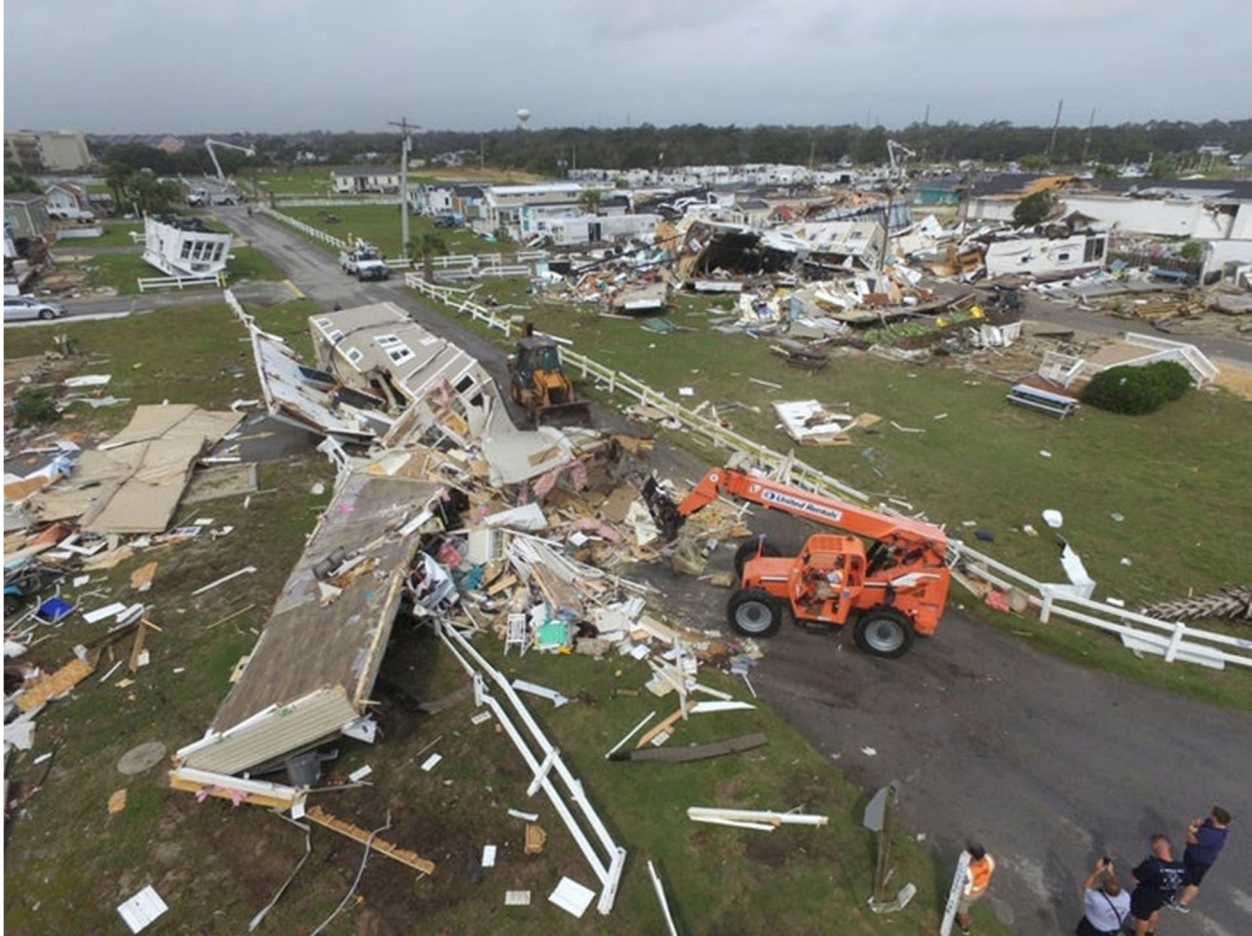
Figure 4.35. Boardwalk RV park in Emerald Isle, NC damaged by a tornado induced by Hurricane Dorian (Source: [Patch.com](https://www.patch.com)). From available photographs, the RVs had minimal anchorage to resist the tornado-induced winds.

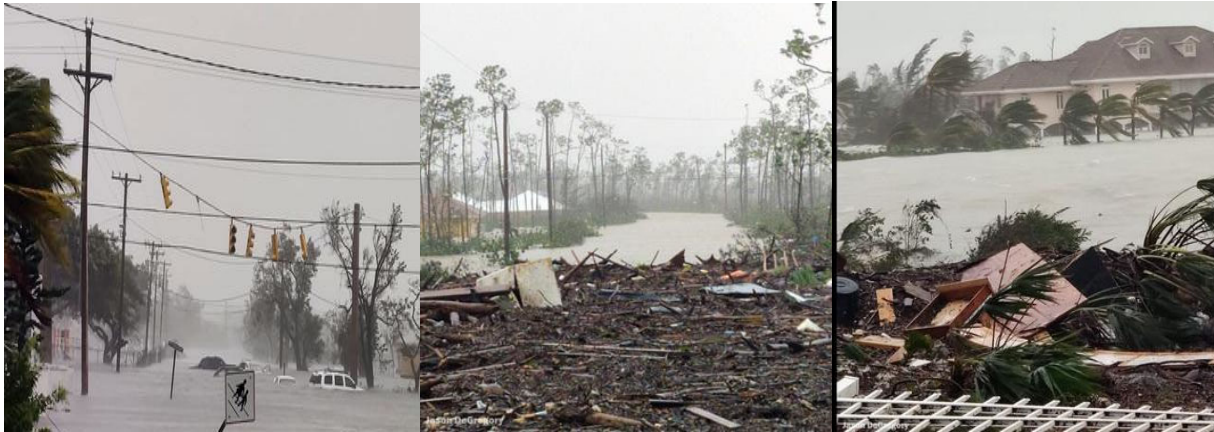
- In both the Abaco and Grand Bahama Islands, there are considerable access restrictions due to flooding and debris fields (Fig. 5.1) which have hindered recovery efforts substantially.

Figure 5.1. Flooded roads and spread damage in Freeport (Source: [Fox 13 News](#))

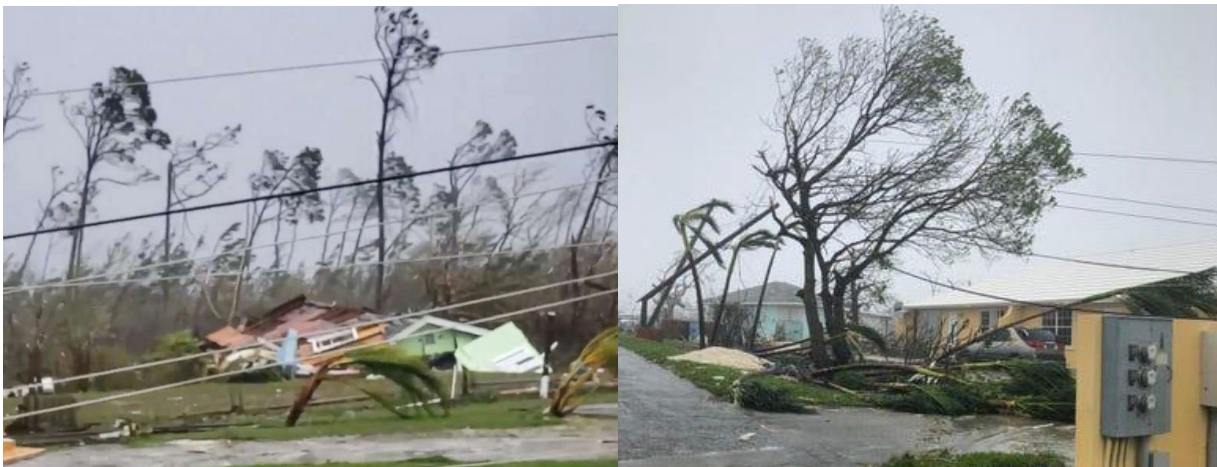
Figure 5.2. (left) Downed power lines, stripped trees and collapsed homes in Marsh Harbour, Bahamas, Sept. 1st (Source: [ABC News](#)); (right) snapped utility poles in Spring City (Source: [News Press](#))

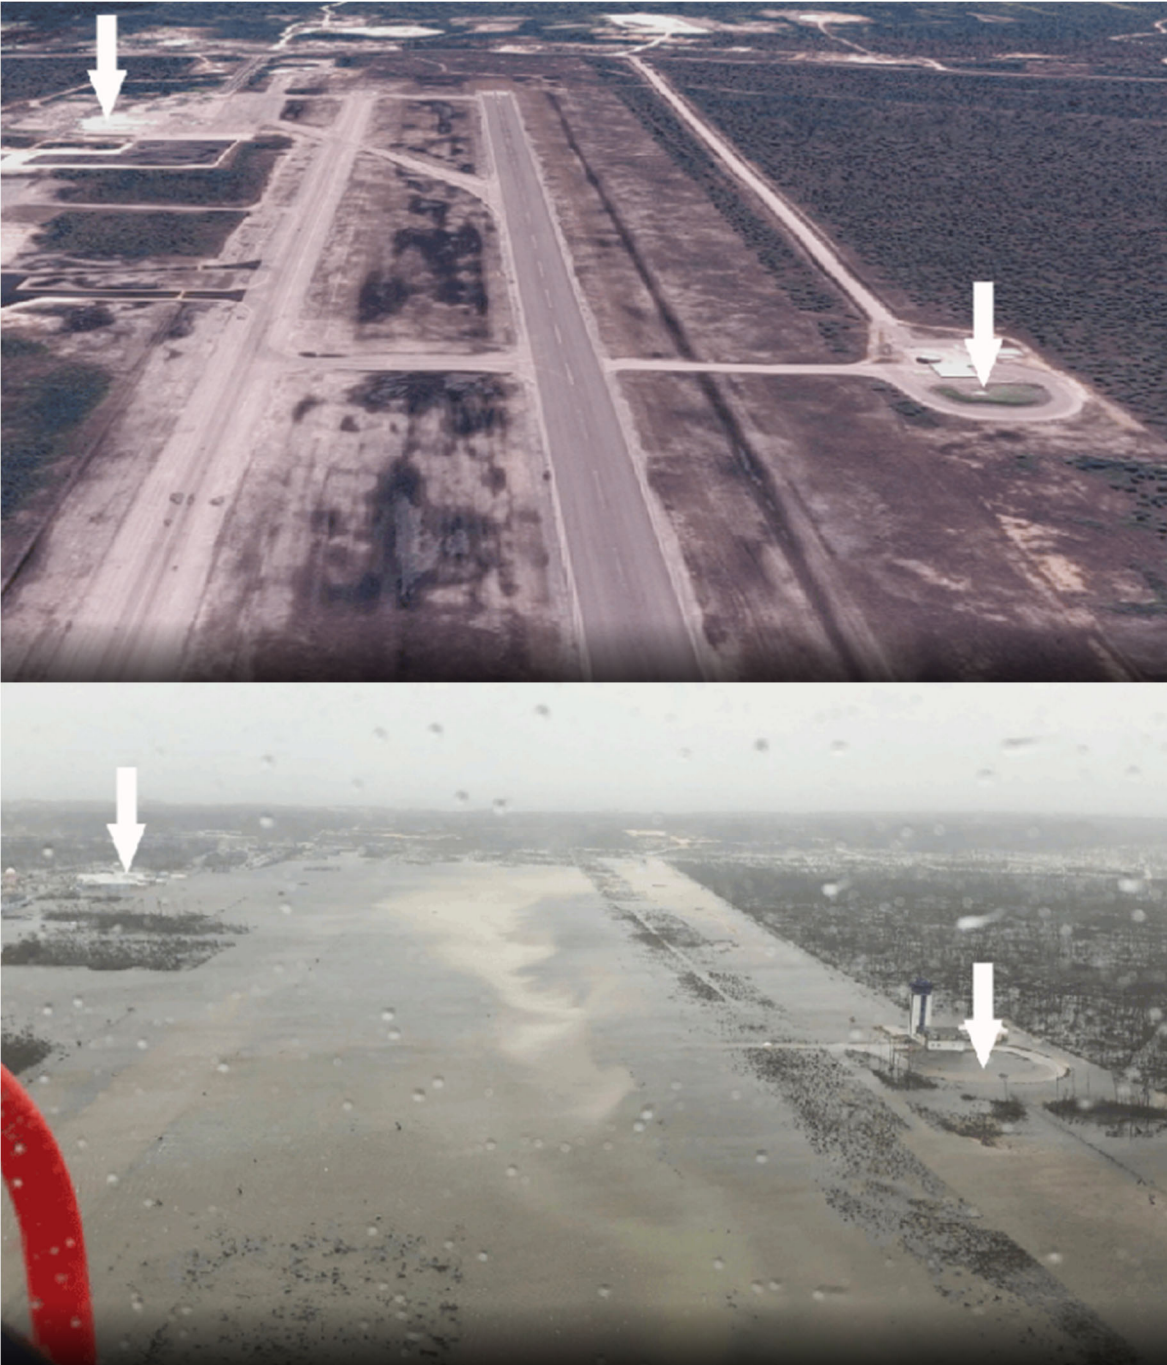
Figure 5.3. Comparison of the Leonard M. Thompson International Airport [26.511, -77.085] serving in Marsh Harbour before (above) and after (below) the Hurricane Dorian 2019.) (source: above: Google Maps, below: U.S. Coast Guard via [Weather Channel](#))

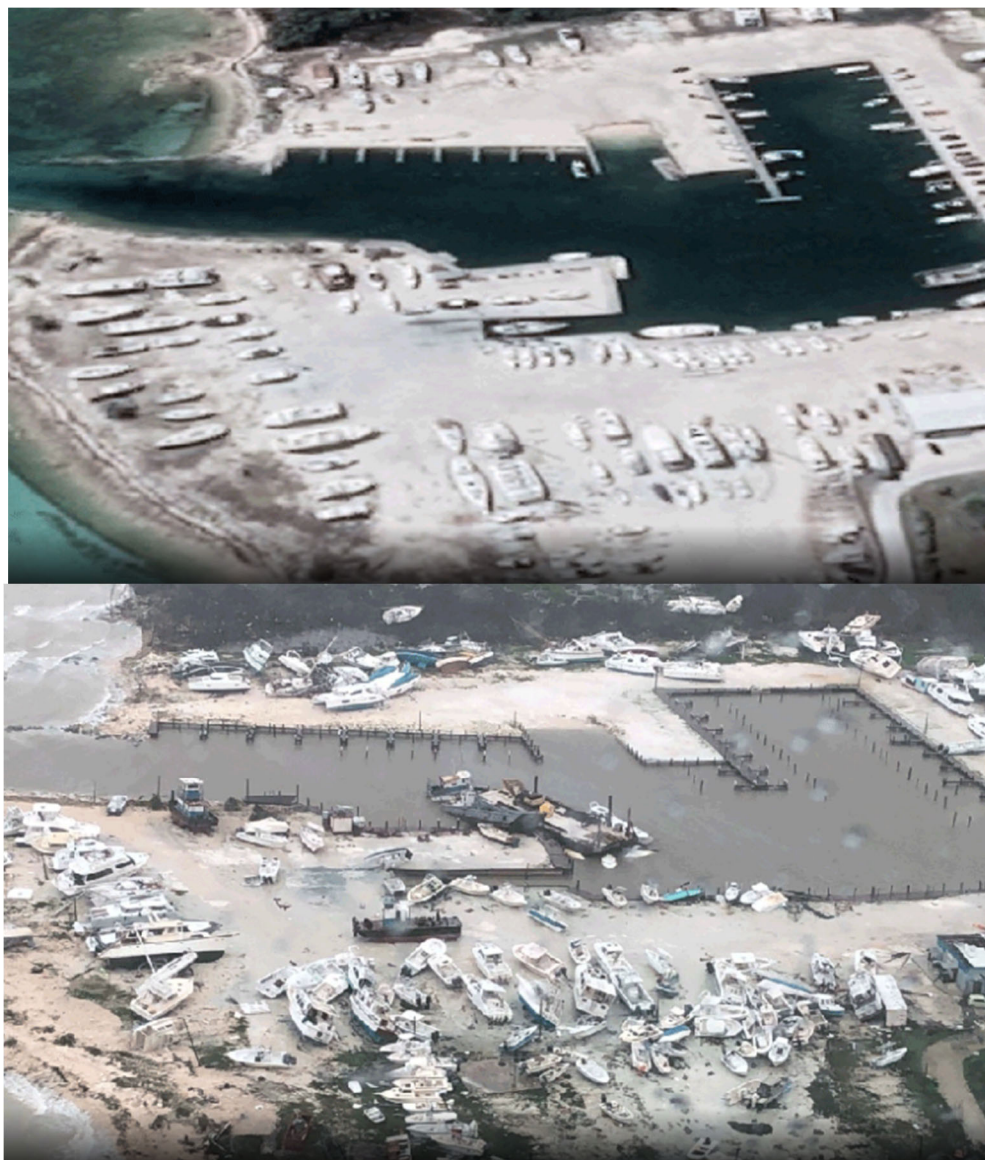
Figure 5.4. Comparison of marina (26.532, -77.054) in Marsh Harbor, Bahamas, before (above) and after (below) Dorian's storm surge on September 2, 2019. (Sources: before image: Google Maps, after image: U.S. Coast Guard via [Weather Channel](#))

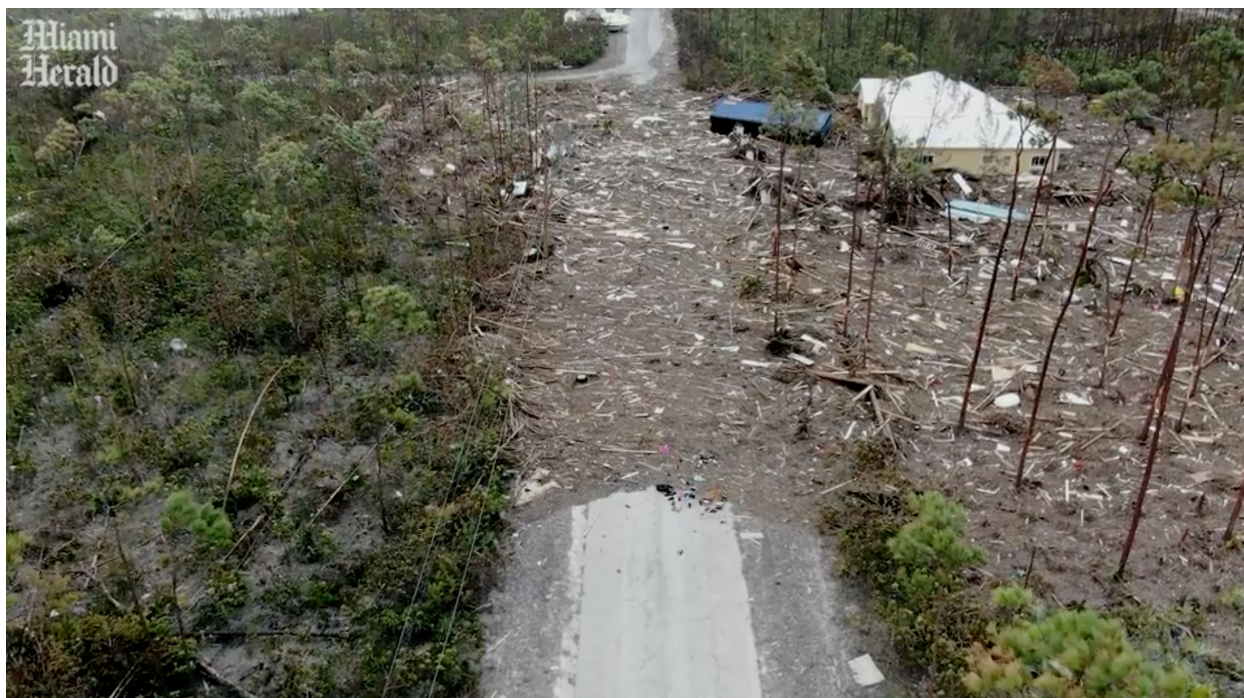
Figure 5.5. Grand Bahama Highway blocked by debris (Source: [Miami Herald](#))

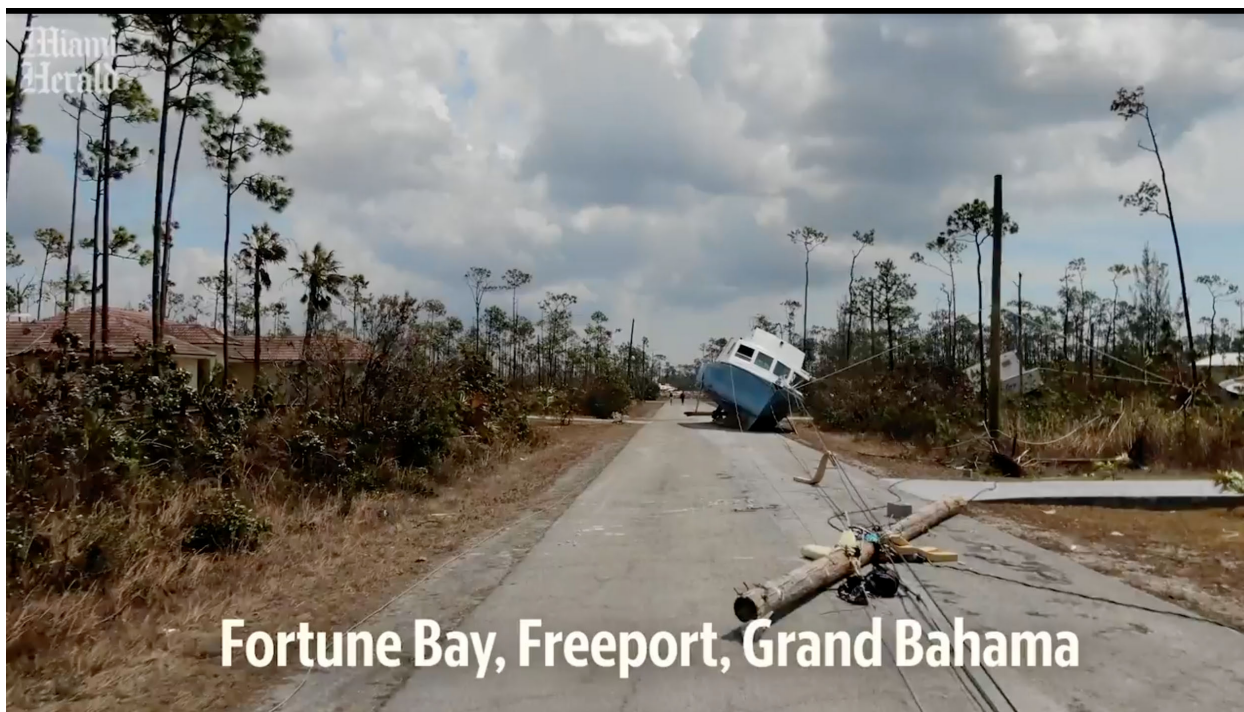
Grand Bahama Island was largely inaccessible until September 5, with severe damage to roadways on this island inhibiting rescue efforts and aid distribution. **Grand Bahama Highway** was completely submerged and blocked by debris (Figs. 5.5-5.6). Similar conditions were noted at a number of other primary and secondary roads in the Freeport area (Figs. 5.7-5.8).

Figure 5.6. Grand Bahama Highway at Fortune Bay, Freeport. (Source: [Miami Herald](#))

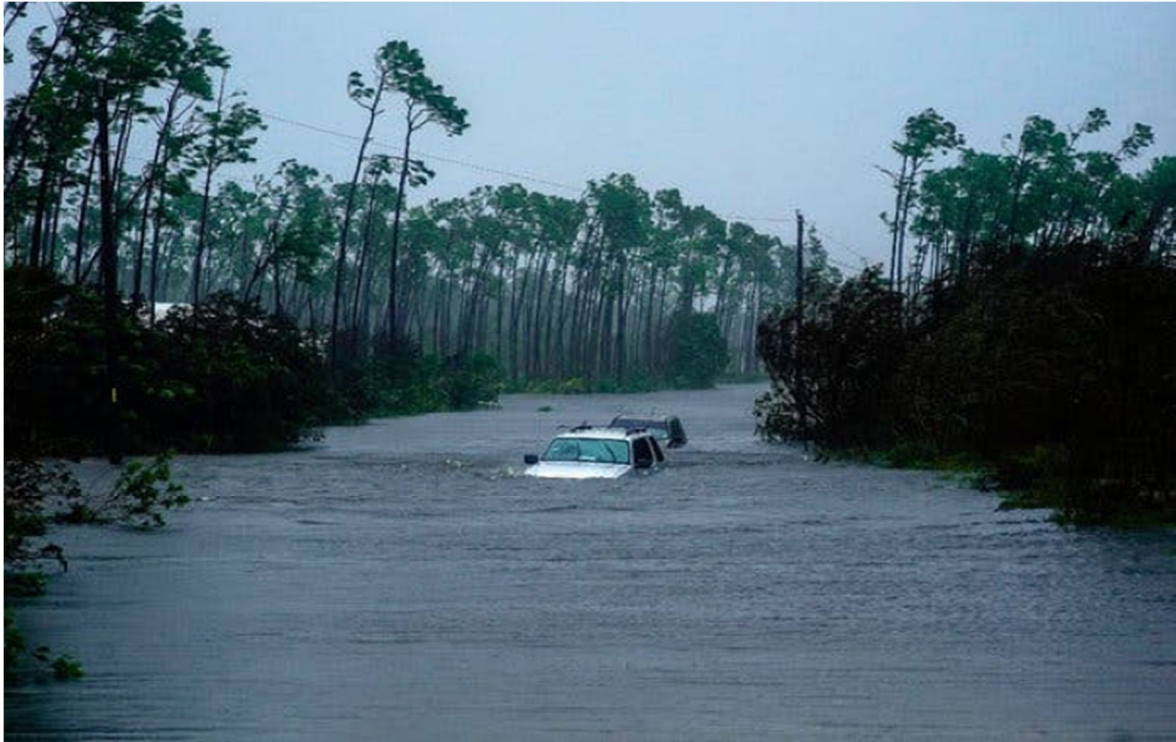
Figure 5.7. Freeport main road on September 3 (Source: [NY Times. Ramon Espinosa/Associated Press](#))

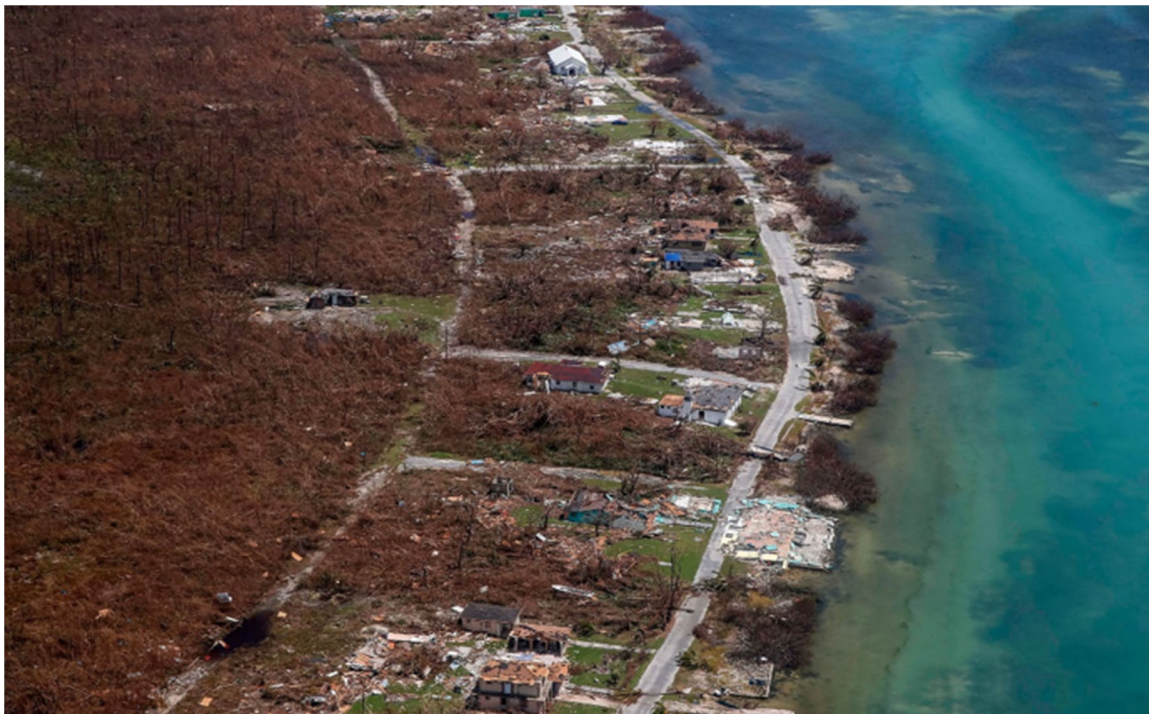
Figure 5.8. Aerial view of damaged roads near Freeport. Source: [NY Times](#)

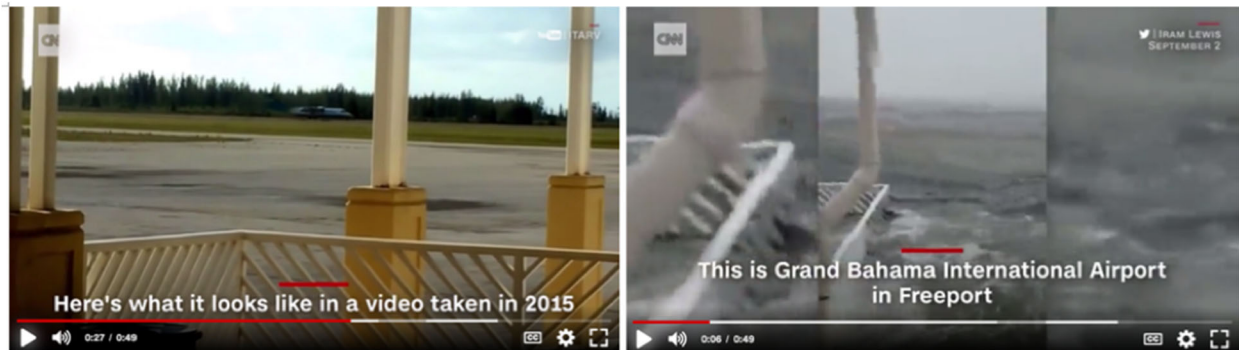
Figure 5.9. Comparison of Grand Bahama International Airport in Freeport (26.548, -78.696) in 2005 (left) and on September 2, 2019 after (right), flooded with Dorian's storm surge (Source: [CNN](#))

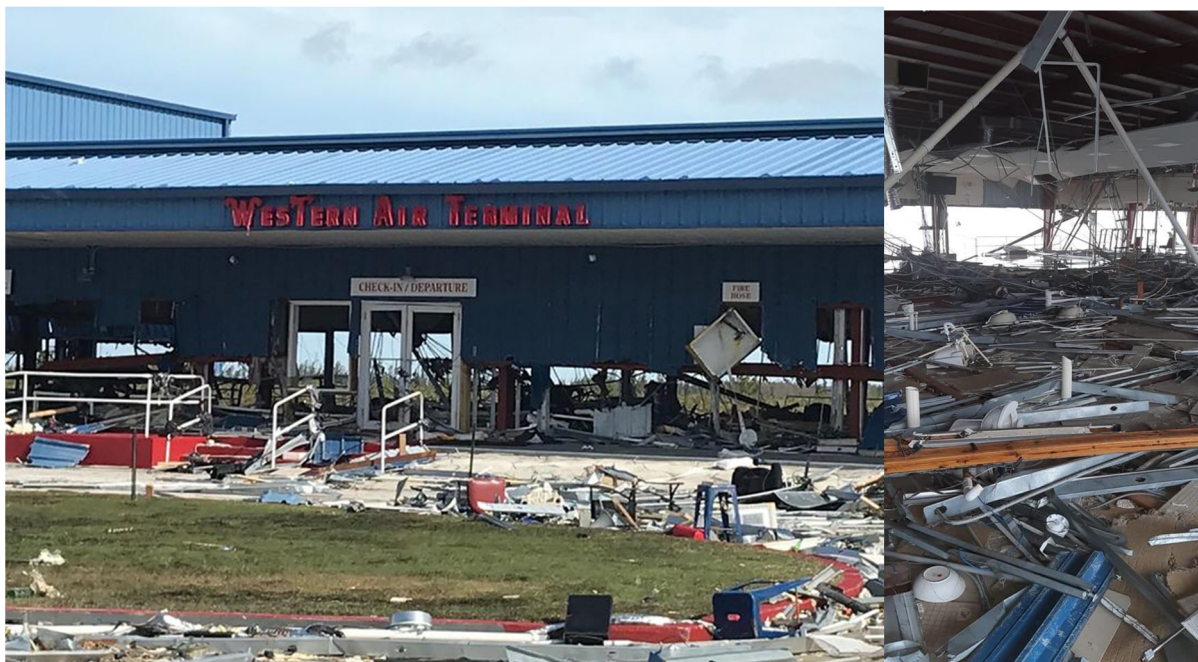
Figure 5.10. Damage to terminal building at Grand Bahama International Airport in Freeport (26.548, -78.698): (left) exterior view and (right) interior view (Sources: left image: [Orlando Sentinel](#), right image: [Getty Images](#))

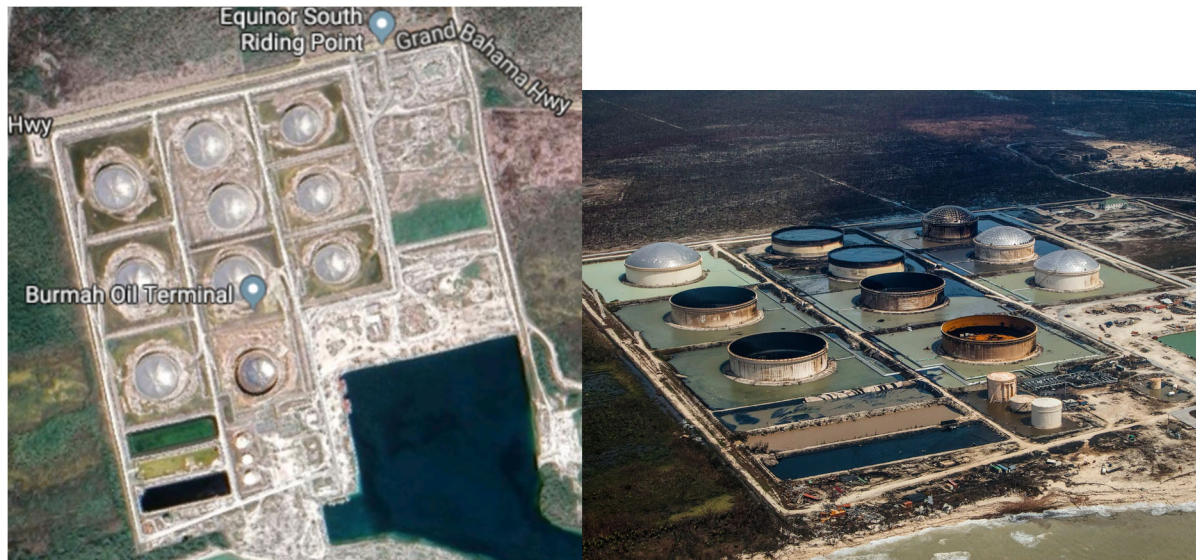
Figure 5.11. Burmah Oil Terminal at South Riding Point on the east side of Grand Bahama Island [26.626, -78.232] before Hurricane Dorian (left) and after (right) (Source of after image: [New York Times](#), Source of before image: Google Maps)
