StEER
STRUCTURAL
EXTREME EVENTS
RECONNAISSANCE

HURRICANE DORIAN

Released: September, 10, 2019
NHERI DesignSafe Project ID: PRJ-2549

PRELIMINARY VIRTUAL RECONNAISSANCE REPORT (PVRR)

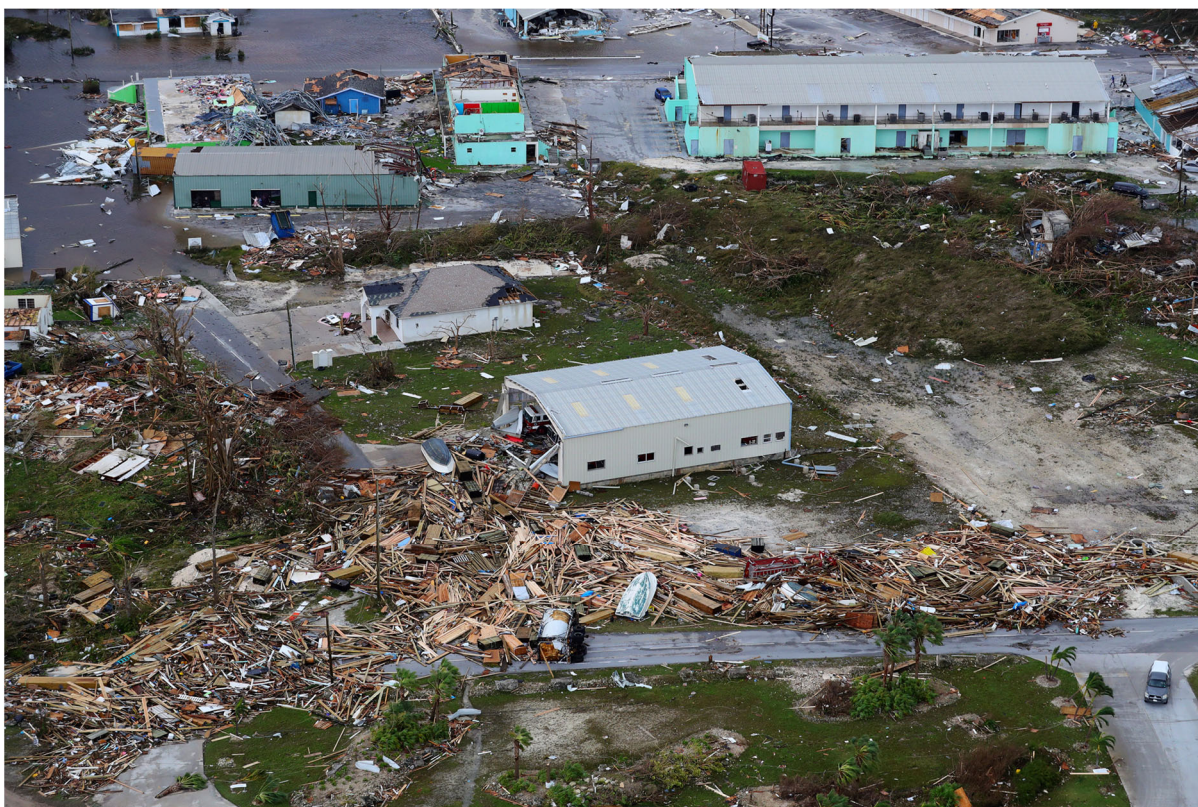
Figure 8.1. Aerial photo of the damage from Dorian on Great Abaco Island demonstrating the mixed performance of buildings across occupancy classes. (Source: [CNN](#))
