Damage Survey from the 2024 Noto Peninsula Earthquake

ver.01 (2024/02/01)

Understanding geotechnical failure and ground motions

This report partially covers damage due to ground failure with a focus on liquefaction and some damage to buildings. (This is not an extensive report of all damages in the area)

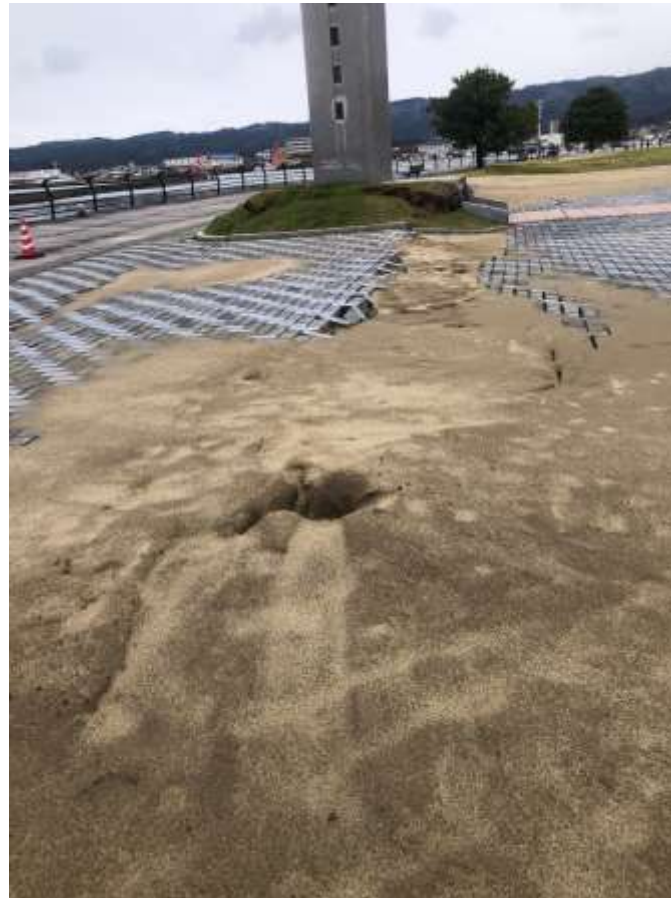
Sand ejecta and ground subsidence

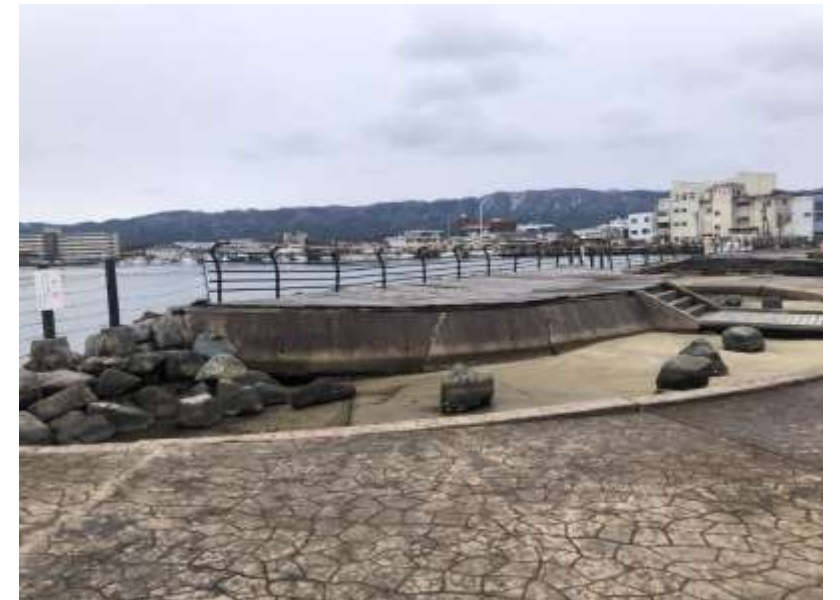
Subsidence and curved quay

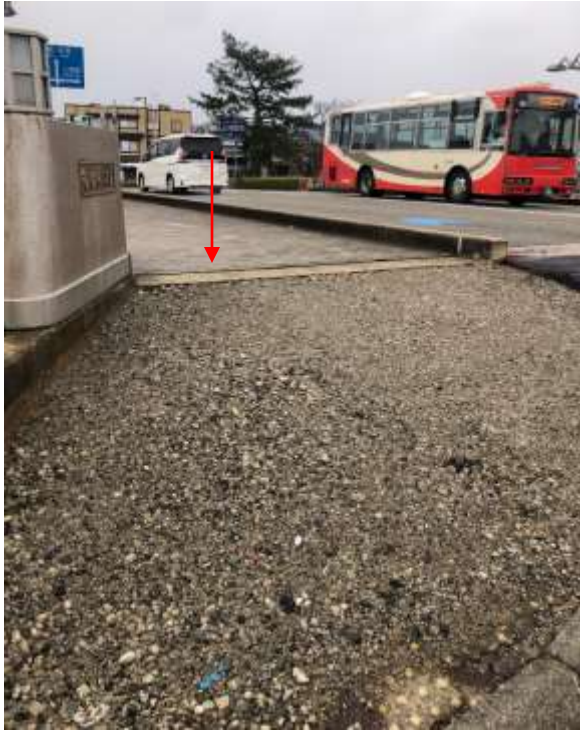
3. Ground subsidence around bridge
