Damage Survey from the 2024 Noto Peninsula Earthquake

ver.01 (2024/02/01)

Understanding geotechnical failure and ground motions

This report partially covers damage due to ground failure with a focus on liquefaction and some damage to buildings. (This is not an extensive report of all damages in the area)

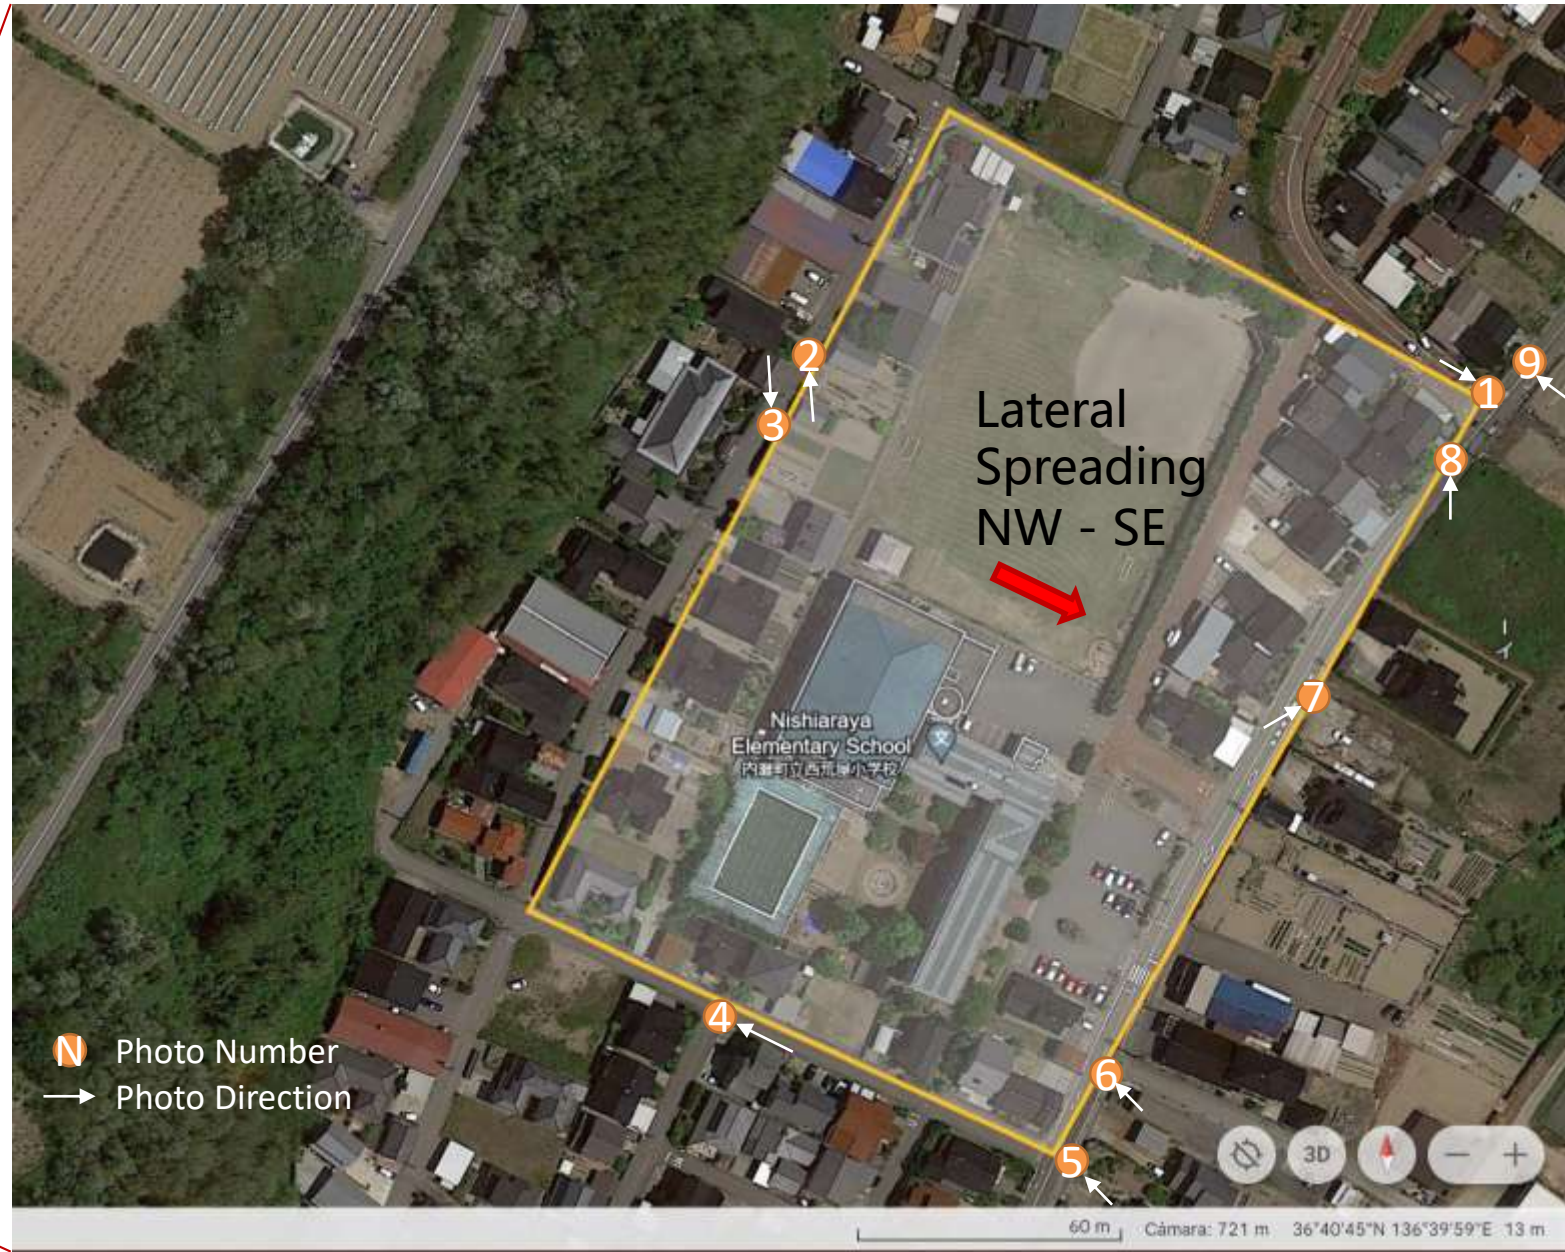
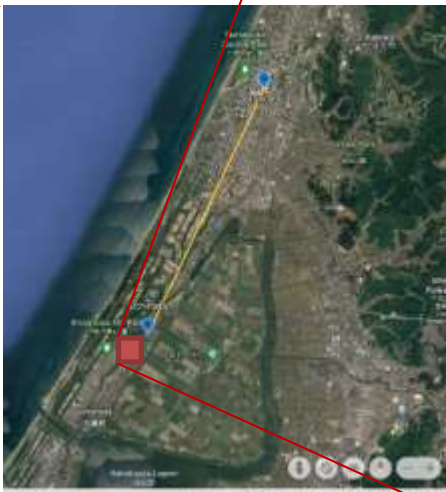
Uchinada

- Liquefaction-induced damage:
 - Lateral spreading (about 2.7 Ha)
 - Ground upheave
 - Ground settlement
 - Sand ejecta

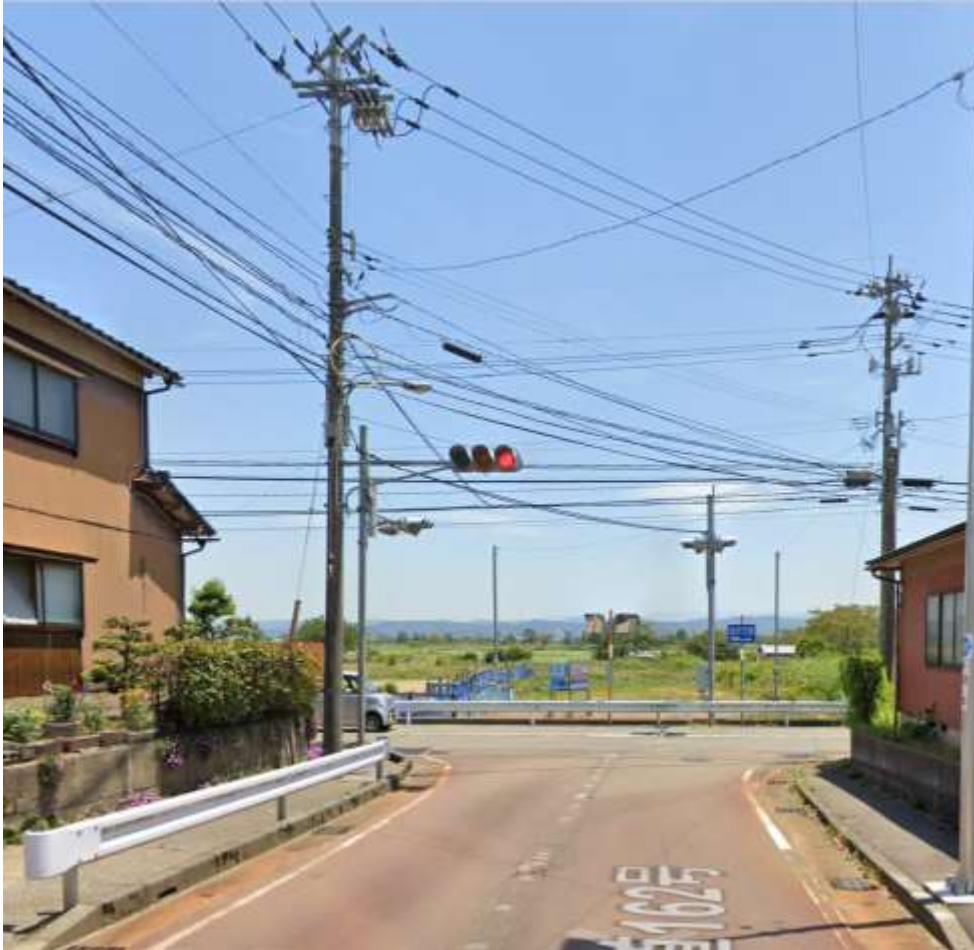
1. Sinking of Traffic Light and upheave of side walk

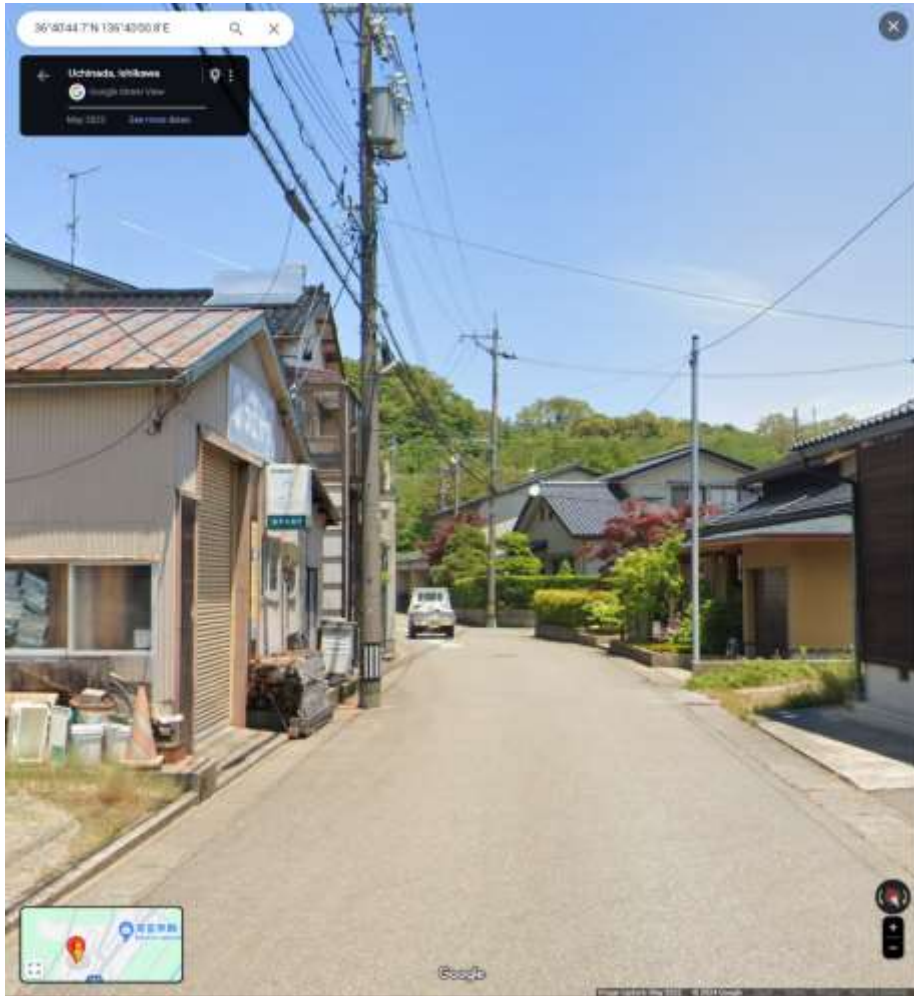
2. Lateral displacement (NW to SE) and vertical relative settlement

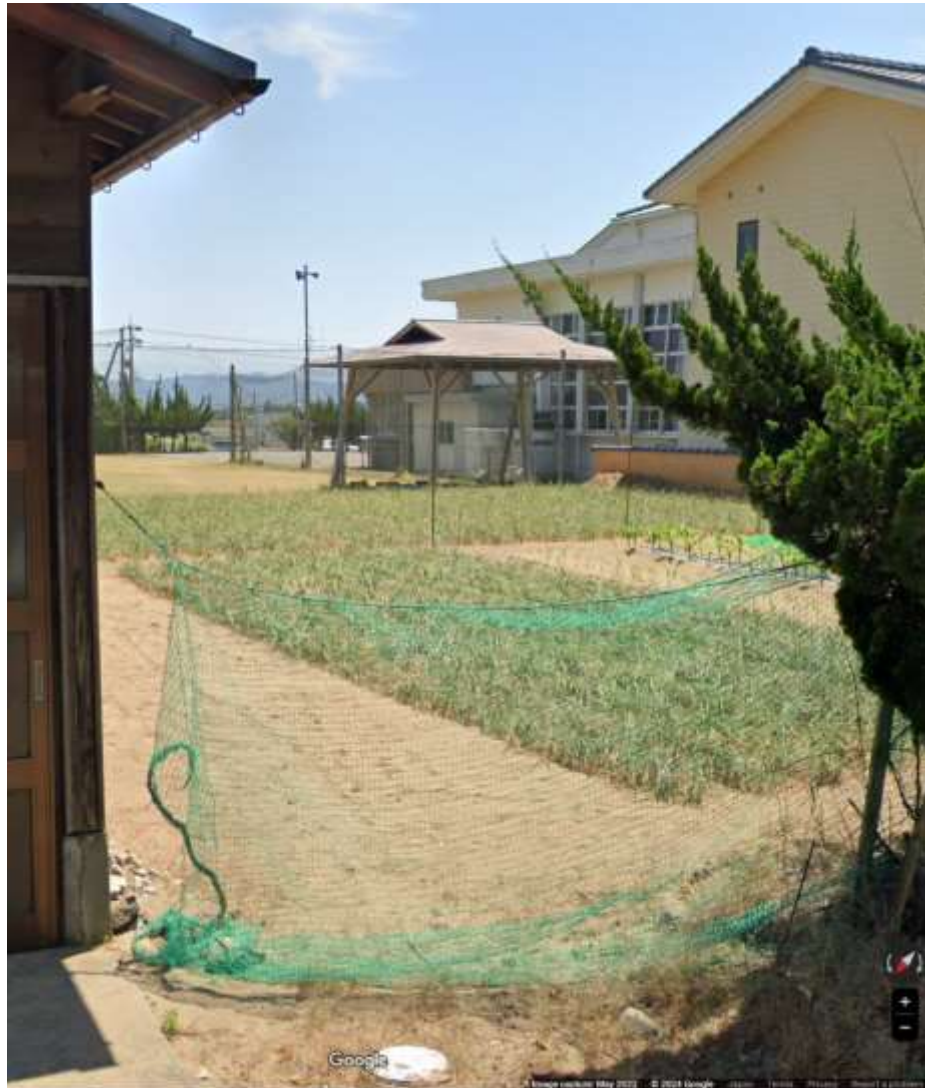
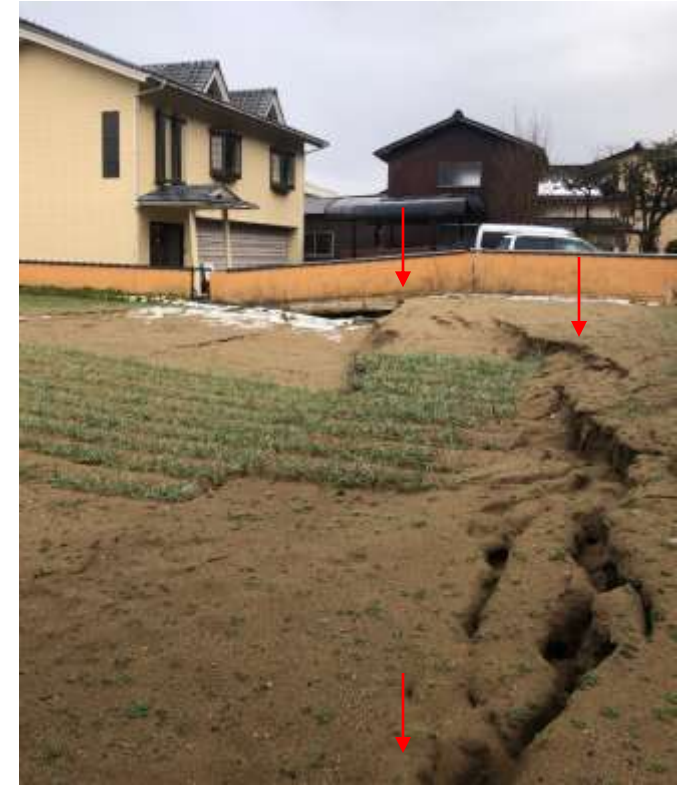
3. Tensile cracks, settlement and lateral spreading

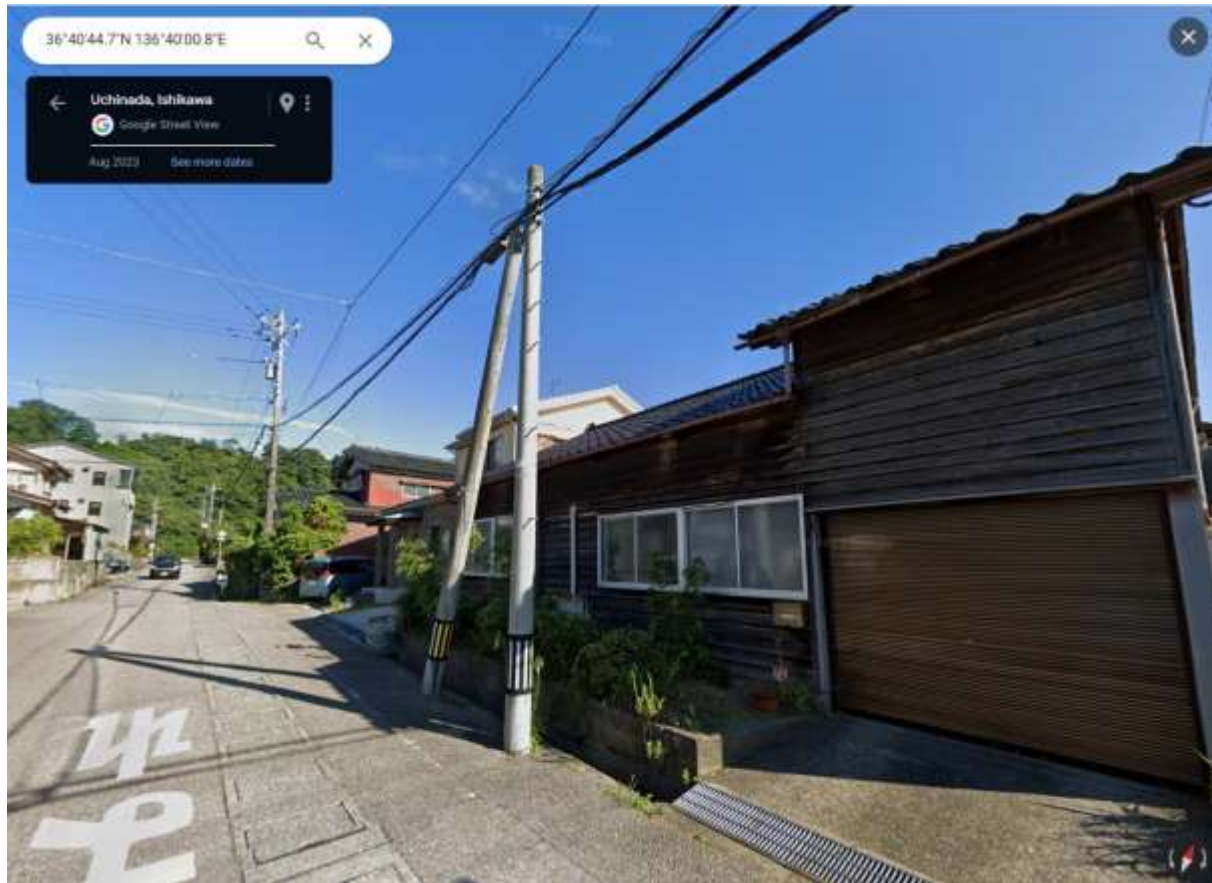
5. Sand ejecta, utility pole sinking and ground upheave

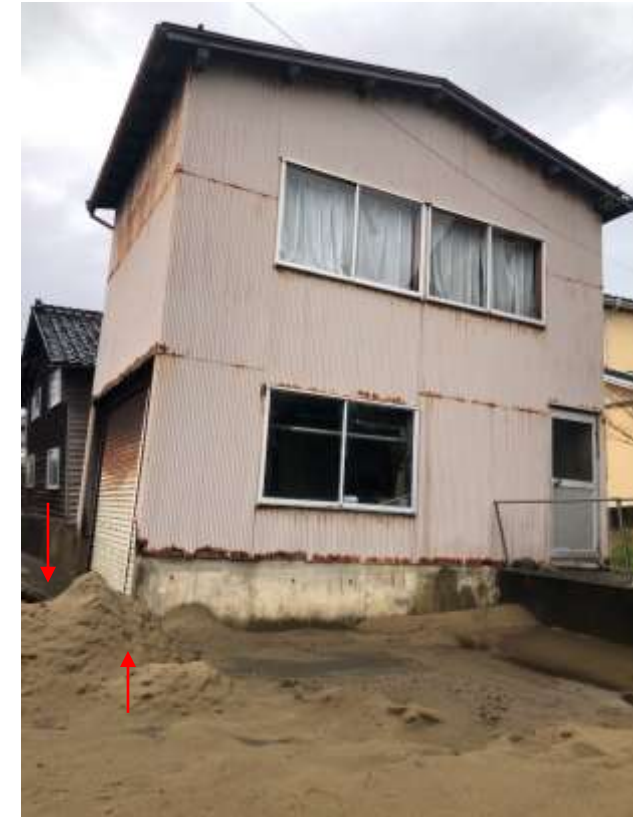
6. Sand ejecta, relative settlement and ground upheave

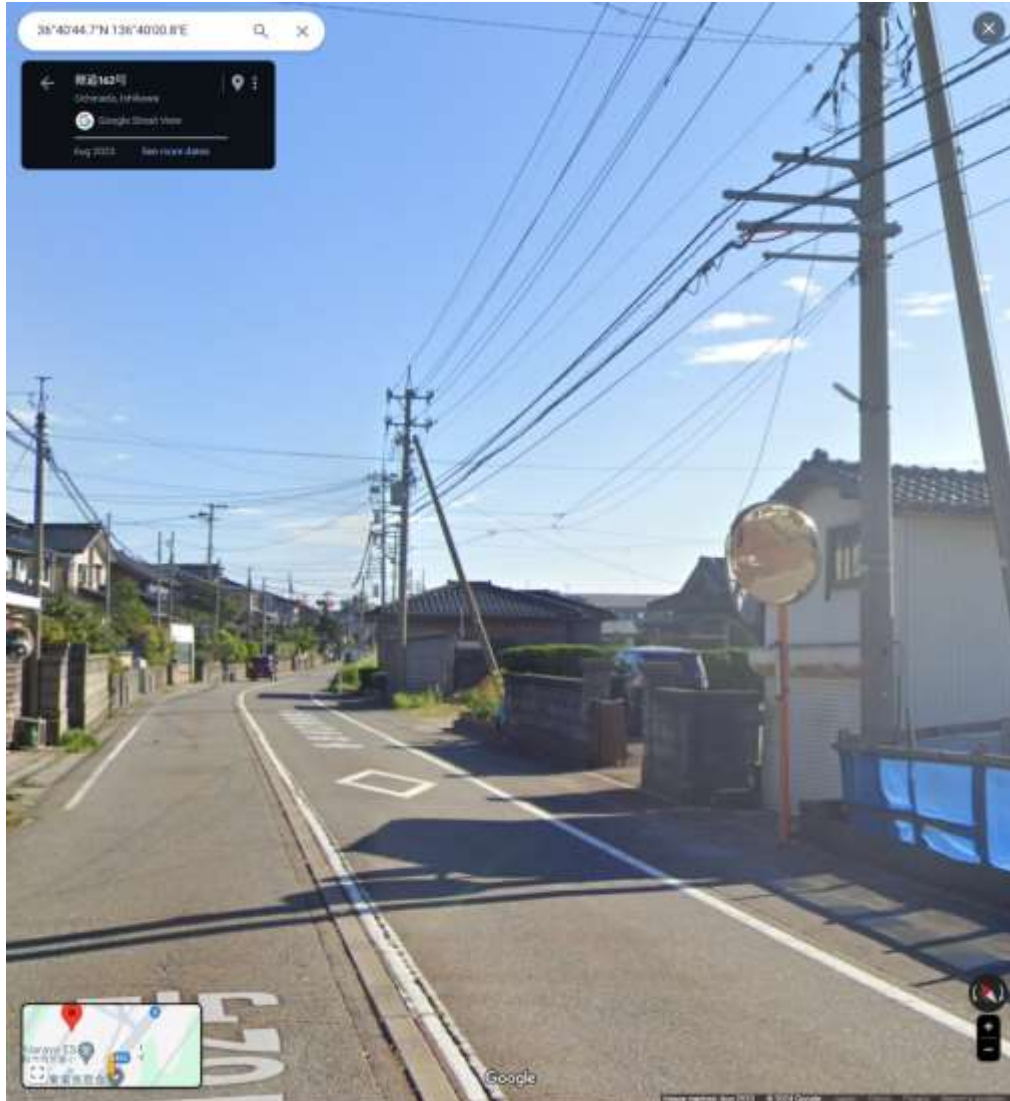
7. Sand ejecta, horizontal displacement and ground upheave

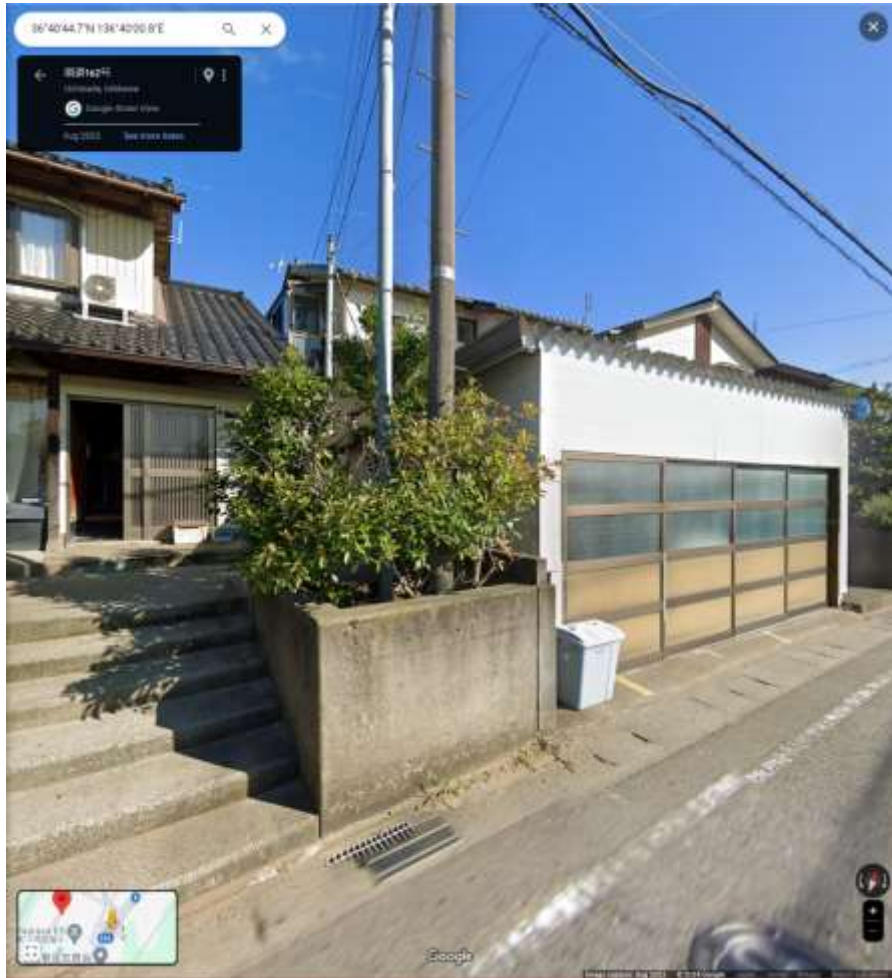
8. Sand ejecta, rotation, and ground upheave

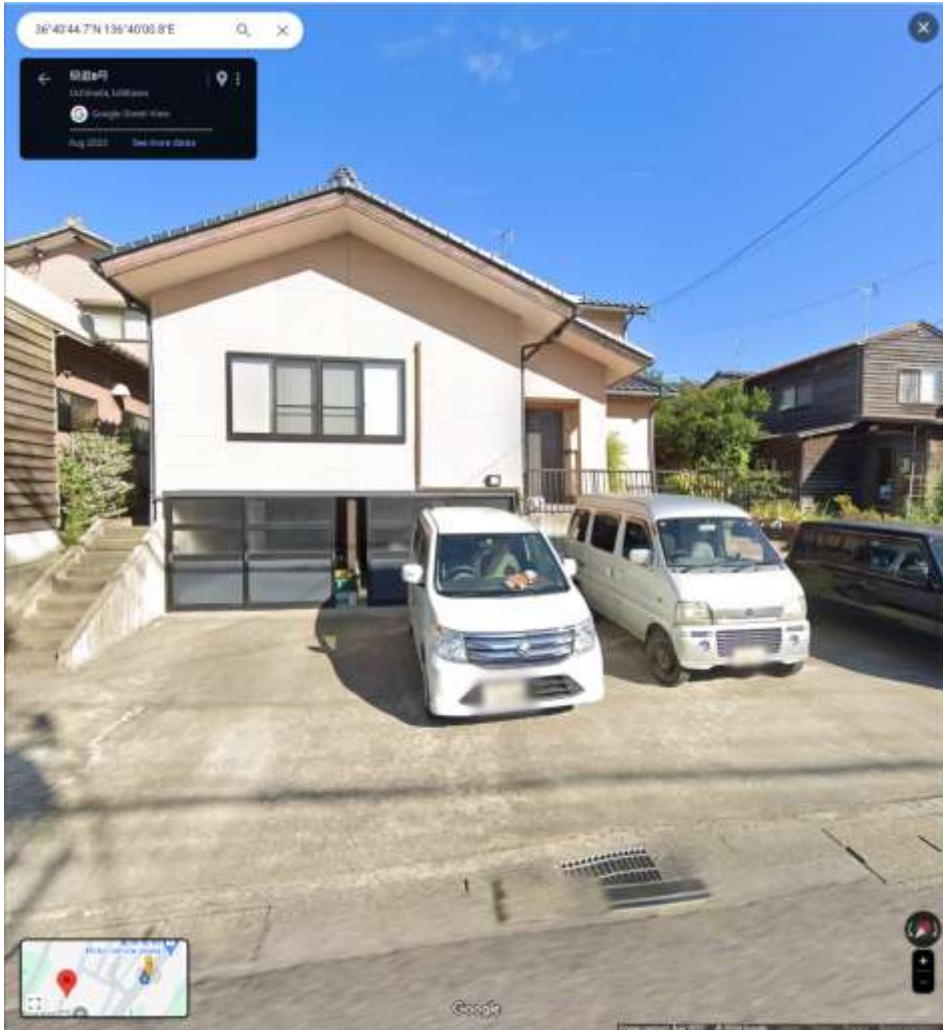
9. Vertical settlement

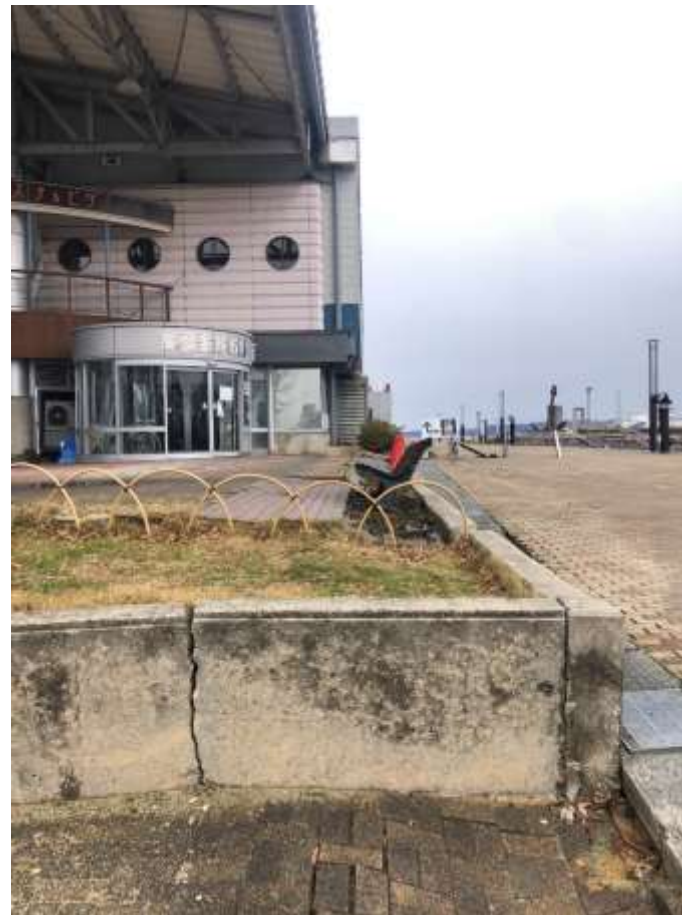
Relative settlement

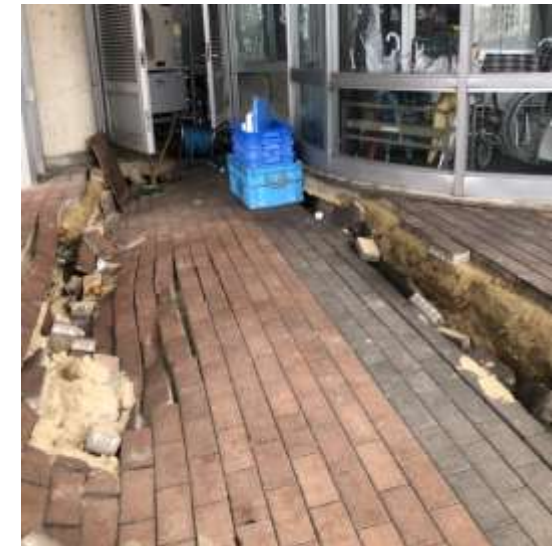
Ground subsidence

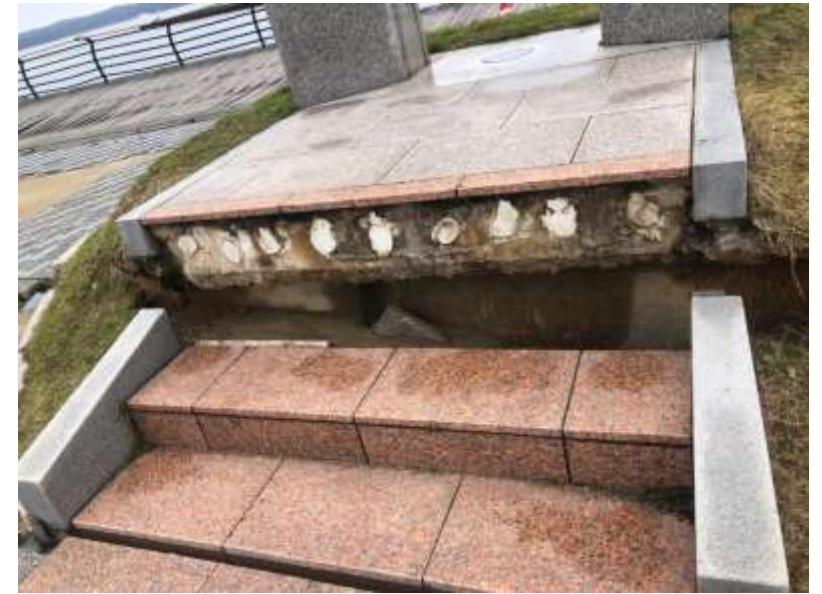
Ground subsidence

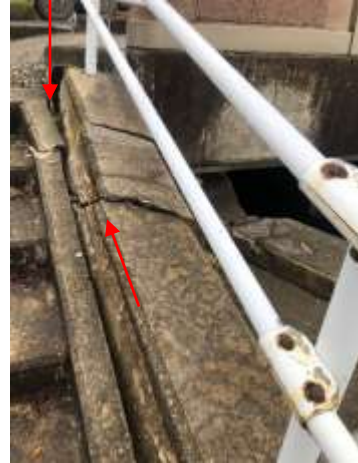
Cracks in bridge stairs

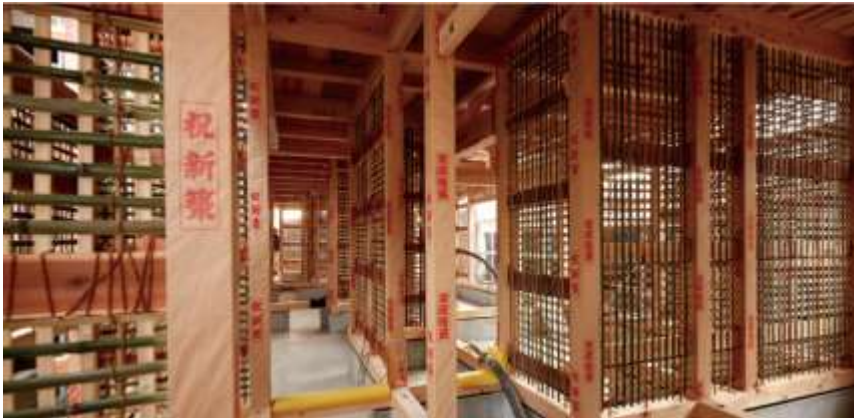
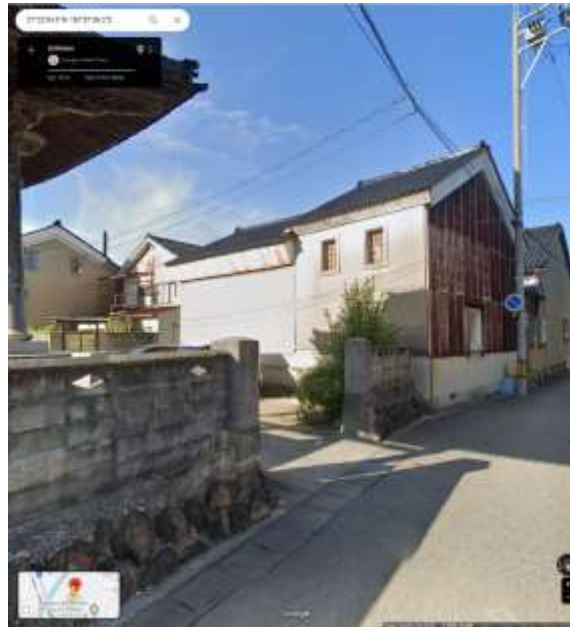
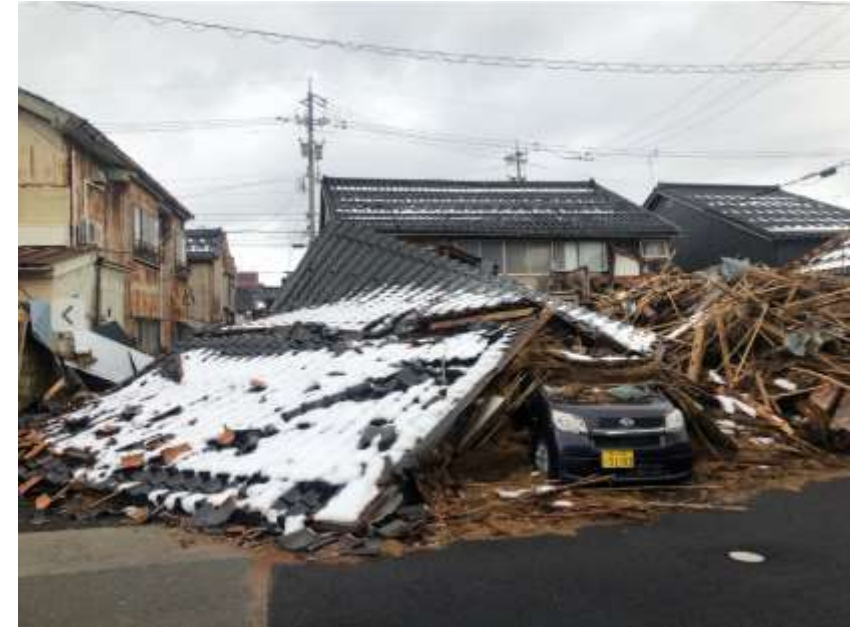
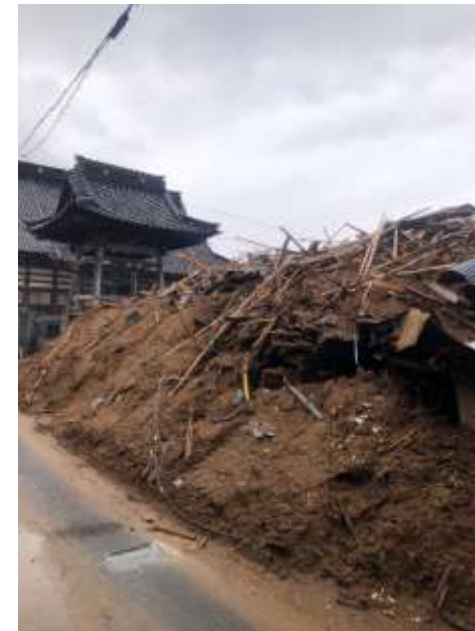
4. Collapsed traditional wood house

Timber structure and earthen plaster

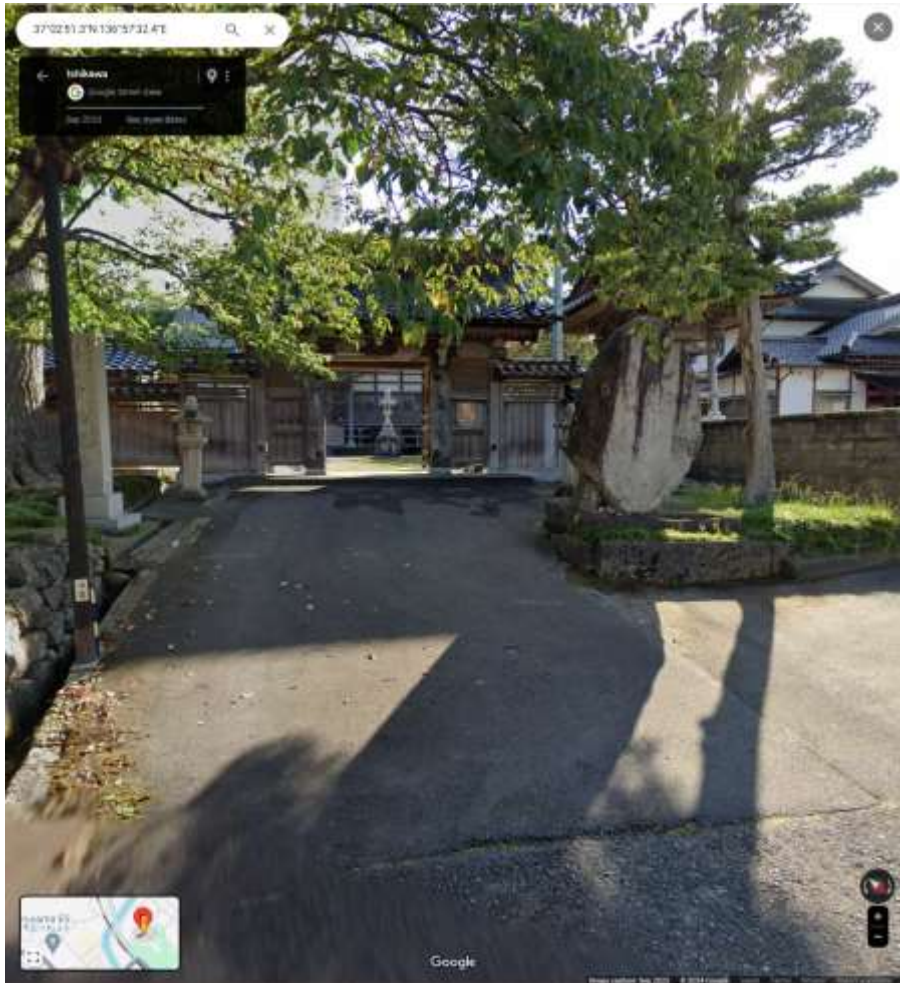
5. Collapsed entrance gate

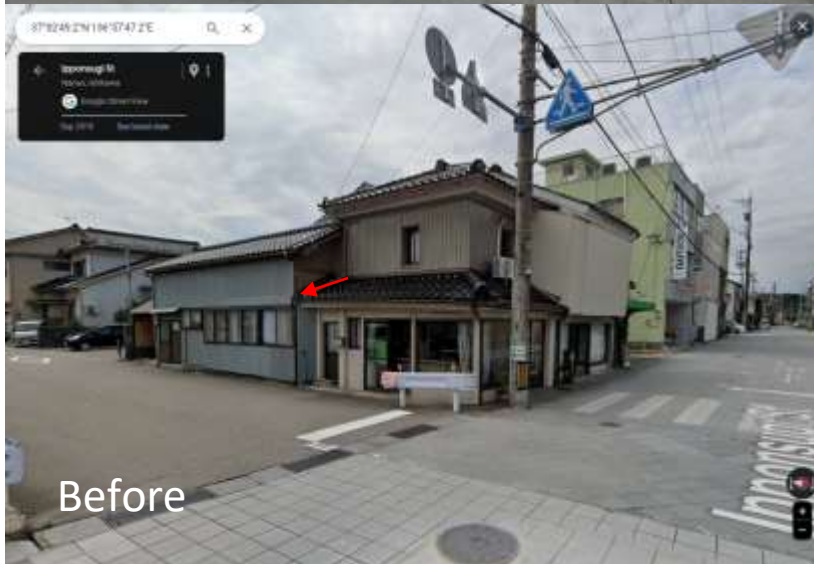
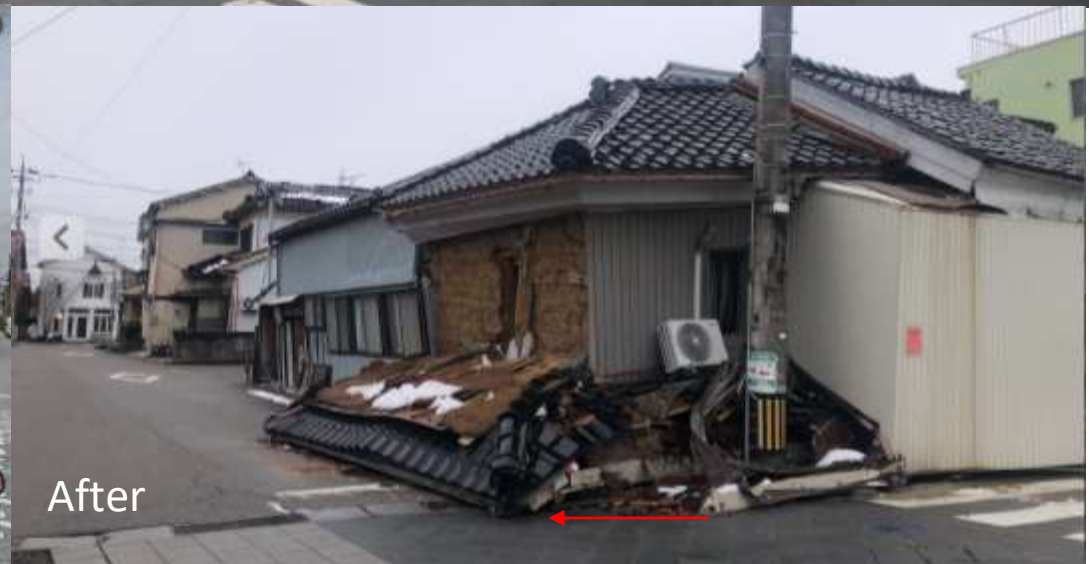
6. Collapsed of first floor of wood house

Vertical and horizontal asymmetry

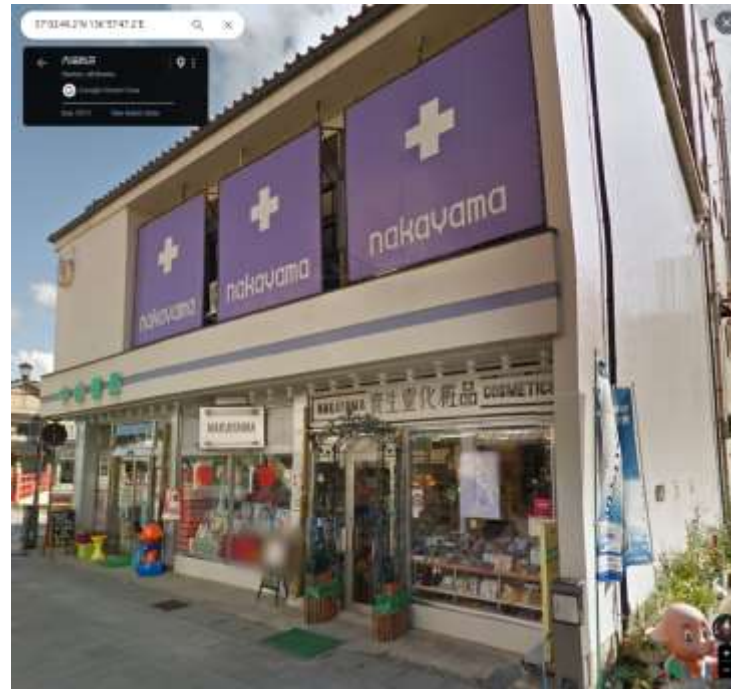
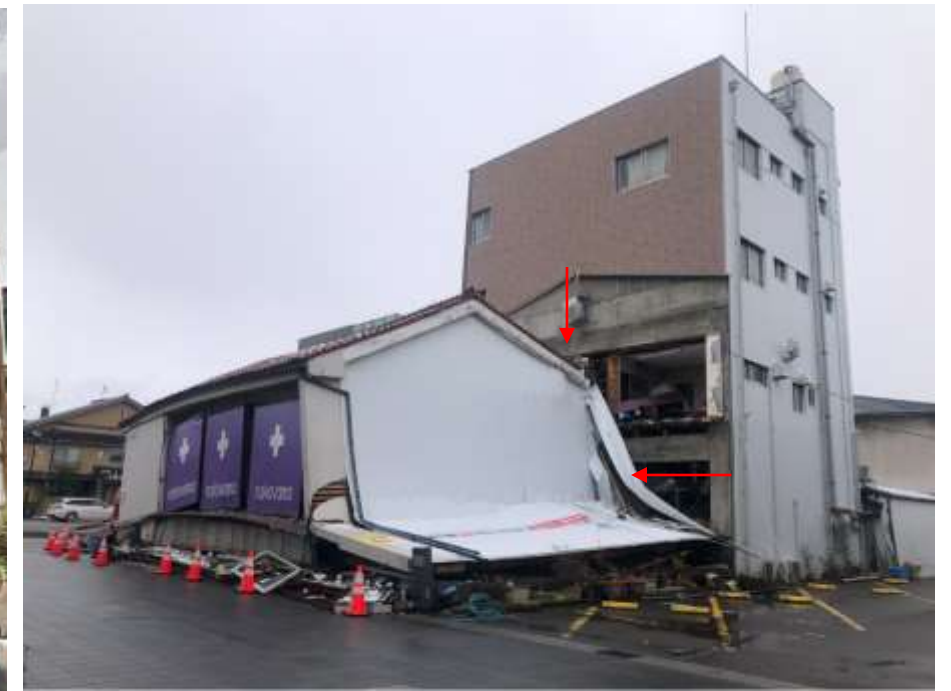
6. Collapsed of first floor of wood house

First “Weak floor”

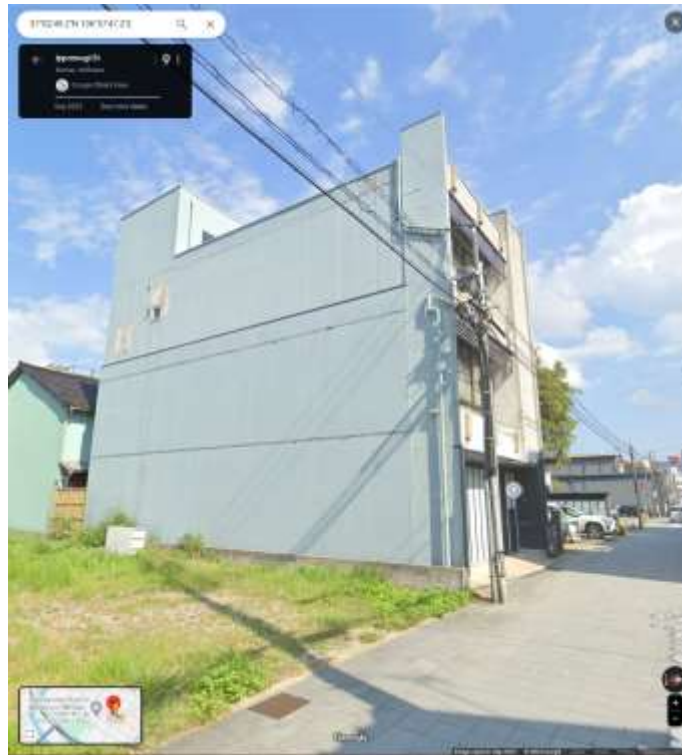
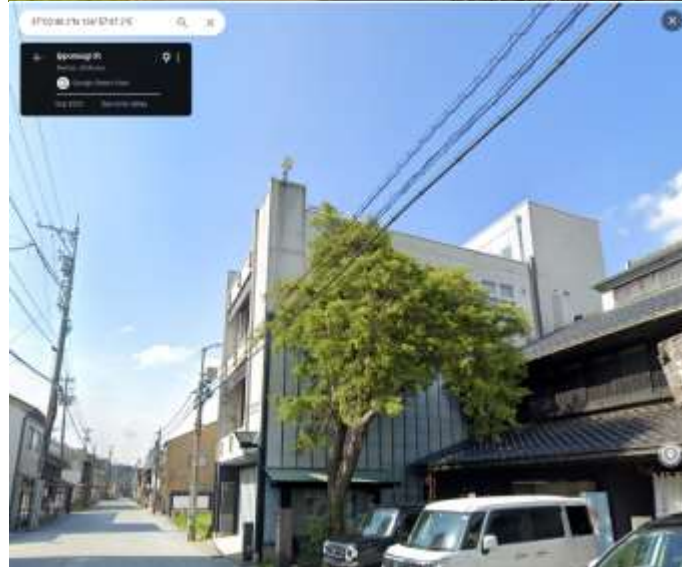
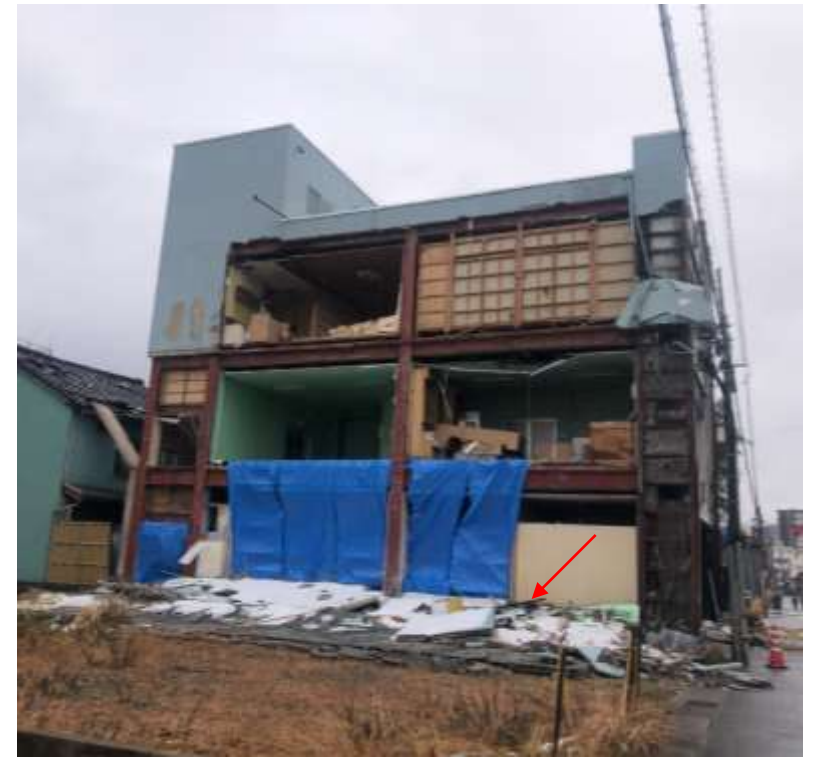
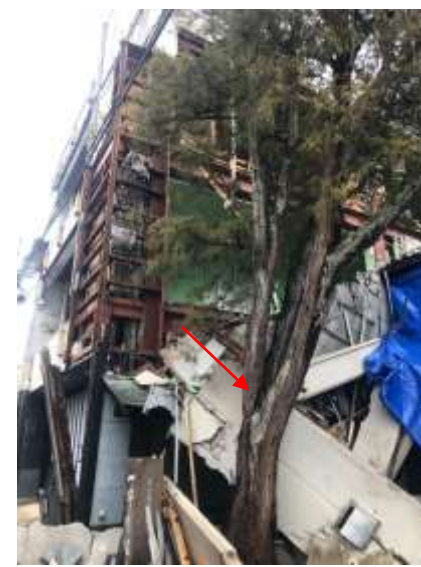
7. Fallen facade of steel structure

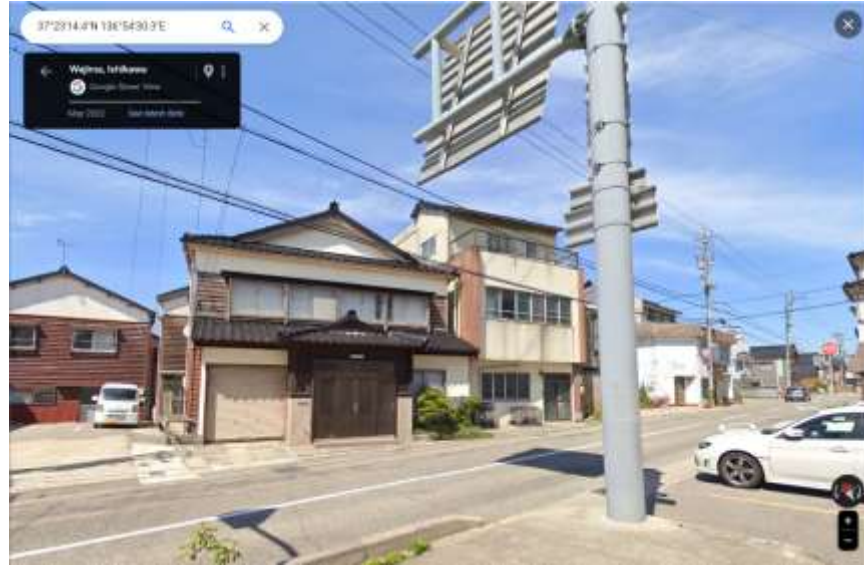
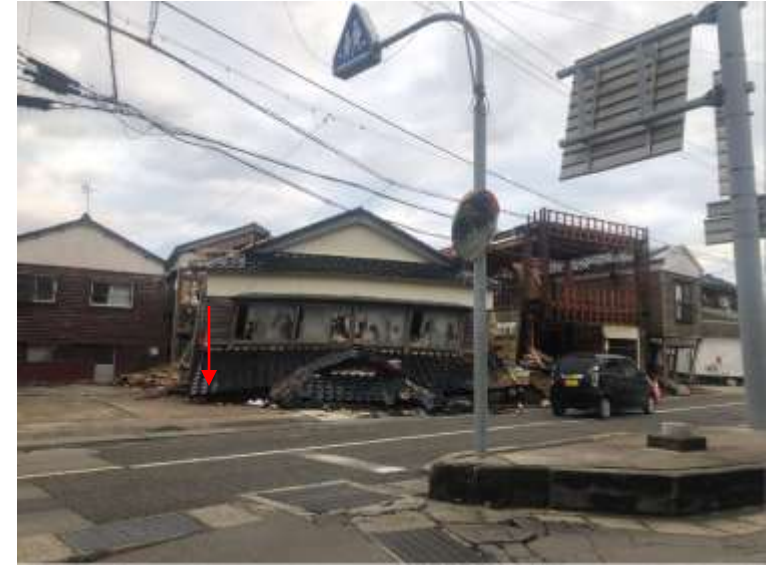
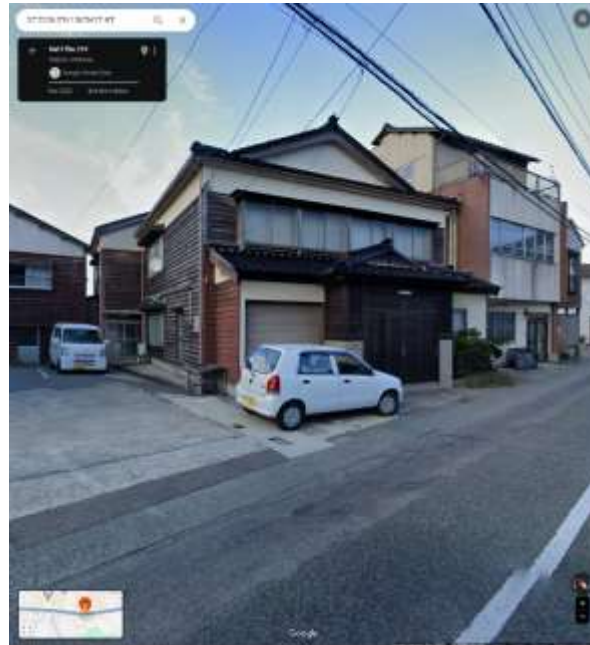
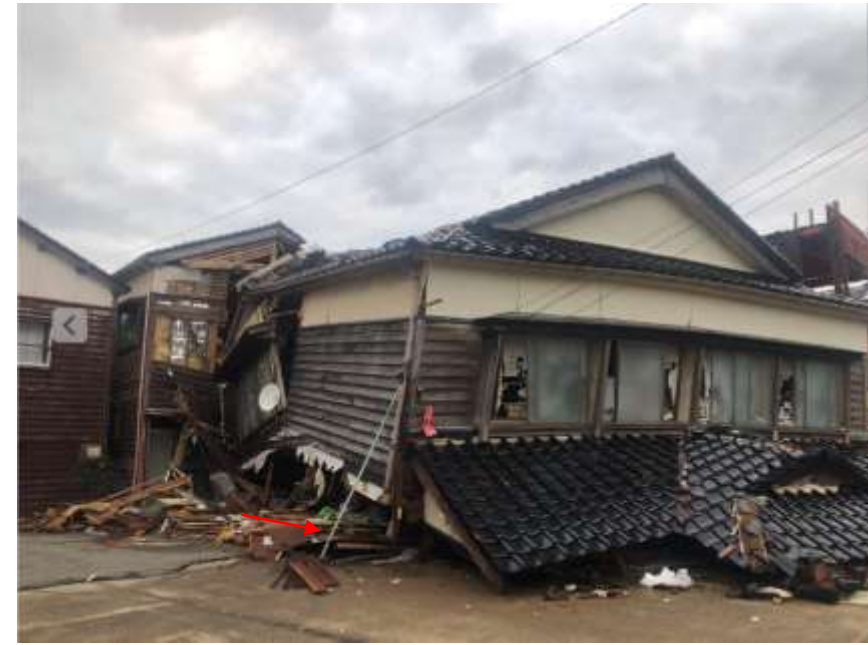
Wajima

1. First floor collapsed

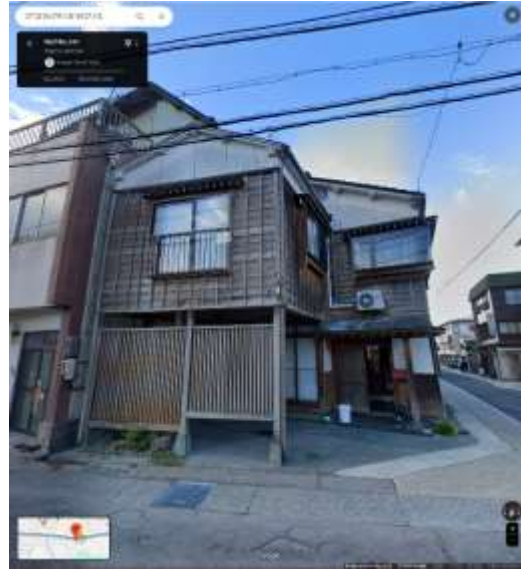
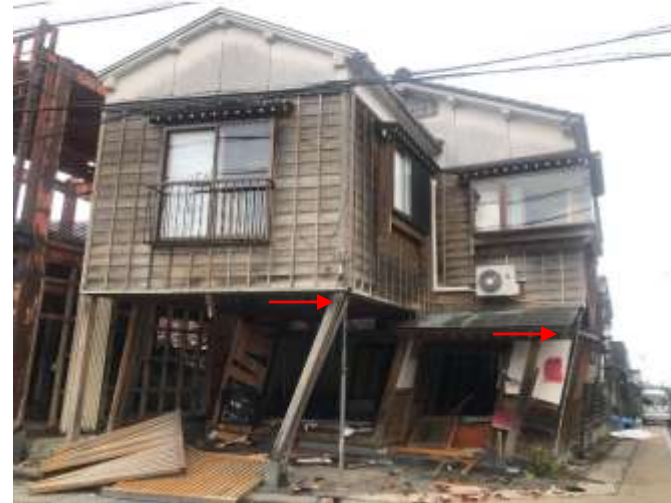
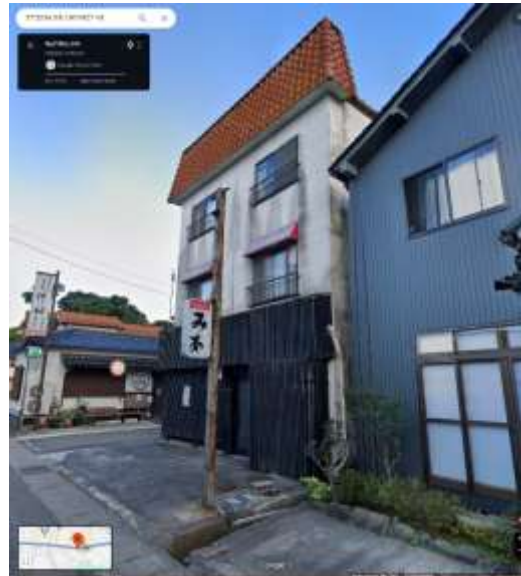
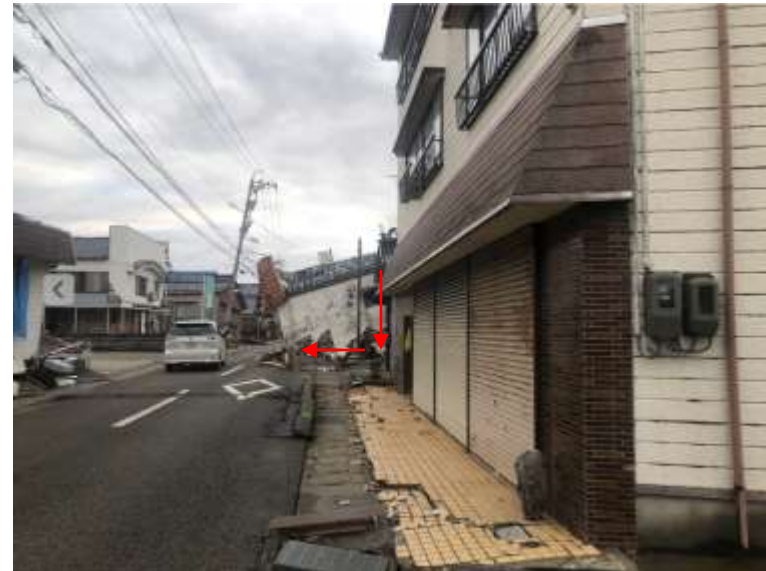
Wajima

2. First floor tilted or collapsed

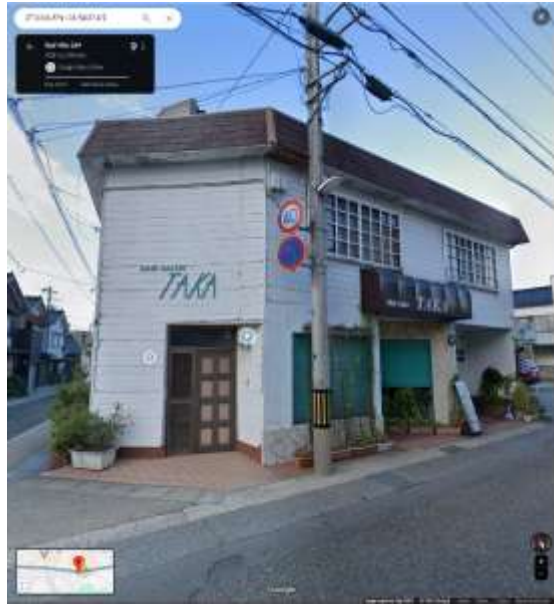
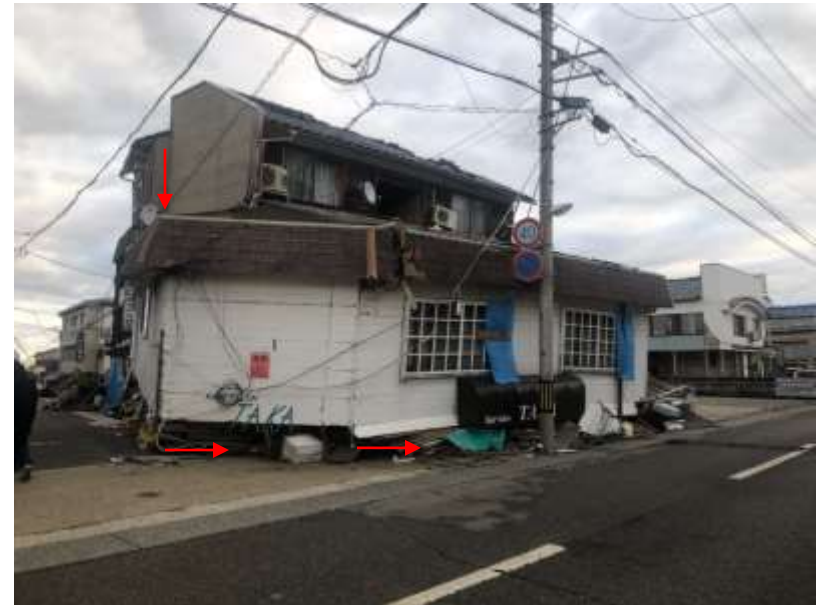
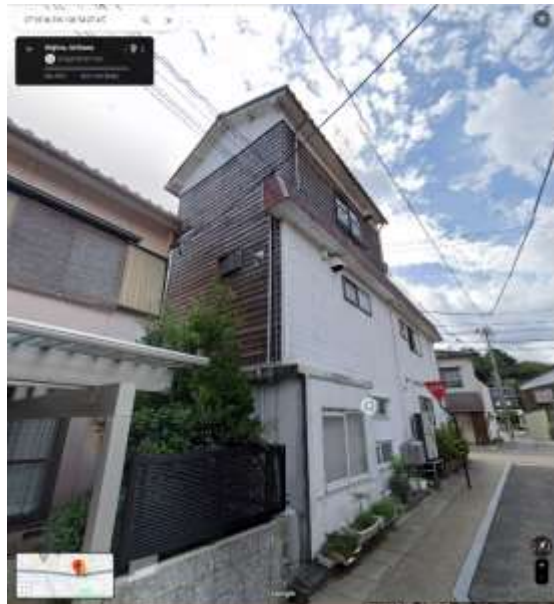
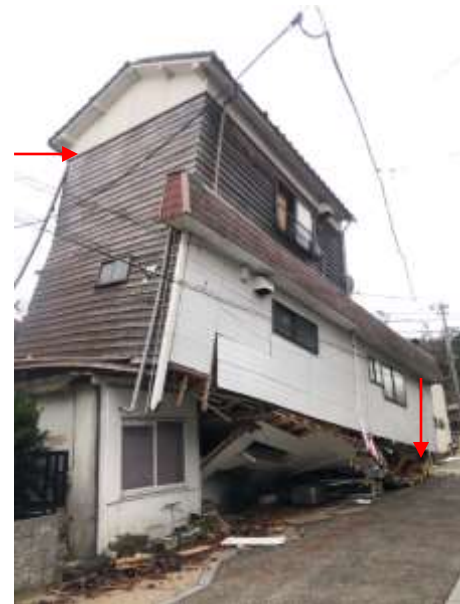
Wajima

3. First floor collapsed
