Damage Survey from the 2024 Noto Peninsula Earthquake

ver.01 (2024/02/01)

Understanding geotechnical failure and ground motions

This report partially covers damage due to ground failure with a focus on liquefaction and some damage to buildings. (This is not an extensive report of all damages in the area)

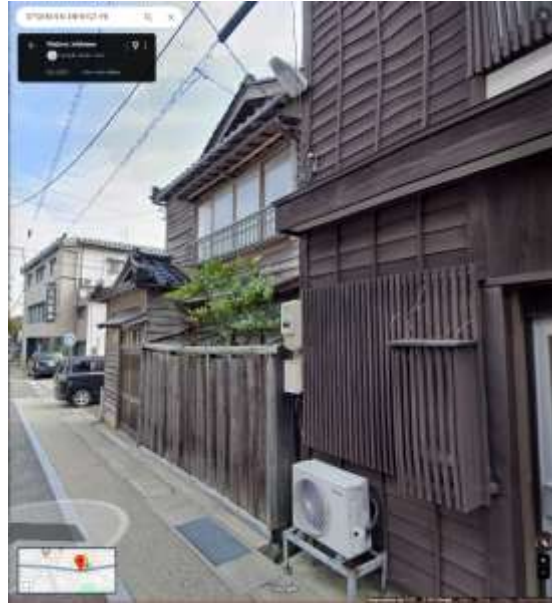
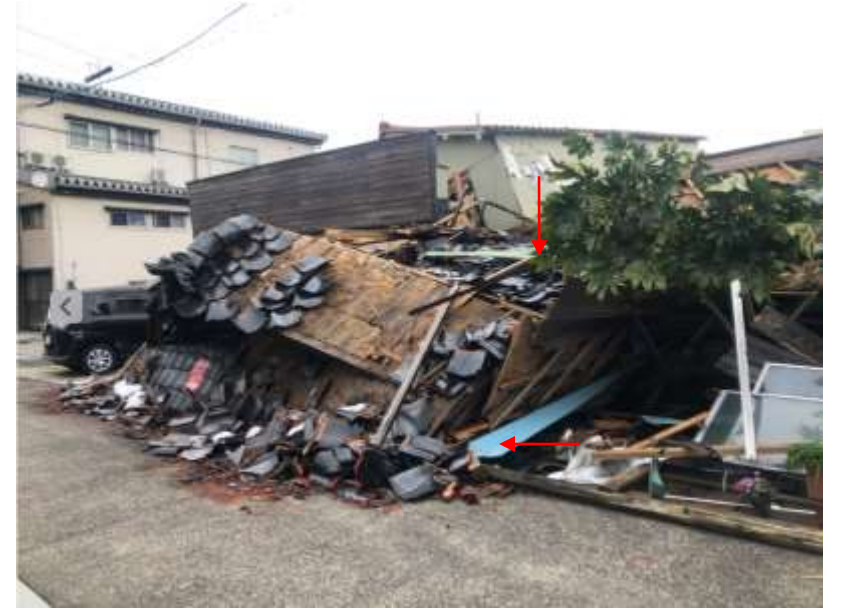
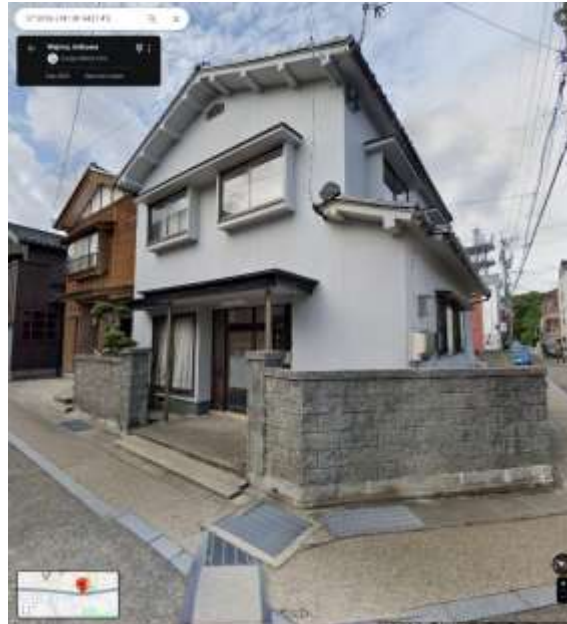
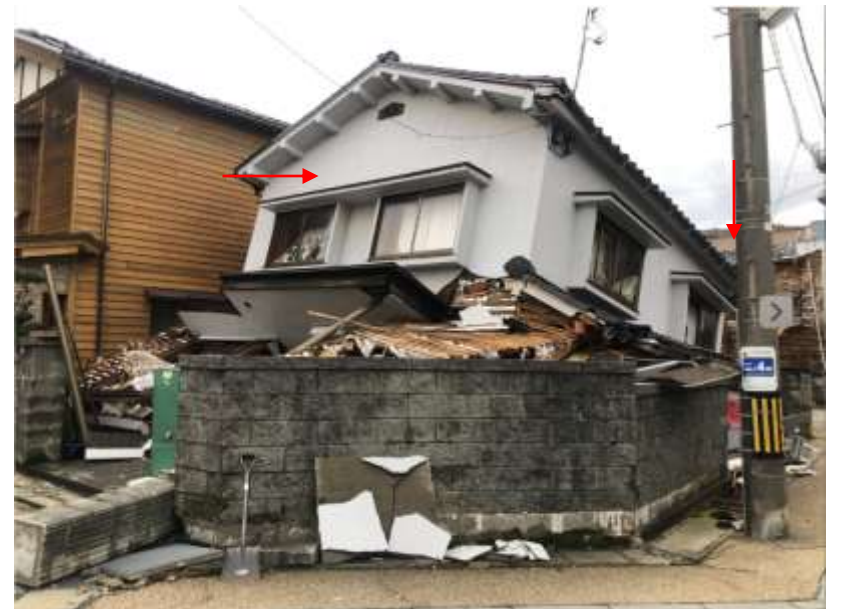
Wajima

4. First floor collapsed

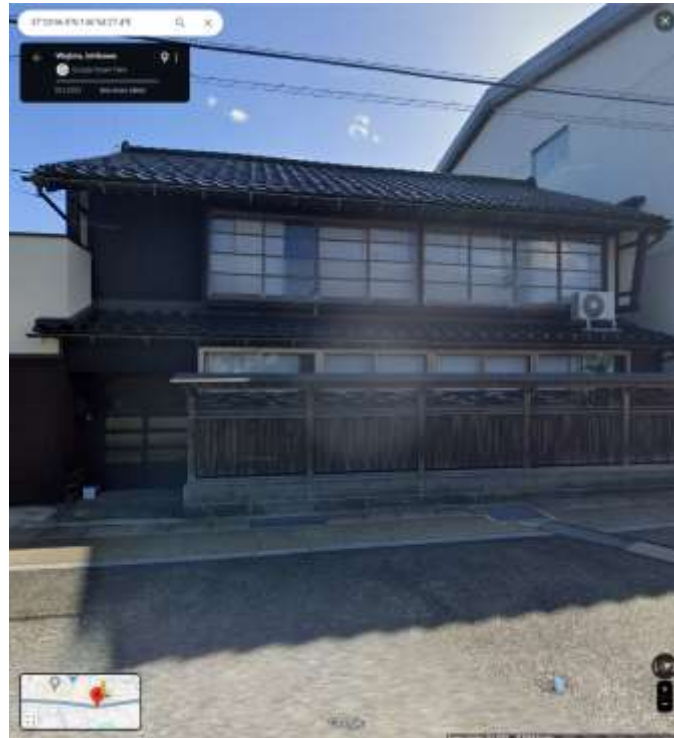
Wajima

5. First floor collapsed

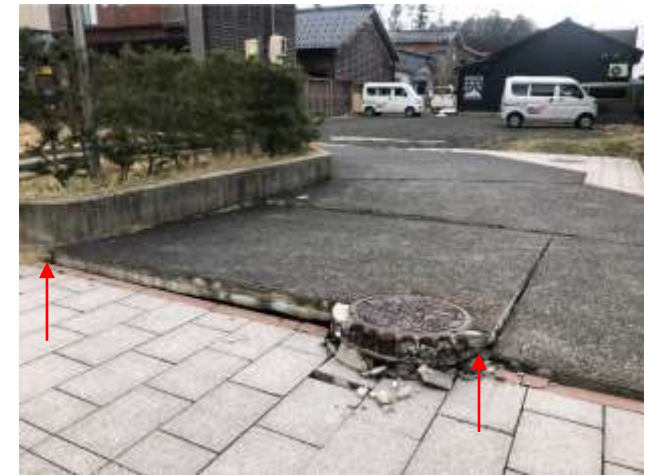
Wajima

6. Liquefaction evidence: sand ejecta, ground cracks and manholes uplift

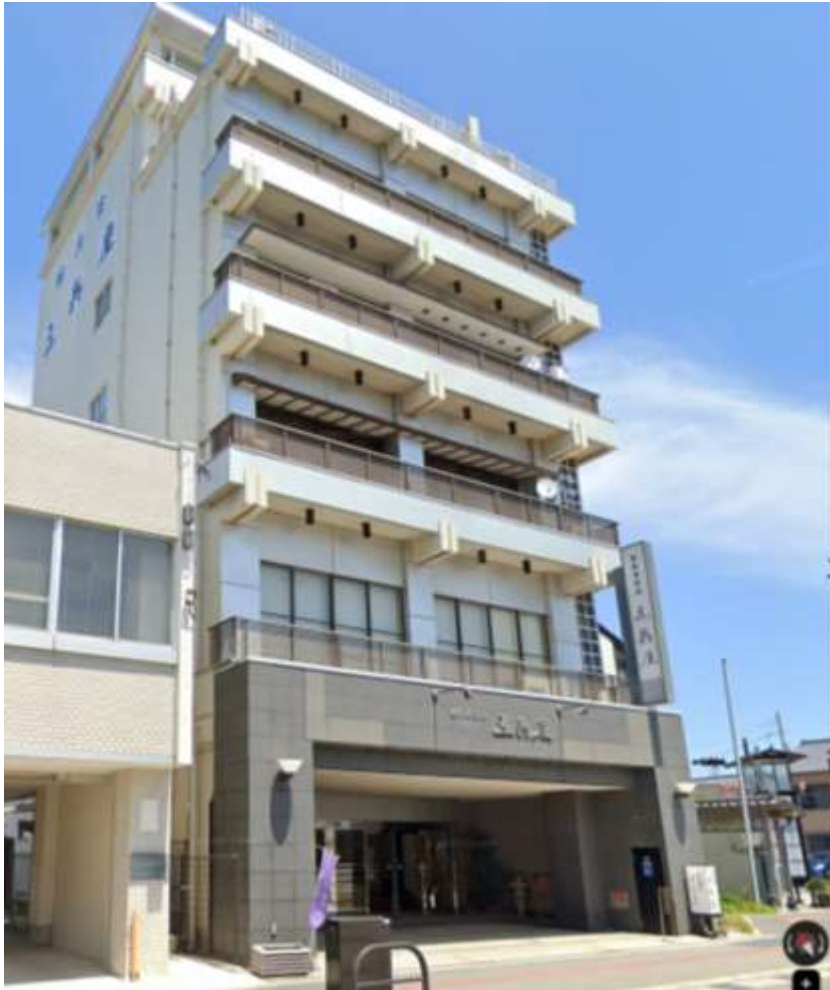
Wajima

7. Collapsed seven-story building (toppled)

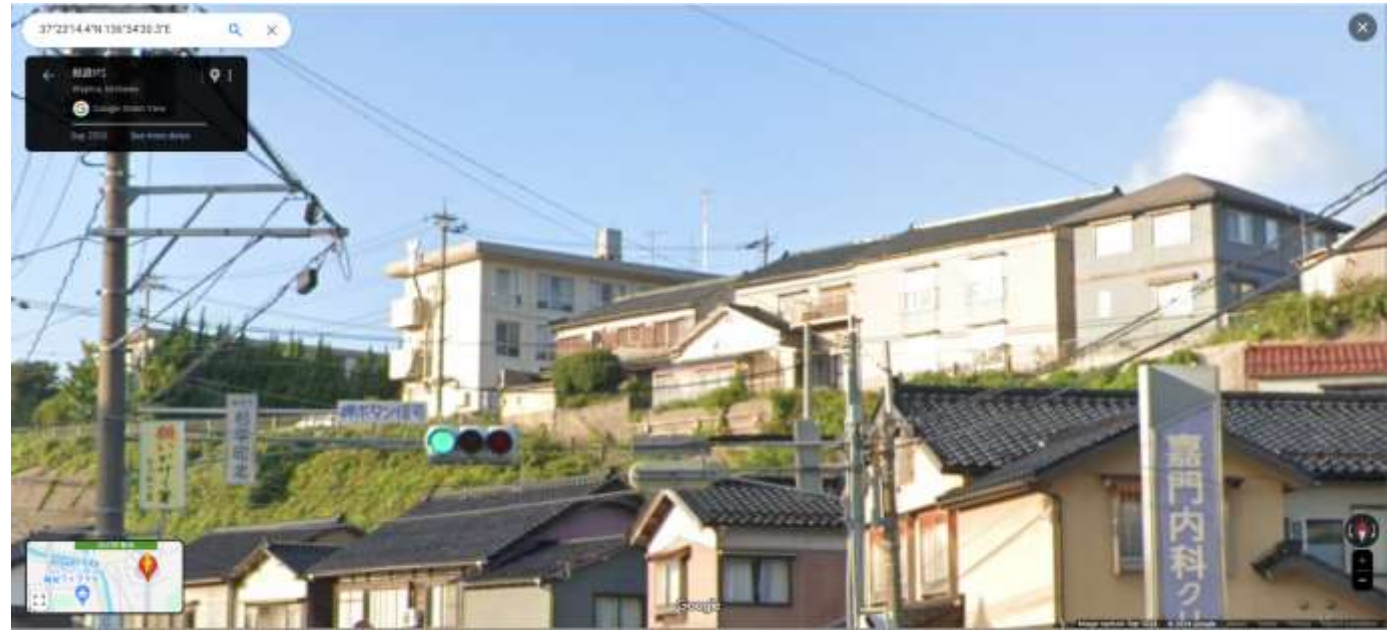
Wajima

9. Houses collapsed due to seismic landslide

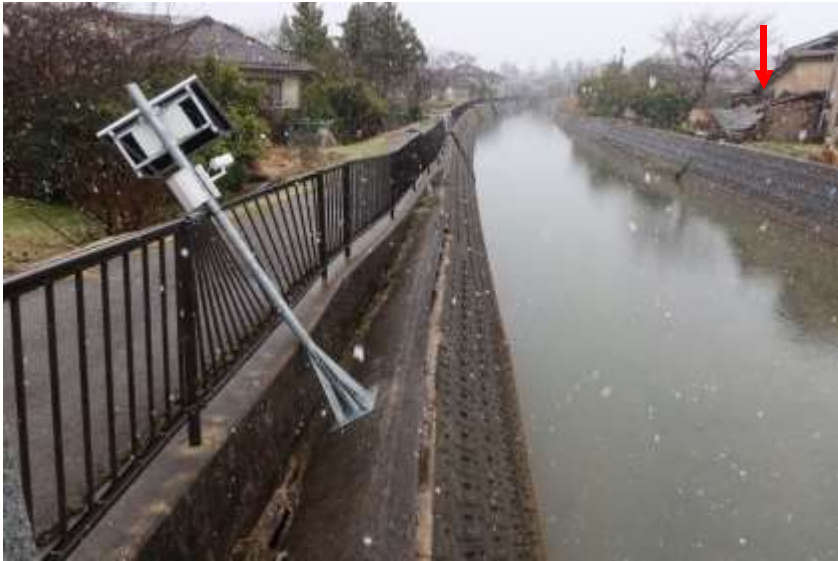
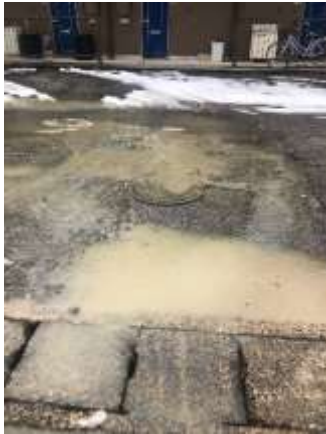
Anamizu

1. House tilted and settled near ISK005

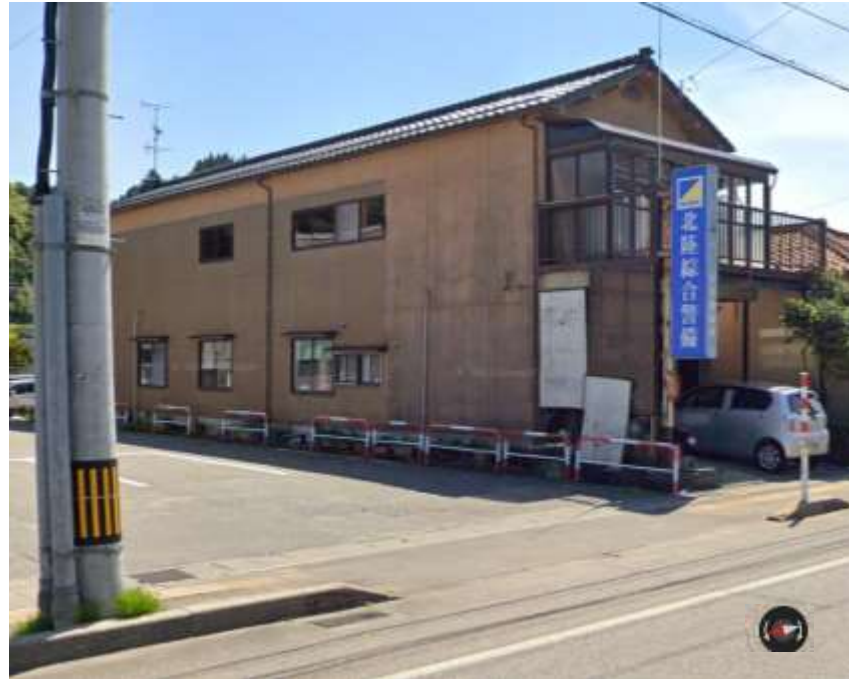
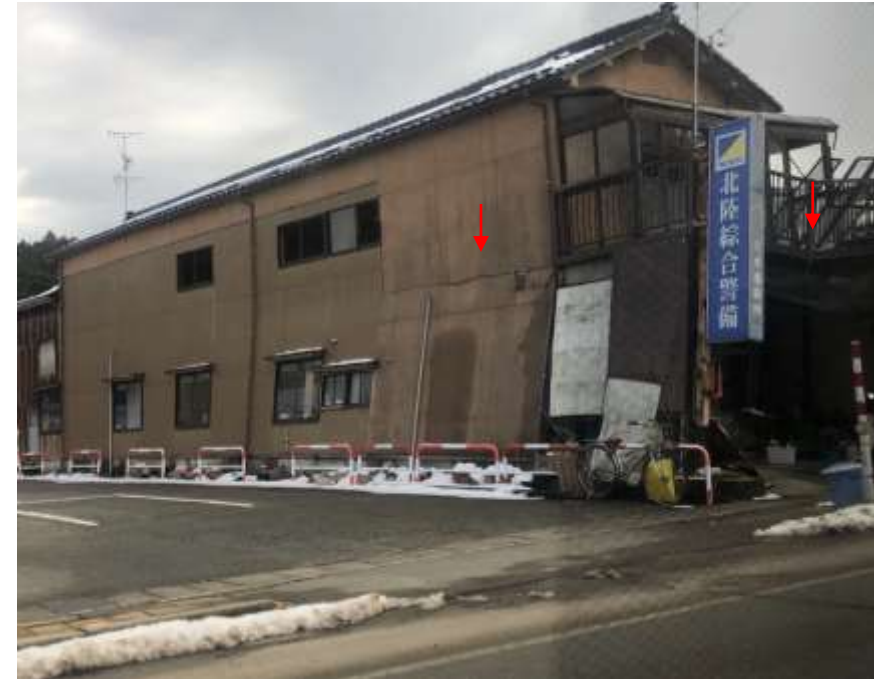
Anamizu

2. Building tilted

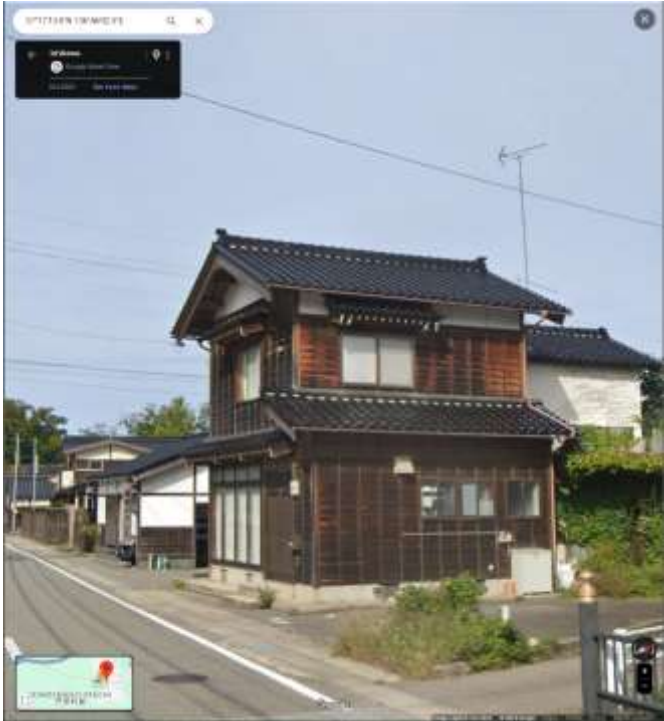
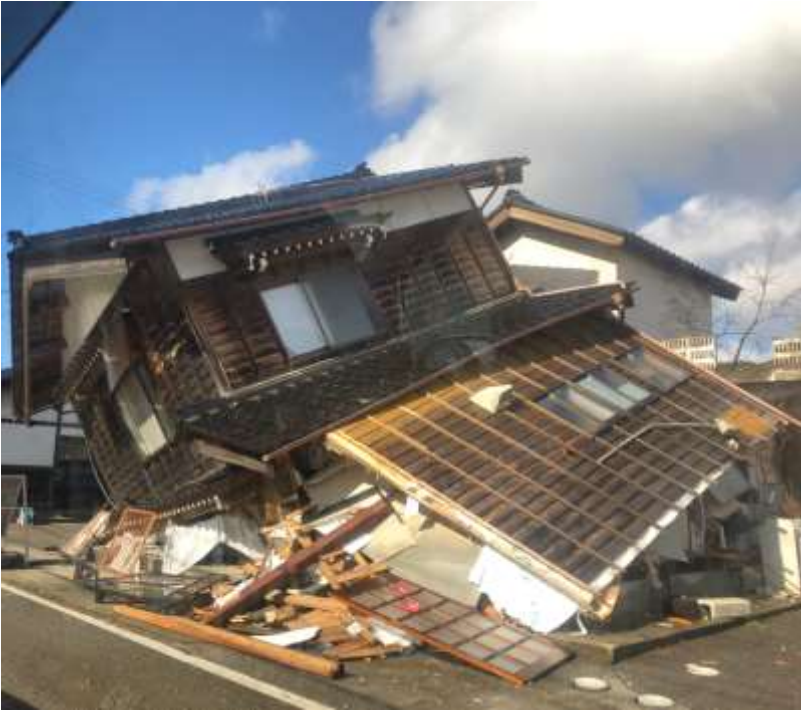
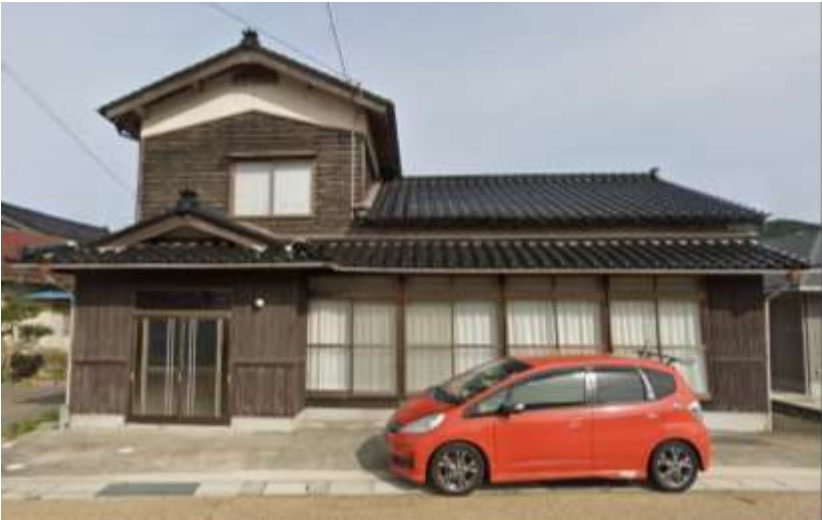
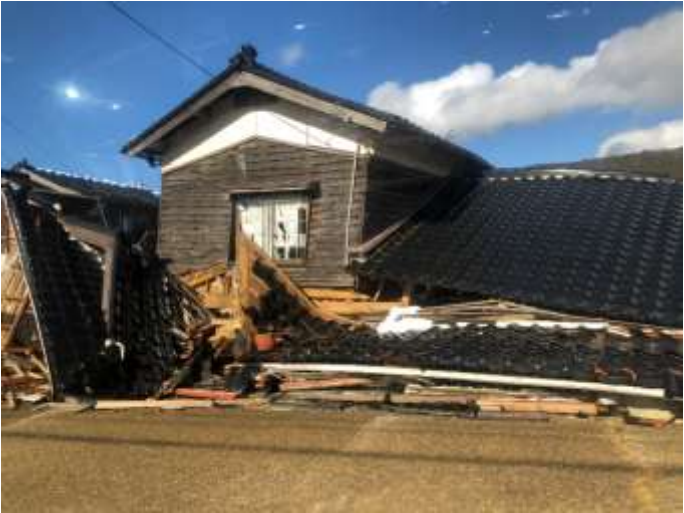
Wajima Monzen

1. Collapsed first floor

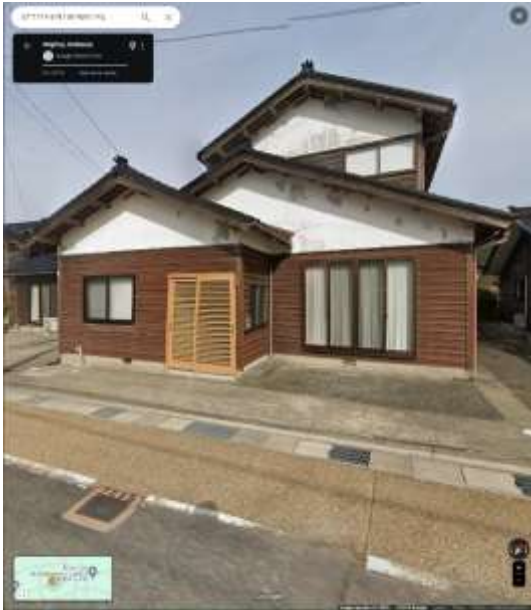
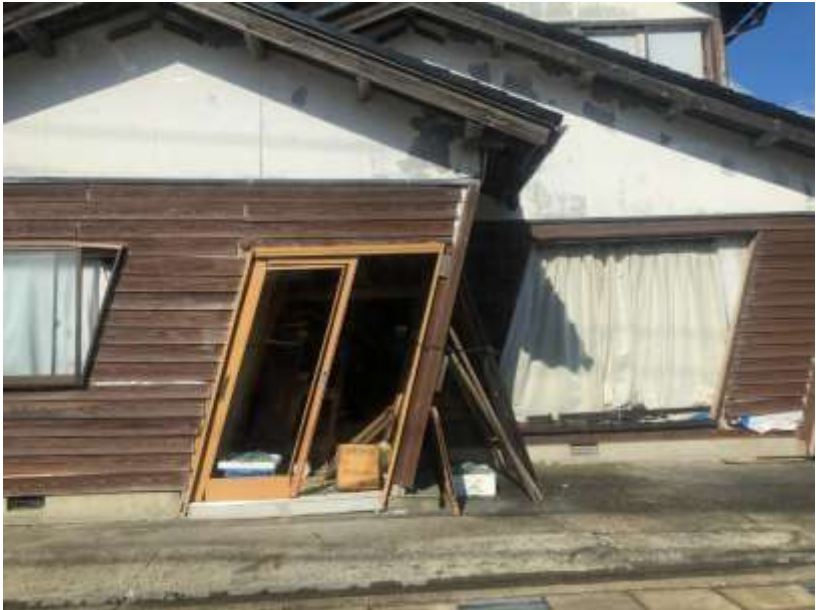
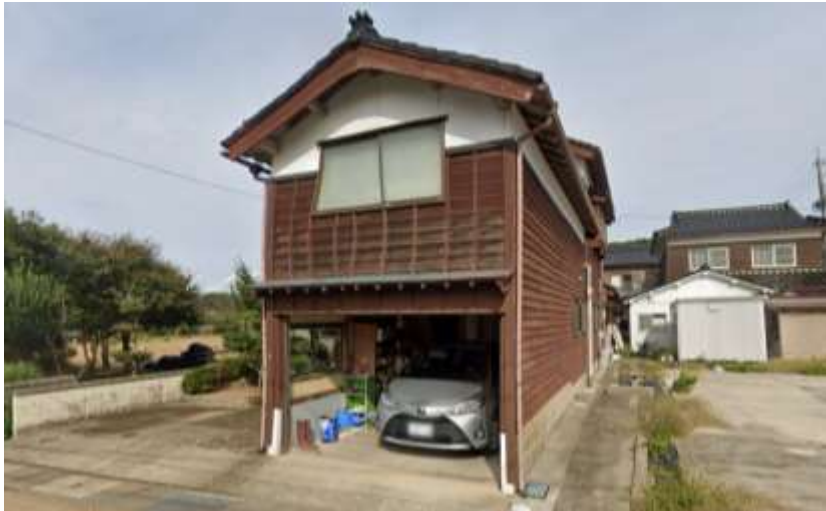
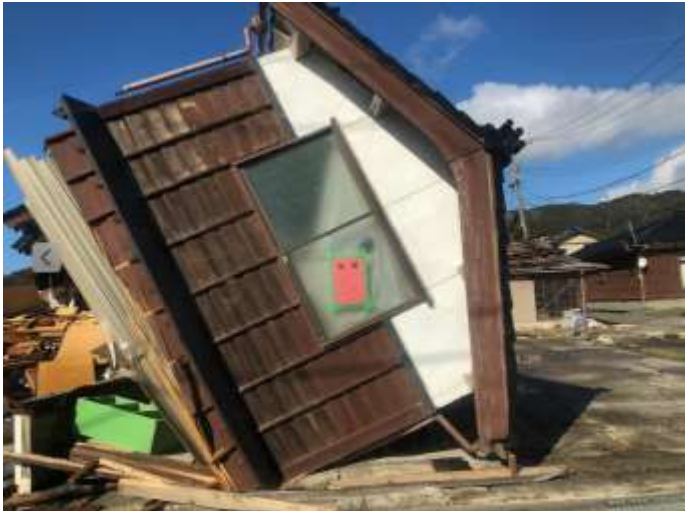
Wajima Monzen

2. Tilted houses

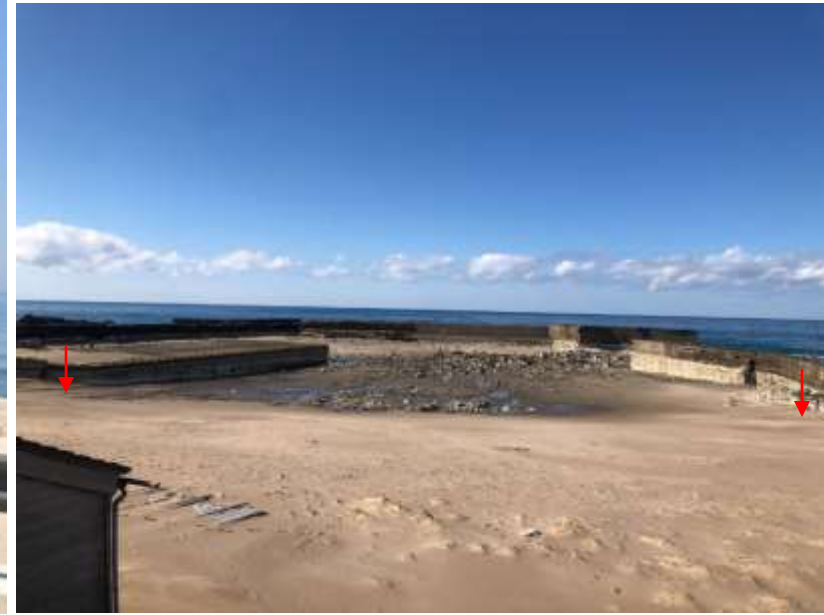
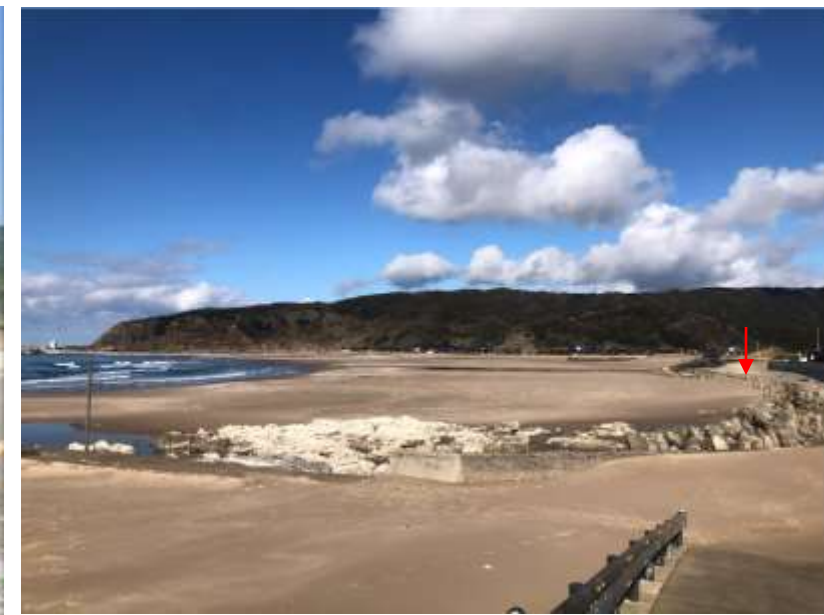
Wajima Monzen

3. Dry port and
Coast uplift

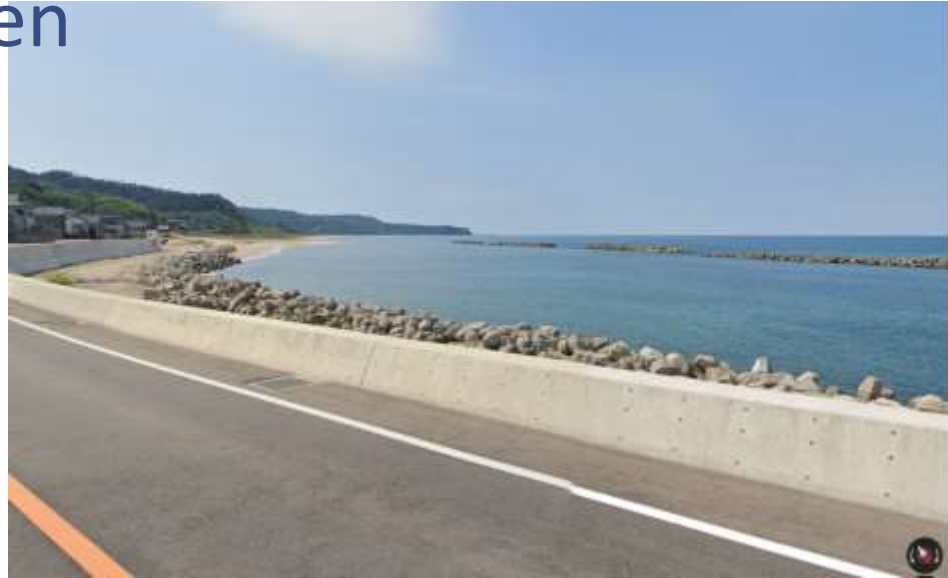
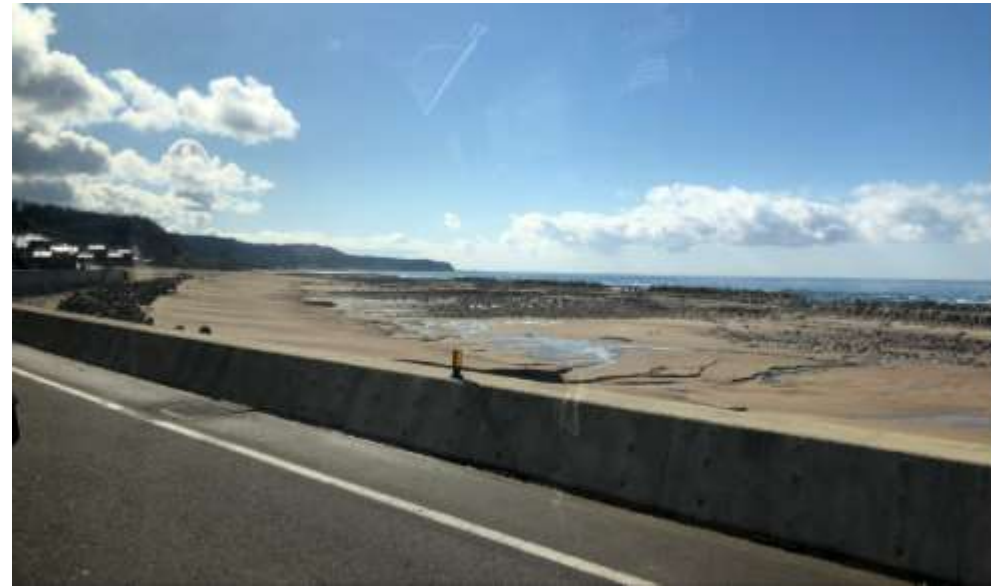
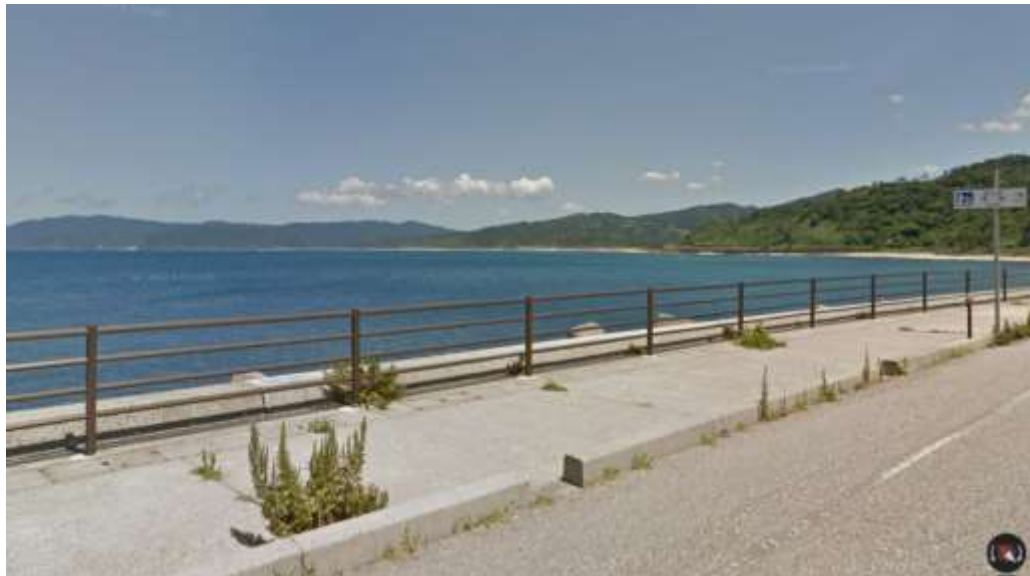
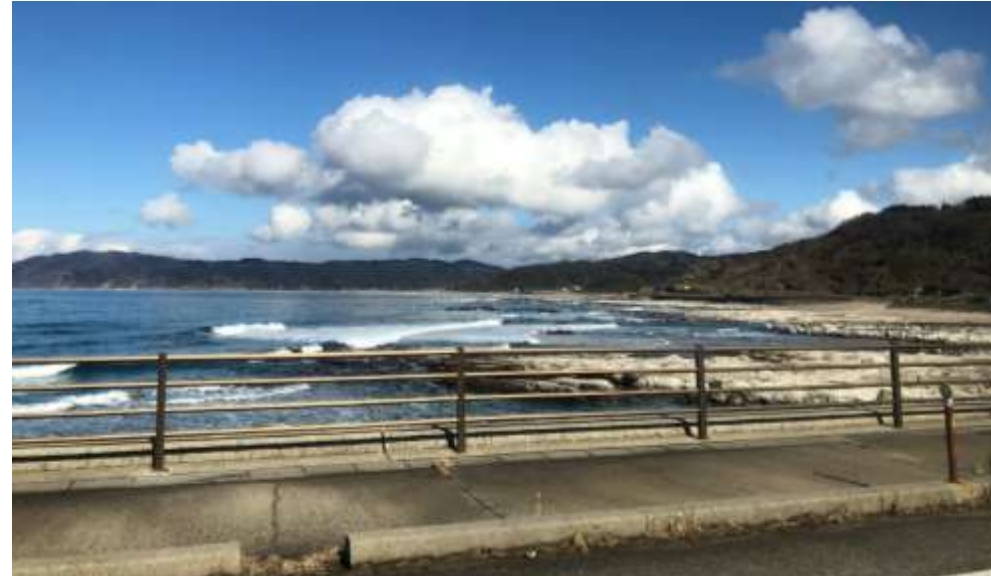
3. Coast uplift

- Many collapsed and damaged wood houses.
- Dry port
- Coast uplift
